Tadeusz Majcherczyk

Zbigniew Niedbalski (niedzbig@agh.edu.pl)

Faculty of Mining and Geoengineering, AGH University of Science and Technology

THE INFLUENCE OF UNDERGROUND COAL MINING ON AN OVERHEAD HIGH-VOLTAGE POWER LINE

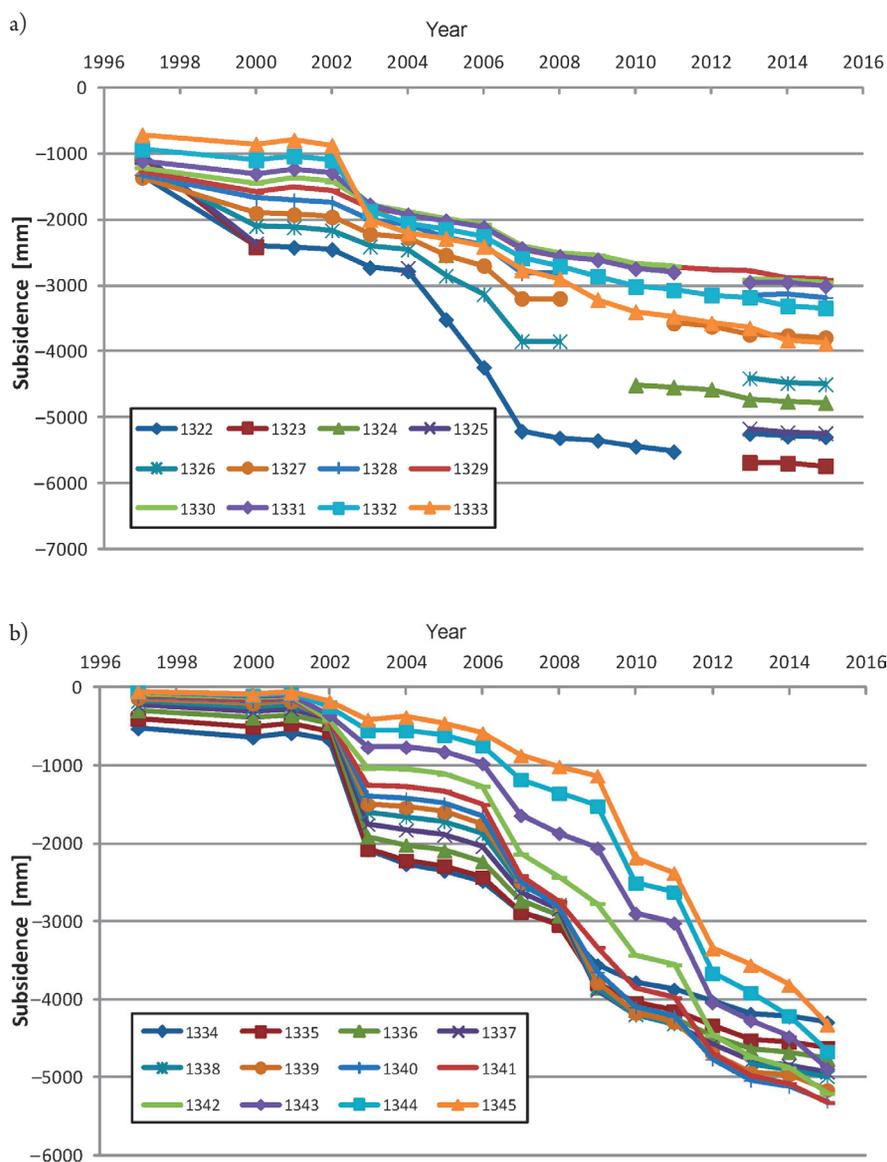
Fig. 2. Subsidence of selected points in measurement line XIII – XIII: a) for points 1322–1338; b) for points 1334–1345

The measurement results indicate that there is a mining-induced surface subsidence in the range 3.0–6.0 m (Fig. 2, 3), depending upon which point was taken as the point of reference. A detailed analysis of the land survey point of reference proves that some transmission pylons subsided by as much as 4.0–5.0 m – this was a change which was not uniform over time and caused uneven subsidence of the pylons, i.e. their inclination from the vertical plane.

The observation study shows that the ground movements and varied direction of the strains (compressive and tensile) caused ground weakness i.e. discontinuous deformations. Mining induced changes occurring in the surface resulted in: changes of distances between the transmission pylon footings; the occurrence of cracks in spread footings; damage to reinforcement in transmission pylon footings; increase or decrease of the sag of overhead electrical conductors.

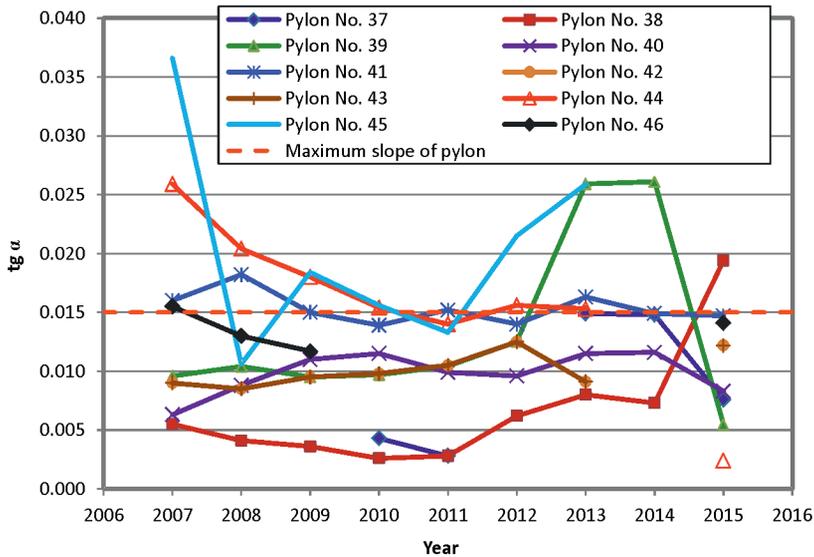
Fig. 4. Change of transmission pylon inclination over time

Due to the varied height of each of the transmission pylons, a different value of displacement the top of pylons from the vertical axis was assumed for each of them. The results of measurements displacements of the tops of the pylons is shown in Table 1. In the year 2015, only transmission pylon no. 38 had exceeded the permissible value of inclination. It was subject to corrective action.

Analysis of measurements from the last 10 years indicates that over time, there are both increases and decreases in the inclination of the transmission pylons – this is related to the intensiveness of the exploitation of the mining areas (Fig. 4). Large decreases in pylon inclination are related to works to restore them to the vertical (e.g. transmission pylon no. 45), and in the case of transmission pylon no. 39, this was due to its total replacement.

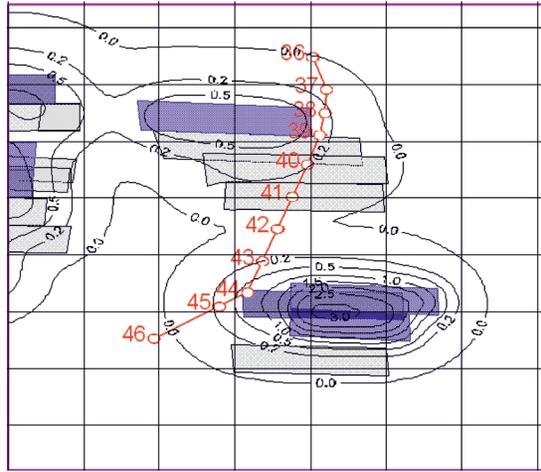
Fig. 6. Target increase of surface subsidence for the mining exploitation planned for the years 2015–2018

Prognostic calculations indicate that the increase of deformation indices for the target situation will assume the highest value in the area of transmission pylons marked as 38, 39 and 44. In the immediate vicinity of pylon no. 44, the subsidence will reach approx. 0.7 m (Fig. 6), whereas in the area of the pylons nos. 38–40, 43 and 45, the surface subsidence will range between 0.2 and 0.5 m. Additionally, at a distance of approx. 500 m east from transmission pylon no. 44, the predicted subsidence slightly exceeds a value of 3.0 m.

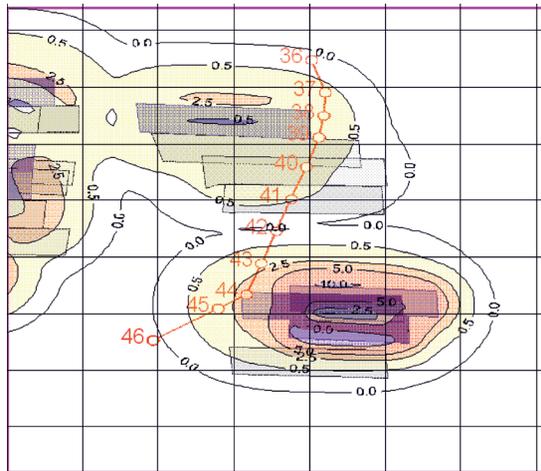
Fig. 7. Target increase of surface tilt for the mining exploitation planned for the years 2015–2018

Surface tilt seems to be a crucial parameter from the perspective of transmission pylon safety. The prognostic calculations clearly indicate that the tilt will reach around 3.0–3.5 mm/m in the area of pylon no. 44, whereas in the case of the remaining pylons, the tilt should not exceed 2.5 mm/m (Fig. 7). The maximum value of this parameter is much higher and slightly exceeds the value of 10 mm/m.

The prognostic calculations also indicate that the mining-induced increase of surface deformation in the period 2015–2018 will result in the increase of deformation indices in the area of the 110 kV high-voltage power line, especially in the vicinity of transmission pylons nos. 43–45 and, to a far lower degree, in the vicinity of pylons nos. 38–40. Hence, the mining exploitation will negatively affect their technical status as it will cause changes in the tension of the overhead transmission lines and, thus, increases in the inclinations of the transmission pylons.

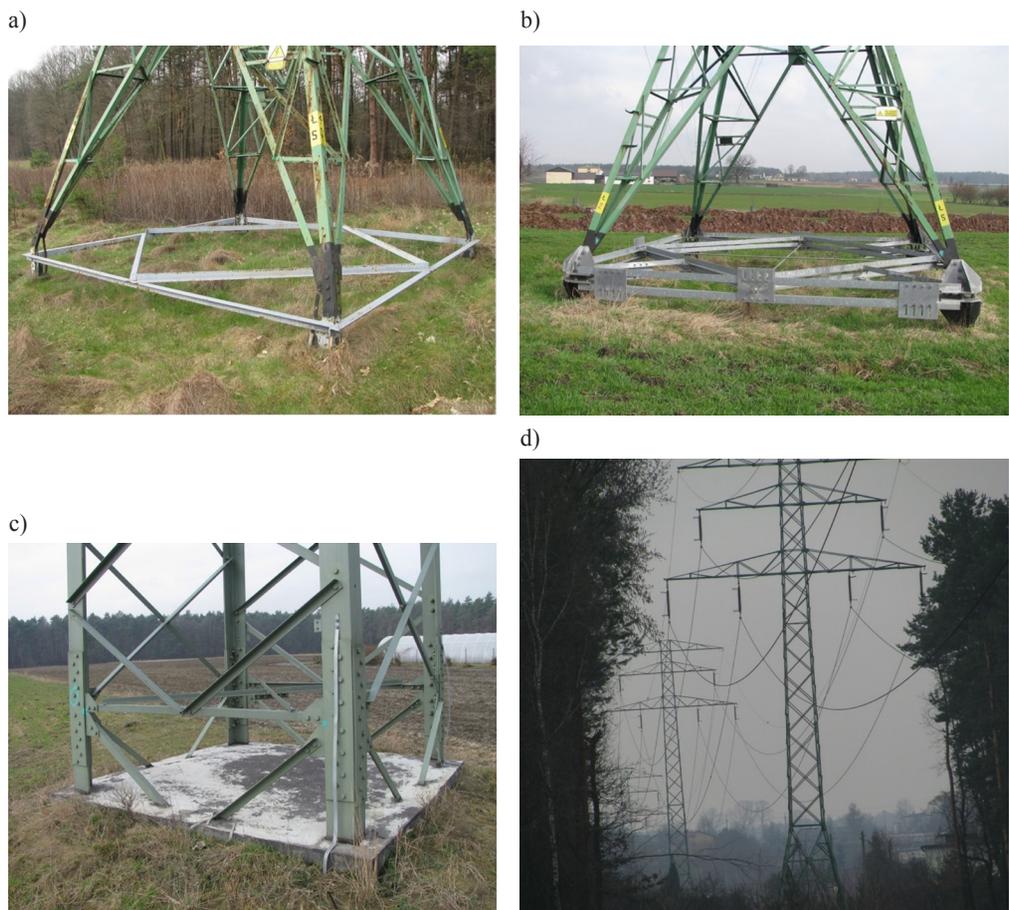
The above-mentioned changes of the terrain surface, as well as their impact on the foundations and construction of transmission pylons and the sag of electric conductors made it necessary to carry out the following repair works:

Fig. 8. Examples of repairs of electric power line: a) bracing of the pylon leg, b) bracing of the leg with the possibility of restoring the pylon to the vertical; c) total replacement of the transmission pylon and its foundations; d) regulation of tension stringing of electric conductors

- ▶ application of additional leg bracing of transmission pylons (Fig. 8a);
- ▶ application of bracing with the possibility of restoring the pylon to the vertical (Fig. 8b);
- ▶ replacement of old transmission pylons (Fig. 8c);
- ▶ regulation of tension stringing of powerline conductors (Fig. 8d).

- ▶ restoring the transmission pylon to the vertical (allowing for a safe usage of the construction) and fixing the bracing frame (if it was not used earlier);
- ▶ restoring the pylon to the vertical by means of steel spacer plates inserted between the curbs of the pylon head and the foundation bolt; the thickness of spacers depends upon the degree and direction of the transmission pylon's inclination from the vertical and the spacing of the bolts;
- ▶ restoring the transmission pylon to the vertical and replacement of all deformed elements of the construction;
- ▶ cutting out the ground under the foundation (only in exceptional situations);
- ▶ rebuilding the whole transmission pylon if its repair proves impossible.
