Microstructure investigation of premature corroded heat exchanger plates

Anna Wassilkowska,
Tadeusz Skowronek and
Stanisław Rybicki, Cracow, Poland

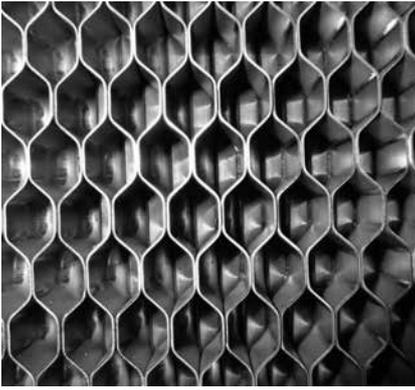
Figure 2: Outside view of an assembly of heat exchanger plates (batch D)

Batch (C) covers strips of material cut from the edge of assembled plates so as not to open the heat exchanger. Batch (D) comes from assembled plates with an increased permeability during hydrogen test (above 10 ppm), which, according to the manufacturer's instruction, must be removed from service (see Figure 2). This PHE was opened and it was found, that plates having worked only about 400 h showed pitting on the water circuit side. The electrochemically active surface area, i.e., the observed pattern of corrosion spots, corresponded exactly to the contact points of adjacent plates.

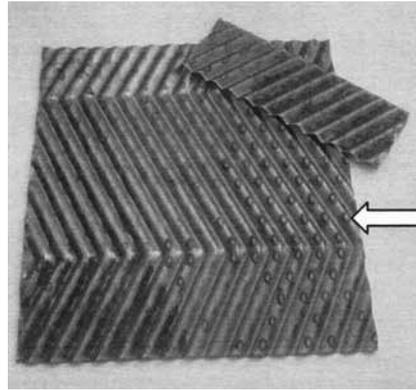
Figure 3: Specimen cut from a leaking heat exchanger plate (batch E), pitting shown with arrow

Batch (E) comes from a damaged plate, taken away during plate exchange in year 2008. It had worked for five years and was already unsuitable for use due to numerous corrosion pits (see Figure 3). Plates hang correctly when placed alternately, i.e., with chevron pointing downwards and chevron pointing upwards [1]. Basically, the leaking places are clearly manifested by regular pattern of burned spots in contact points of adjacent plates.

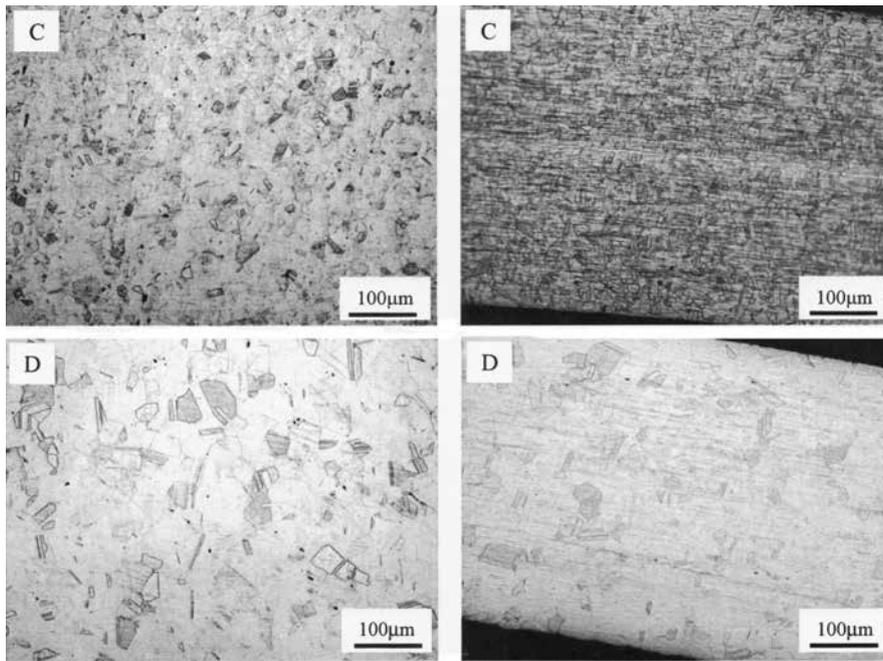
Figure 4: Light microscopy of metallographic specimens: plane section (left) and transverse section (right)

The comparative analysis of the material C and D shows that the size of austenitic grains of specimen D is larger (see Figures 4 and 5). A reason for this is probably a smaller degree of plastic deformation in those plates which have different profiling. It is known that the low degree of plastic deformation (from 3 to 8 %, also called “critical”) leads to an intensive growth of austenitic grains after recrystallization [8].

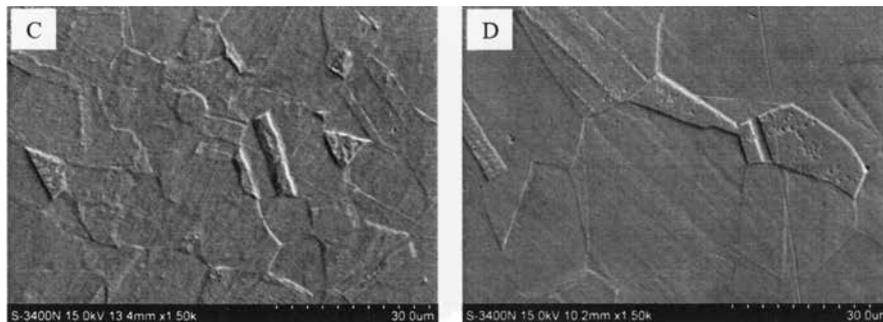
Figure 5: SEM images of plane section (etched) metallographic specimens

More detailed examination of the contents of the elements (even in different grains, see Figure 5) is summarized in Table 2. The measurement was made in ten grains, but only the highest and lowest values for each of the main elements are shown here. It is not possible to characterize the peaks of characteristic X-ray emission from trace elements phosphorus and sulfur (which overlaps with the line of Mo) and from manganese (which overlaps with the line of Cr) [6].

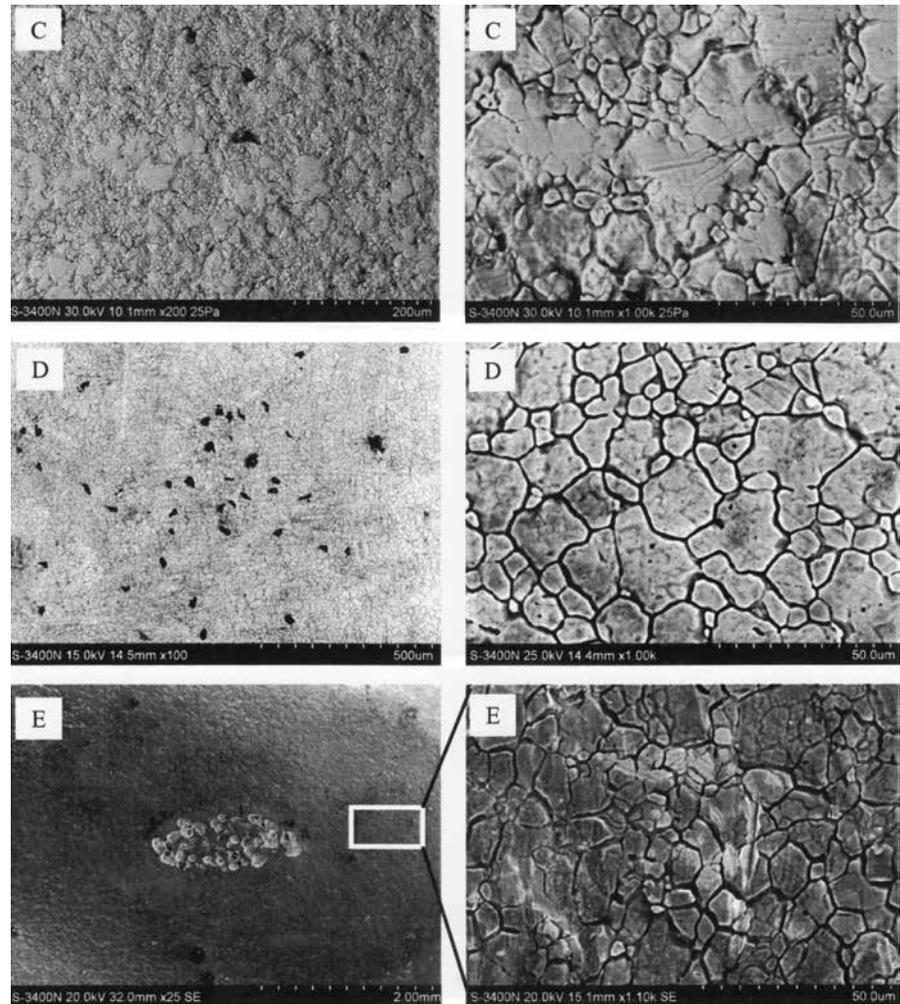
Figure 6 shows the areas of natural convex surface of investigated plates, where the degree of plastic deformation is the largest. When studied under small magnification, an “orange peel” structure was found on the surface of material C, similar to the one referred to for steel grade 304 in [9]. According to [9], the cause of the characteristic surface shape of the deep drawn plates may be one of the following:

On the surface of sample D, many black particles can be seen, mostly uniformly distributed (see Figure 6). They may affect premature corrosion because they are seen only on steel D, therefore an attempt to identify them was made. The EDS spectral analysis of those particles showed that they contain chlorine, sodium and potassium. The presence of these elements in the circulation of cooling water was not expected. However, spectral analysis demonstrated that such elements are present (see Figure 7). These elements could be some particles of salts or solids, but unfortunately, their nature is not clearly established.

Execution of ribbings certainly has an impact on the plate service life. Protrusions or indentations are particularly vulnerable to temperature gradients and water hammer at points of material contact. A detailed SEM analysis of embossing convex zone clearly shows an intergranular structure (see Figure 6). Material C has pronounced grain boundaries which, in the prematurely corroded samples D, are even thicker and deeply indented. The large grain size distribution of both stainless steels could be related to the ongoing recrystallization processes of post-cold plastic deformation. Immediately after recrystallization, the structure consists generally of differently oriented small grains, but due to the significant grain separation surface, the system is in unbalanced energy state [8]. Therefore, the prolonged storage or operation proceedings lead to the growth of individual grains at the expense of the smaller. Obtained structure consists of large individual grains surrounded by small grains. Grains in sample D are also of different sizes, but without surface relief, apparently because of the different degree of cold deformation.

the grains near the corroded places where the plates touch at work, is practically similar (see Figure 6).

Figure 6: SEM images of surface microstructure; C - the "new" plate, D - plate corrosion starts after 400 h of service, E - leaking plate taken off from PHE (end of service life)

Environmental factors could be examined parallel to the materials microstructure characteristics [12]. To prevent the fretting corrosion (the most destructive corrosion mechanism of investigated plates) in the design of the stainless steel PHEs, one should consider the compensation of thermal expansion and avoidance of water hammer.

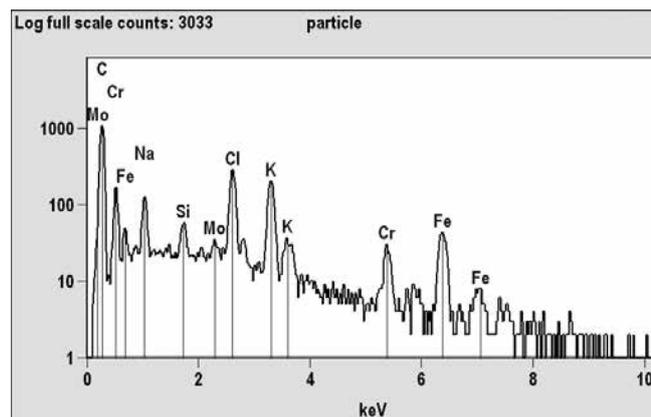
Figure 7: EDS spectrum of dark particles on the surface of material (D)
