HENRYK CIUREJ\*, PIOTR GWOŹDZIEWICZ\*, ANTONI MAZERA\*\*

## ATYPICAL EXAMPLE OF THE REDUCTION OF THE SAFETY AND DURABILITY OF A TYPICAL MOTORWAY OVERBRIDGE

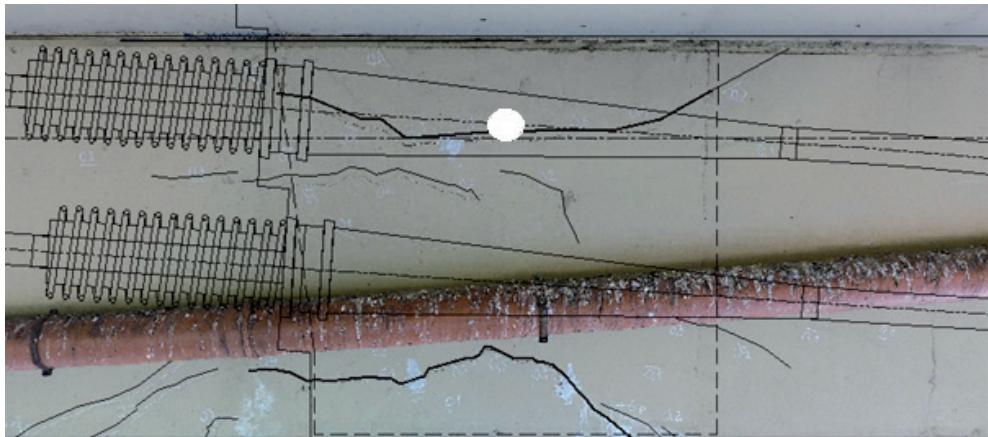
Clearly visible cracks served as the fundamental reason to undertake the tests and evaluation of the technical state of the structure. In the western side span of the bridge, the south girder was the most damaged. Numerous horizontal and skew cracks were concentrated mainly in the area located more than 5.0 m from the support towards the abutment. The area

with a high concentration of cracks is located directly at the construction joint, which is 5.0 m from the support. Fig. 2 presents the crack distribution over the surface of the beam together with the position of the cable ducts and the joint between the construction segments built successively.

Fig. 2. Layout of cracks on the beam surface and the position of the joint between the structure segments and prestressing cable ducts

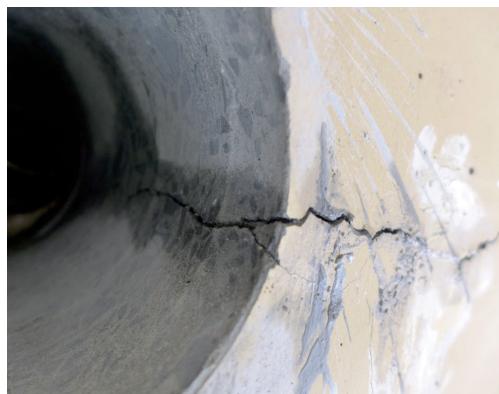
Due to the large width of cracks observed on the member's surface, the decision was taken to drill a core specimen along one of the cracks. The aim of this drill specimen was to investigate the depth and direction of the crack. The drilling was positioned at the level of the axis of the upper prestressing tendon, where the diameter of the cable duct progressively changes from 275 mm at the coupler to 100 mm at the entrance to the regular cable duct. In Fig. 2, the position of the drill is shown (indicated with a white dot). Because the crack width (Fig. 3) observed in the direction perpendicular to the surface was not decreasing, the drilling continued until the steel cover of the cable duct was reached. Inspection of the drill surface revealed the presence of another crack perpendicular to the drill axis and located 80 mm below the concrete surface. This crack is visible in the upper part of the drilled wall, slightly before the steel shield of the cable duct (Fig. 4). The observation of the crack inside of the drill specimen is in line with another observation of the concrete cover spalling – this was confirmed by means of an acoustic check of the concrete surface using a metal hammer.

Fig. 3. Crack position in the drill wall of the beam under investigation

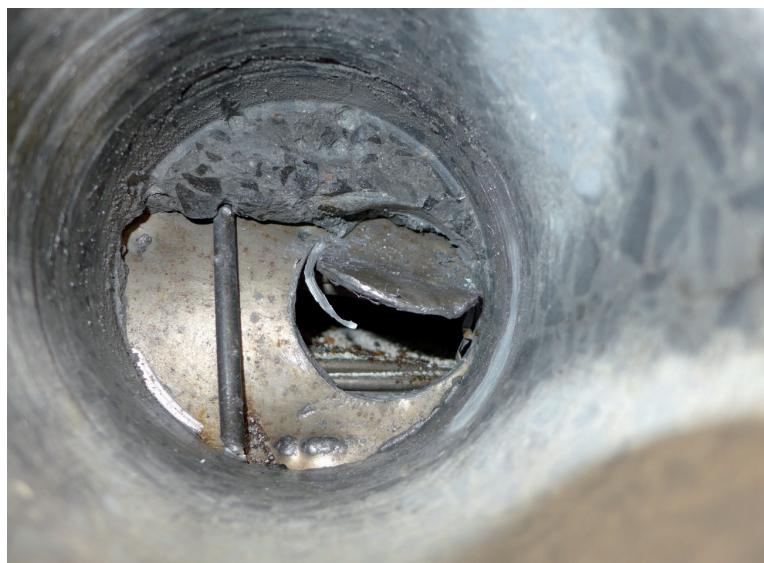
Fig. 4. View into the drilled hole in the girder subjected to investigation. The steel cover of the prestressing cable duct and its interior are visible

Observations regarding materials inside of the structure in the area of drilled cores also brought many interesting observations. After penetrating the cable duct shield, it was found that instead of the duct being completely filled with cement grout as expected, there was a substantial lack of grout (Fig. 4). Punctual corrosion of the stressed, exposed prestressing strands was also found inside of the duct. The mortar filling the bottom part of the prestressing cable duct was non-cohesive – it was in the form of a powder with a grain size of 1–4 mm and with a white-beige colour. The lack of grout in the proper form, local corrosion of the prestressing strands as well as the corrosion points on the surface of the cable duct shield are evidence of the risk of tendon corrosion. The interior of the cable duct is shown in Fig. 6. Naked strands, local corrosion of the prestressing steel as well as of the internal surface of the duct shield was observed. Moreover, concrete splitting from the external surface of the cable duct shield was also observed (Fig. 4).

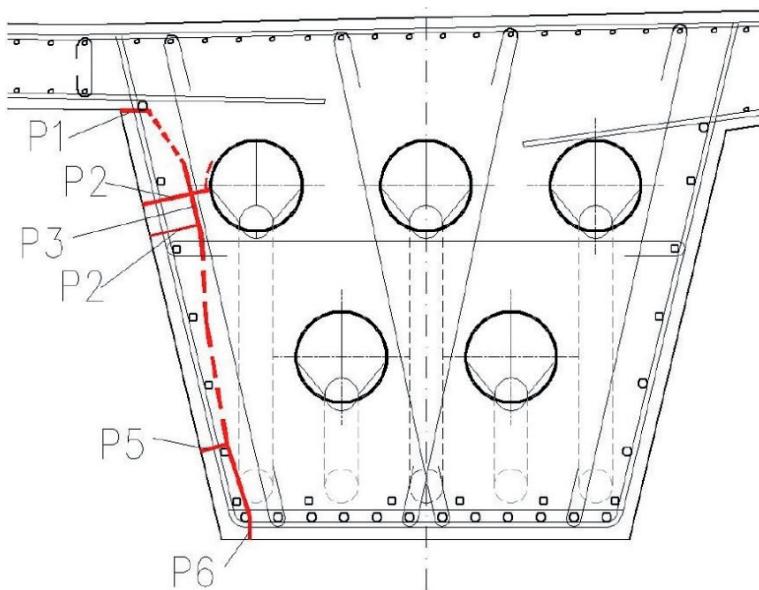
Fig. 5. Spalling of concrete along the depth of the girder – the continuous line represents the observed cracks, the dashed line represents their hypothetical trajectory. P1 to P6 – observed locations of cracks

The acoustic check indicated that the spalled layer occurs on the whole vertical edge of the beam from the slab at its top to the bottom edge and the length of the damaged area along the beam exceeds 2.5 m. The position of the observed splitting and its hypothetical trajectory are shown in Fig. 5.

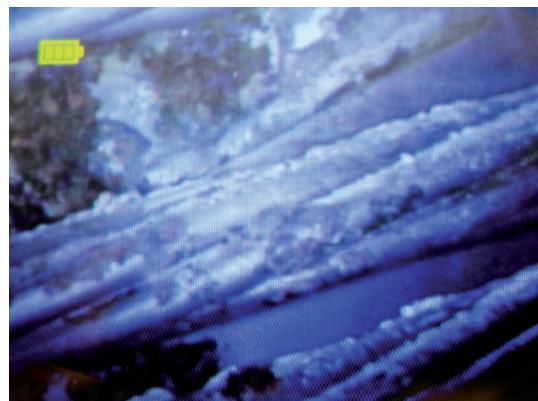
Fig. 6. View of the interior of the prestressing cable duct
