BARBARA MARIA DEJA\*

## RENOVATION OF THE HISTORIC OLSZTYN VILLA CASABLANCA

The paper outlines the details of the design and difficulties that had to be overcome in the course of the renovation and adaptation of a rich German factory owner's residence from 1912, which in 1988 was entered into the register of historic buildings of the Warmia and Mazury region.

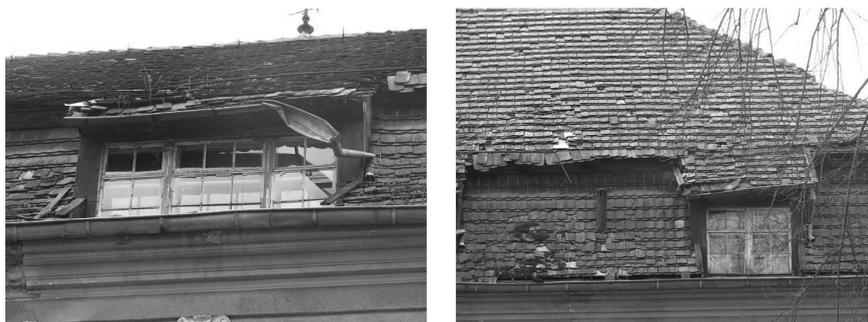
The most extensive damage noticed by the present owners when taking the building over were caused by leaking insulation layers, the failure of the rain water drainage system and losses of roof sheeting (Fig. 12, 13).

The result of flooding was partial fungal infection of the roof structure (which were also infested with wood pests) and floor damage.

Fig. 12, 13. The condition of roofing and guttering before renovation, 2008

Solving the rain water drainage issue, the structural repair of the roof, the replacement of the roofing (new timber and tiles), the protection of terraces and balconies against damp, replacing old plaster and the terrazzo layer and rebuilding the main entrance stairs were considered the main tasks to fulfil.

The roof structure required only minor repairs, but the roofing was completely replaced (the colour of the new plain tiles perfectly matched the original).

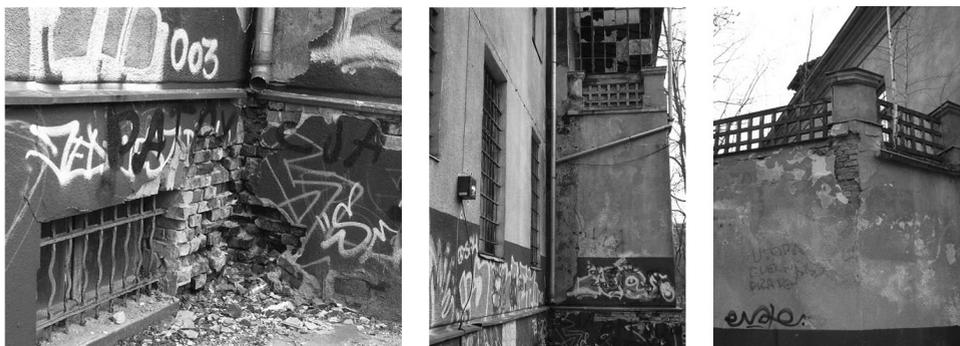
The dampness of the walls, escalated by recurrent freezing and thawing, caused numerous seam failures as well as the powdering and flaking of plaster. Areas of the walls striped of plaster were infested with micro-organisms. The destruction of the walls increased because of the cement plaster that was applied in the mid-twenties of the 20th Century being too permeable to water vapour [5].

Some parts of the plinth walls were also damaged due to rain water gathering caused by failure of the original sewer system. In the second half of the 20th Century, the plinth walls were fixed with terrazzo but it also did not help and finally went off especially around the main entrance and around the drain pipes (Fig. 14–16).

The cornice under the roof and the stuccowork details around the windows (covered with sealing cement, and few layers of emulsion paint) were constantly soaked with water which resulted in many seam failures and chipping. The terraces and the walls beneath lacked tight horizontal waterproofing. The most exposed elements of the elevations and the external stairs were also severely damaged by rain water (Fig. 16).

Fig. 14–16. The damage to walls caused by soaking, 2008

The old, damaged plaster of the diverse structure covering the external walls, which was successively repaired by applying more new layers in the past, was removed, and after scrupulous stratigraphic studies, the original colour of the elevation was restored.

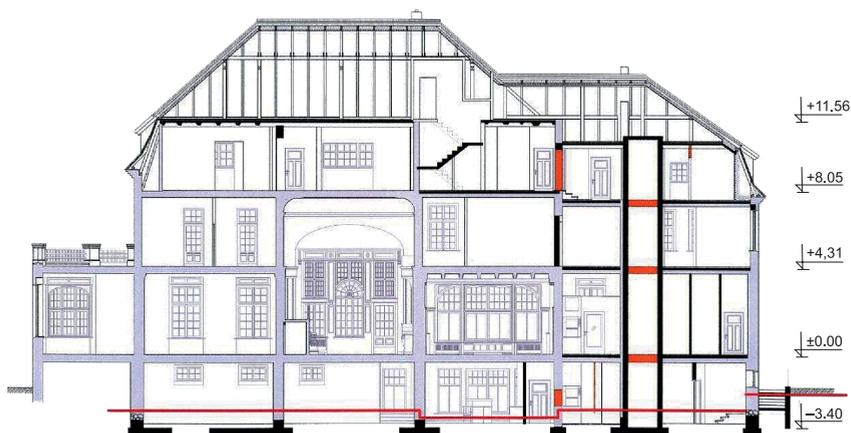
Fig. 19. Longitudinal section of the Villa Casablanca, 2010. The red line indicates the cellar floor level before the deepening of the basement

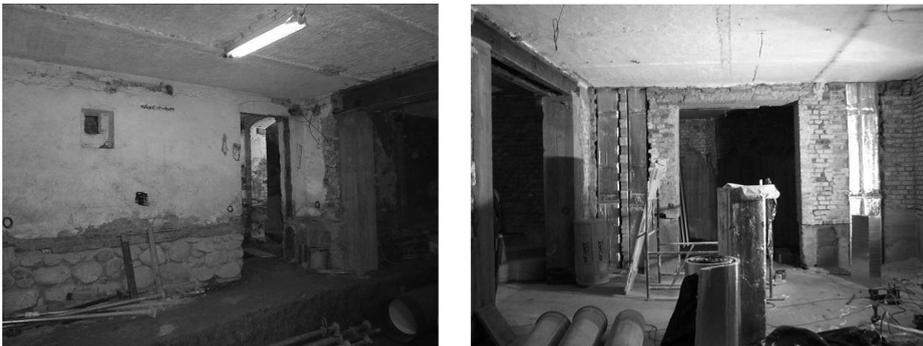
Fig. 21, 22. The works of deepening the cellar, 2011

The decision of locating a restaurant in the cellar required the removal of some of the walls and the lowering of the floor level, hence lowering of the foundations. In the foundation design (proceeded according to Eurocode 7 [12]) there were many elements that had to be considered, and namely the relocation of bearing walls and bigger load of the building as a result of the functional changes and the allocation of the ventilation channels under the floor of the cellar (Fig. 21).

In order to make the usable height of the underground rooms greater than 1.0 m, the cellar walls were partially undercut and founded on the monolithic walls and the strip foundation (Fig. 22). Work was conducted with a high degree of diligence in order to avoid damaging the ceramic, segmental ceilings above the cellar.

The sectional strengthening of the foundation was made alternately from both sides of the walls. The excavated wall segments were cleaned of debris and the brims were hammered to the required level of the designed floor and finally, after setting up reinforcement bars,

they were filled with concrete of C16/20 class. The reinforcement of the foundation was conducted successively after reaching the required strength in the previously repaired foundation sections.

The foundations were covered with a damp proof course. The foundation walls and cellar walls were isolated with waterproof plaster and a cover against mechanical damage.

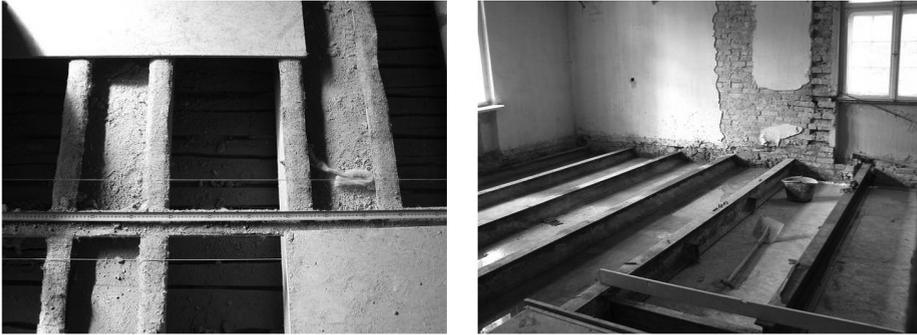
In the main part of the building, where the historic value of the ceiling is considerable and the strength of the wooden beams is insufficient (calculations made acc. to Eurocode 5 [15]), the cross-sections of the beams were reinforced by fixing additional timber elements on both sides of the beams (Fig. 23). The gaps between the beams were filled with mineral wool – additionally, fiberboard was used as sound insulation. Fire protection was guaranteed thanks to the paneling of the ceilings with fireproof materials (this protection was applied only from the upper side due to the need to preserve the original stuccowork of the ceilings).

Fig. 23, 24. The timber ceiling beams strengthened by additional wooden elements from both sides, and a new R-C ceiling based on steel beams, 2011

In the lower part of the building, because of the installation of lifts and the demolition of a part of the bearing walls as well as large load changes, new R-C I-bars ceilings were designed (Fig. 24). These ceiling slabs are made of C16/20 class concrete reinforced with 34 GS steel, resting on the steel I-bars which were put in previously prepared chases in the old masonry bearing walls or new steel binding joists replacing some of the areas where the walls were demolished.

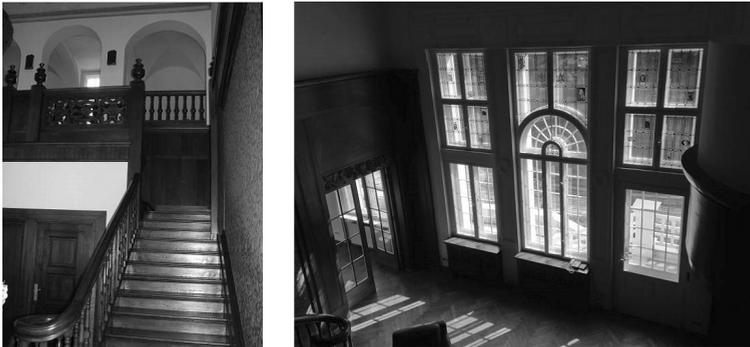
Fig. 25, 26. The historic staircase and the stained glass window in the ballroom after the renovation, 2013

The original, presentable, wooden staircase from the conference hall in the ground floor was restored (Fig. 25), as well as the ceramic stairs on steel beams in the maintenance area of the building. On the ground floor, to the left of the main entrance, a new staircase leading to the restaurant was made (Fig. 20).

The stained glass window in the ballroom (Fig. 26), as with most of the windows and interior doors (including a two-winged sliding door, hidden in the wall), was renovated. In the publication [16], there is a detailed description of the complex conservatory concerning the historic windows of Villa Casablanca.
