THE EFFECT OF TRADITIONAL STRUCTURAL  
ELEMENTS OF PARTITION WALLS  
IN RESIDENTIAL BUILDINGS ON THE QUALITY  
OF THE USE OF THE PREMISES

This paper describes the phenomenon of mould growth on the inner surface of partition walls of multi-block constructed residential buildings. An assessment was undertaken of the impact of the resulting damage, in terms of health and safety of residential premises.

The study focused on one of the buildings of the Bytom housing estate. The selected property is a multi-block technology construction, using the WBS system – Big Silesian Block. The external construction walls are comprised of light-coloured concrete blocks, 32 cm thick, and are insulated with 12 cm PGS cladding. The curtain walls and canopy hooded walls of the vented flat roof were fortified with PGS blocks with a thickness of 24 and 19 cm. During its period of use, the building has been insulated with 5 cm thick mineral fibre panels and exterior wooden panels have been coated with asbestos-cement.

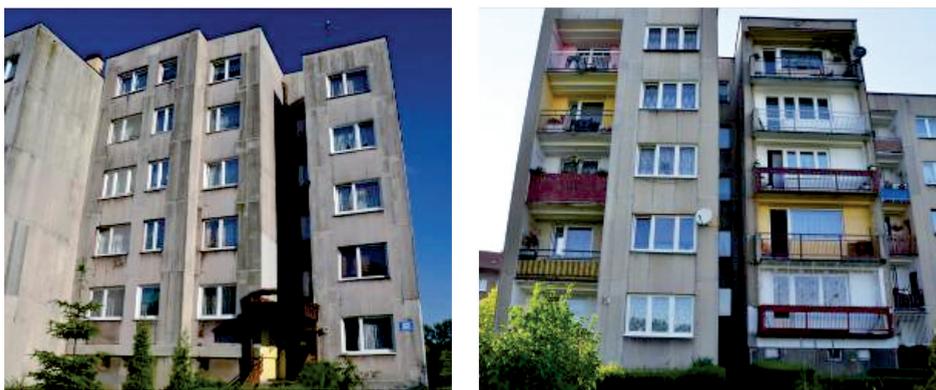
Fig. 1, 2. Bytom, view of the surveyed building, north-west elevation (1) and south-east elevation (2)

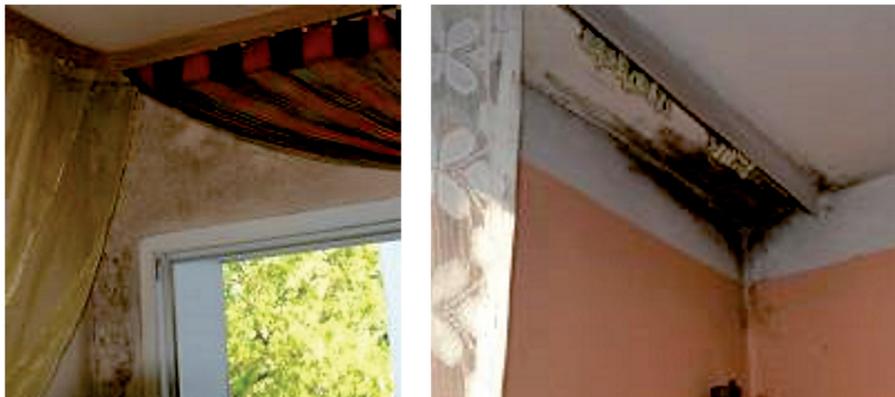
In June 2013, the building was subject to a visual inspection, in response to residents reporting a problem with mould affecting partition walls in part of the premises. The surveys confirmed that mould had affected the inner surfaces of the walls and small areas next to ceilings. Spores were located in corner positions, at the juncture of the curtain walls and external structural walls, mostly next to loggias (recessed balconies on the south-east elevation), but also on the north-west elevation.

calibration protocol No. 02356831). Moisture values were given as a percentage value expressed in relation to dry material mass. The level of humidity present on the inner surfaces where mould damage had occurred, ranged between 1.3% to 2.8%. An increase in humidity of 3.2% to 5.4% was recorded at the north-west side on the second and fourth floors.

Fig. 3, 4. The view on mould outbreaks on external walls: detail D1 (3) and D5 (4) in flats on second floor

Detail	Site of occurrence	Floor	Humidity
D1	wall	1	1.8–1.9%
		3	1.9%
		4	1.7–1.8%
D2	wall	1	1.9–2.5%
		2	1.8–2.1%
		4	2.5–2.7%
D3	wall	1	1.6%
		2	1.3–1.8%
D4	wall	4	5.4%
D5	ceiling	2	5.0–5.2%

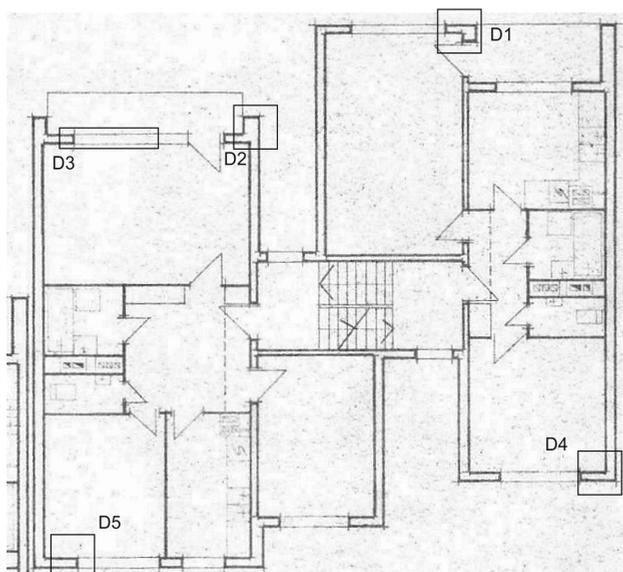
Detail\_1: connection of recessed balcony wall with curtain wall

Detail\_2: connection of recessed balcony wall with curtain wall

Detail\_3: connection of balcony panel with curtain wall

Detail\_4: corner of wall (juncture of block wall and PGS block wall)

Detail\_5: juncture of ceiling and curtain wall

Fig. 5. Sites of mould occurrence and details

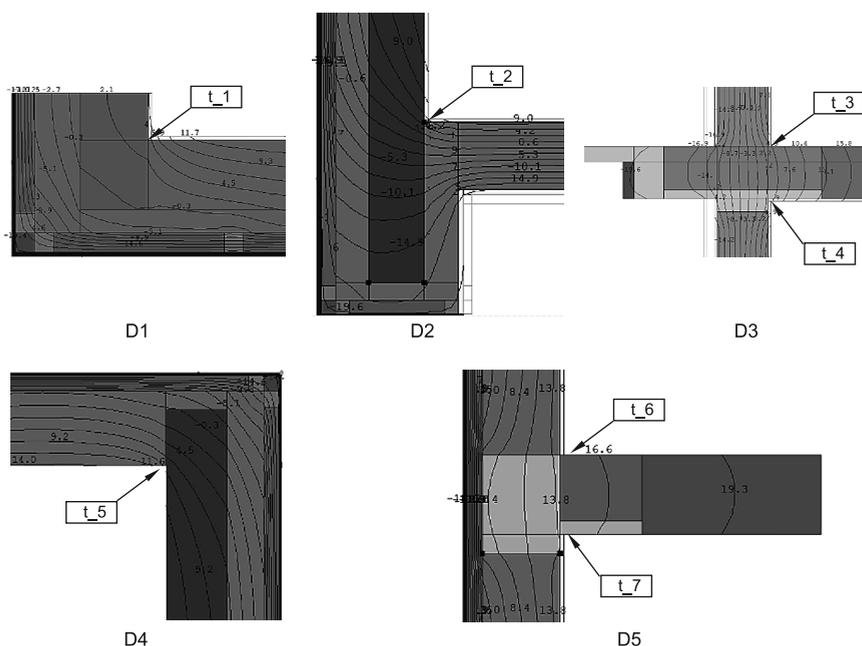
Fig. 6. Geometric models of details and locations of temperature readings

Scheme	Surface temperature determination method	Temperature in joint [°C]		Temperature factor $f_{Rsi}$	
		Variant_1 $t_i = 20^\circ\text{C}$ $t_e = -20^\circ\text{C}$	Variant_2 $t_i = 20^\circ\text{C}$ $t_e = -2.4^\circ\text{C}$	Variant_1 $t_i = 20^\circ\text{C}$ $t_e = -20^\circ\text{C}$	Variant_2 $t_i = 20^\circ\text{C}$ $t_e = -2.4^\circ\text{C}$
Detail D1	t_1	4.8	11.5	0.62	0.62
Detail D2	t_2	6.7	12.4	0.66	0.66
Detail D3	t_3	4.5	11.2	0.61	0.60
	t_4	3.7	10.8	0.59	0.58
Detail D4	t_5	8.6	13.6	0.71	0.72
Detail D5	t_6	14.7	17.0	0.86	0.86
	t_7	14.4	16.6	0.86	0.84

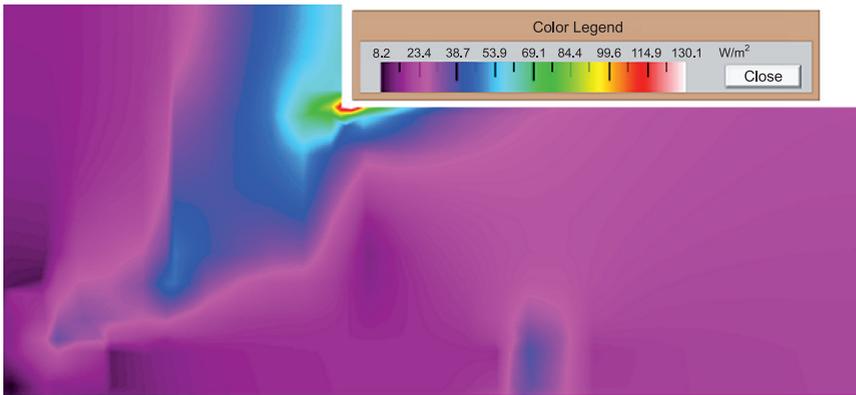
Fig. 7. An example of the heat flux density distribution in the cross-section – Detail D\_1

The calculation results indicate there is a risk of surface condensation and of the formation of mould in both of the computed variants, in the joints marked D\_1, D\_2, and D\_3. These partitions have complex material elements and characteristics. A concrete (class B20 according to the old marking) core joint, reinforced with plain bars, with favourable thermal parameters (shown in details D\_1 and D\_3), is in place alongside the light concrete elements of the wall. In comparison to the temperature reading of the D\_1 structural wall and curtain wall combination (i.e. wall blocks with PGS blocks but without a column

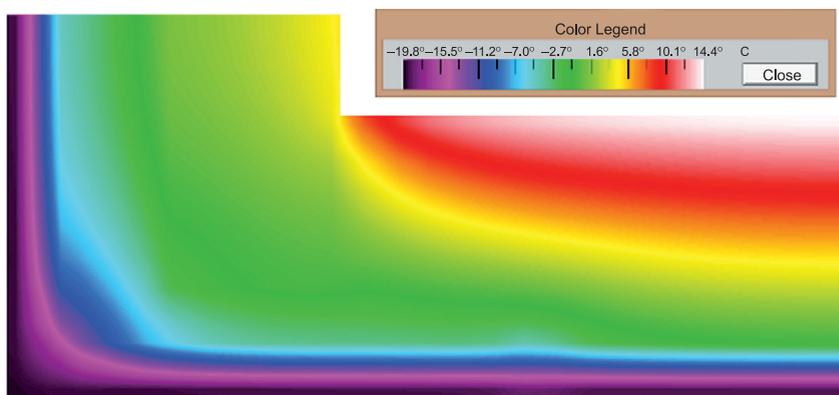
Fig. 8. An example of the field temperature distribution in the cross-section – Detail D\_1
