SELECTED ISSUES CONCERNING RECONSTRUCTION OF THE PALACE COMPLEX IN GORZANOW

The paper discusses an assessment of the technical condition of the historic Palace Complex in Gorzanow, and the reasons behind the damage incurred to its structure. The research has been carried out by the authors. The article presents the scope of implemented repair work intended to secure the building against further degradation, as well as a work plan that would make it possible to fully reconstruct the most valuable qualities of the palace in Gorzanow. The primary focus of the article has been applied to technical and organisational issues, regarding an ambitious endeavour to restore the building in question to full functionality and serviceability.

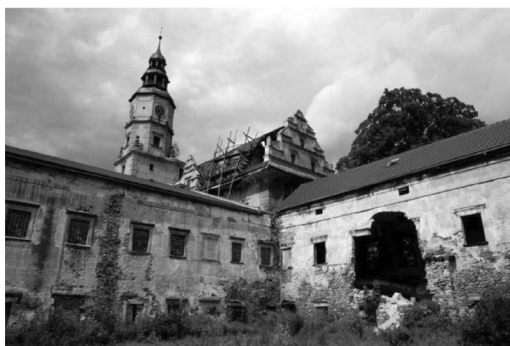
The highest level of damage was recorded in the central part of the palace – the east wing (Fig. 1), where incorrect repair work resulted in destroying parts of the roof. The original roof was covered with red shingles, and then roof tiles. The roof was later covered with ceramic tiles during repair work. The scope of repair work did not include reinforcing the wooden structure of the rafter framing, which demonstrated symptoms of biological corrosion that resulted from numerous areas of damp, which was almost certainly due to the effect of the bad technical condition of the roofing. The excessive loading on the rafter framing, due to much heavier ceramic tiles being placed upon it, led to the collapse of that part of the roof. Load-bearing walls of the building were all that remained in the area of that construction disaster. The east wing that did not collapse was however leaky and each successive storey downstairs demonstrated numerous defects, which was a result of the impact of the precipitation of water. The following can be listed as the most frequently recorded types of defects: partial and complete failure of floors; significant development of biological corrosion on dampened materials; damage to stucco decorations on ceilings; damp in load-bearing walls, including loosening of plaster, and degraded structure and painting decoration on the crowning cornice. A large number of defects have also been discovered in the west section of the building – which contained residential rooms, as recently as 2011. The defects resulted from lack of roofing, both wooden elements and the masonry structure.

Fig. 1. View of the facade and roofing in the east wing, on the day of August, 2011 [2]

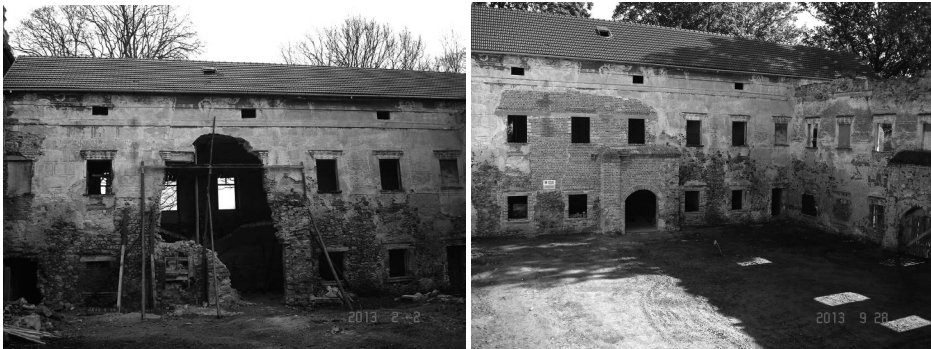
The majority of the roof had collapsed under its own weight, resulting from a lack of maintenance and poor technical condition of the rafter framing. Severe damage was also observed in the staircase in the west wing, which could possibly lead to a dangerous failure. Thanks to the good condition of the roofing (modern roofing systems), the north and south wings have been preserved in significantly better condition. The south wing features a number of modern structural solutions, while many elements of the wooden floors have been cut out (removed), due to poor technical condition. As for the brick vaults on the ground floor, they required securing. The polychrome Renaissance ceilings in the north wing have been well preserved. The defects recorded in the north wing primarily consist of large cracks on the external walls, looking from the north side. This structure contains buttresses, which were added some time after the palace itself had been built. This led to the conclusion that the cracks in that part of the building have been present for a long time. The reason for that could be an unstable foundation, which demonstrates significant damp and a high level of underground waters, on that side of the palace. The administration wing has also demonstrated numerous cracks.

Fig. 2. View of the administration wing and repairs which have been made using ceramic brick. Left side is a view on the day of February 2nd, 2013 to the right as at September 28th, 2013

Securing of the structure included carrying out of 500 m³ of rebuilding (bricklaying), which was primarily related to the elements that demonstrated significant fracturing, cracking and defects. The work seldom involved reconstructing entire wall elements, but in some cases, load-bearing walls and ceilings were rebuilt. All repairs were carried out using ceramic brick, regardless of the different types of materials used to erect the original wall structures in the palace (Fig. 2). The dormer windows on the roof in the east wing have also been restored and filled in, during masonry work.

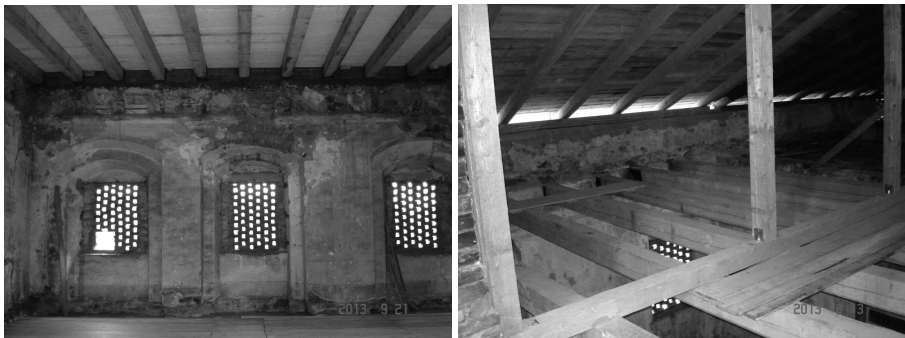
Fig. 3. Wooden beam-framed floors restored in the north wing of the palace

In addition, the securing of the building consisted of repairing and restoring the wooden beam-framed floors present in the palace (Fig. 3). All wooden elements were surveyed, based on which it was possible to select which elements could be left in place or reinforced, and the ones which had to be replaced. Some wooden floors have been replaced with floors based on pre-tensioned pre-stressed concrete, placed in the existing pockets, which enabled work to be completed more quickly.

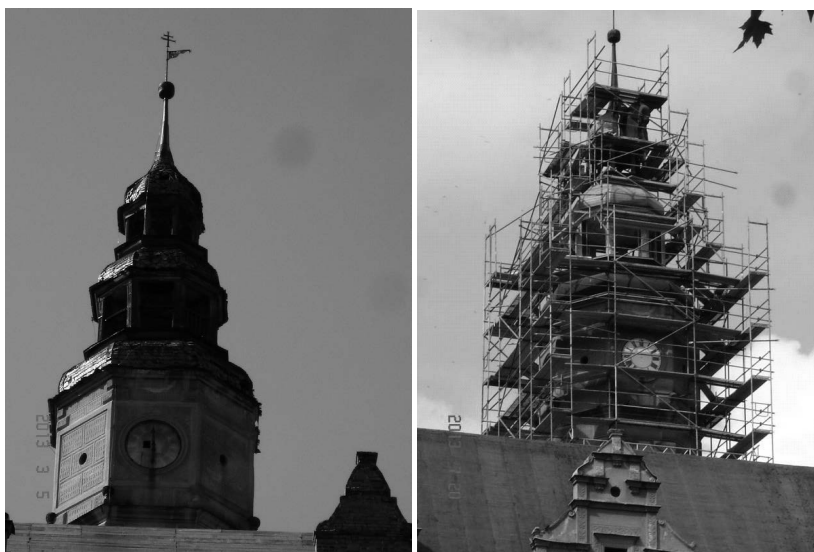
The condition of wooden beams and all other structural elements of the palace's tower cupola turned out to be far worse than initially thought (Fig. 4). Similarly, the rafter framing in the main building turned out to be in far worse condition than was expected after the initial assessment. Additionally, the weather at the end of 2012 and the beginning of 2013, as well as in the first months of 2013, did not permit the covering of the decked roof over the main wing with roofing paper, which extended the period in which the interior was soaking with water, and rendered it impossible to undertake work which was necessary in order to secure Baroque ceilings covered with stuccowork. This brought about many concerns, regarding the soaking walls which still contained precious decorations, including among others the ones in the *Sala Terrena*.

The scaffolding required to repair the palace's tower made it impossible to provide the proper protection of the joints between the roof and walls of the tower, during repair work (Fig. 4). Therefore, the mentioned joints were only temporarily protected against the weather, until the scaffolding was removed.

Fig. 4. View of the clock tower. On the left before renovation, to the right during the renovation

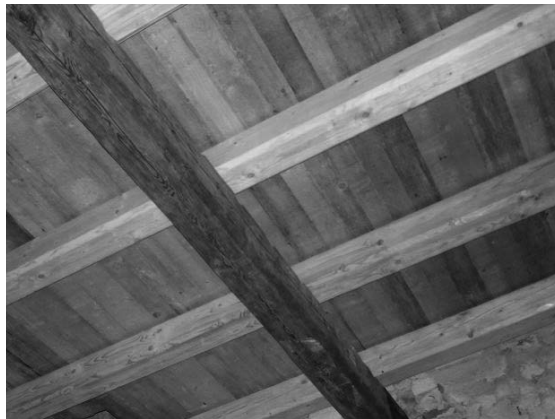
The philosophy behind the repair work was to ensure a significant level of “recovering” building materials, to re-use them in the future. However, only around 15.0% of stones and wooden structural beams have been recovered. Re-cut wooden elements will or have been re-used in the rooms of lesser spans (Fig. 5).

Fig. 5. New and old (recovered) structural elements used as part of the ceilings
