DANIEL WAŁACH, PIOTR DYBĘŁ, JUSTYNA JASKOWSKA-LEMAŃSKA*

REPAIR PROCESS IN THE PITHEAD BUILDING AND ITS INFRASTRUCTURE AS AN EXAMPLE OF REPAIR WORKS IN INDUSTRIAL FACILITIES

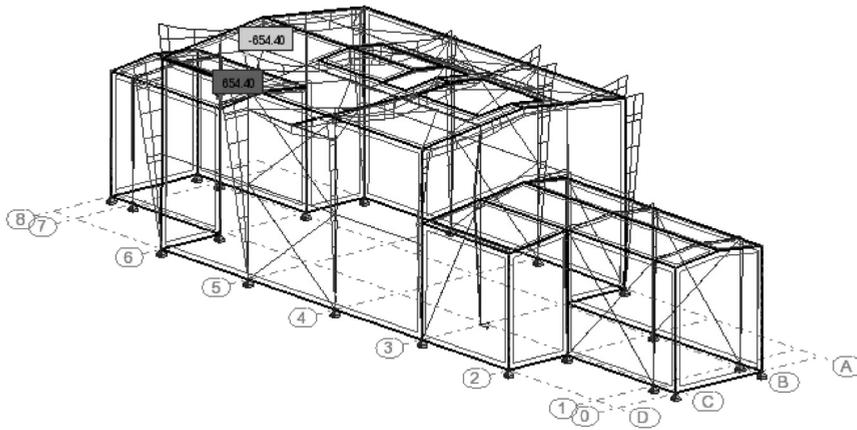
Table 1 shows the values of maximum cross-forces, as well as maximum tension values in the structural elements. Figure 2 shows an example of a graph of maximum torque M_y .

Analysing the values of maximum tension obtained, we can conclude that they do not cause maximum effort in the steel profiles. Stress with approx. values of 150.0 MPa should be safely transferred by the structural components used.

Fig. 2. Graph of maximum torque M_y of the pithead building structure

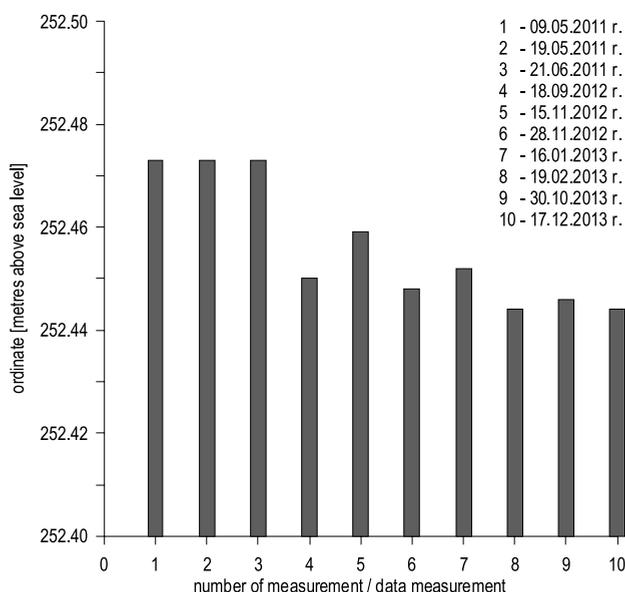
Fig. 3 is an exemplary diagram of vertical displacements recorded at measuring point No. 78, located on the wall in the immediate vicinity of the resting place of the column on the ventilation duct. It should be noted that significant displacements of 2.4 cm at this point were recorded directly before the repair works commenced (18.09.2012). As a result of the repair process, the displacements have stabilised and are currently not hazardous to the pithead building. It should be emphasised that similar relationships have been recorded at other measuring points.

Fig. 3. Vertical displacements of measuring point no. 78
