JUSTYNA JASKOWSKA-LEMAŃSKA, DANIEL WAŁACH\*

## METHODS OF REINFORCING HISTORICAL WOODEN CEILINGS ON THE EXAMPLE OF THE PALACE COMPLEX IN GORZANÓW

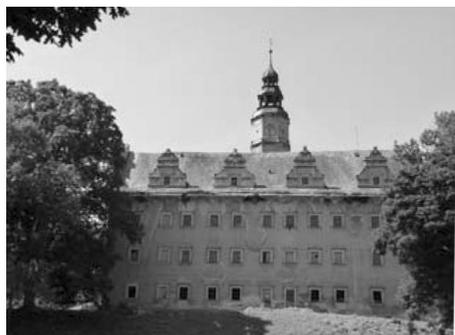
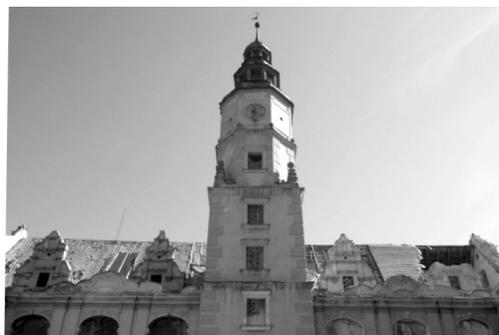
Fig. 2. Palace and park complex in Gorzanów – state as of the year 2012: a) exterior eastern facade [10], b) interior eastern facade

In order to determine the current technical state of the building, an inventory of present damage was taken. The most damage was registered in the central part of the palace – the east wing, in which part of the roof was destroyed as a result of badly performed renovation works (Fig. 2b). Also in the west part, in which residential rooms could still be found up to 2011, much damage resulting from a lack of roofing was observed. The north and south wings were kept in a much better state, due to the good state of the roofing.

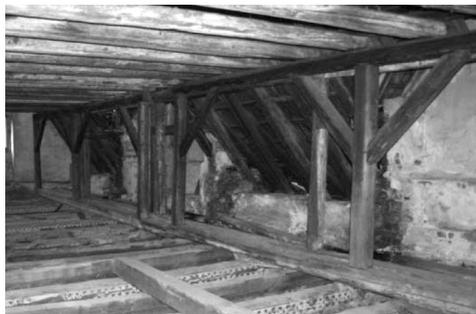
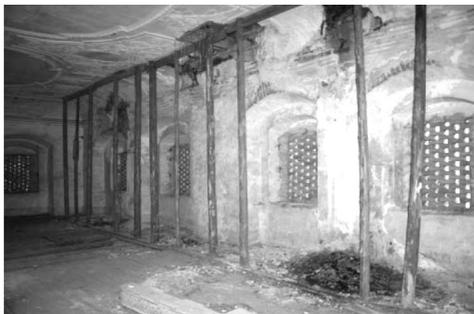
The lack of maintenance work on roof flashing at the point of contact of valley rafters and dormers has resulted in local but intensive impact of water on the structure of the wooden ceilings. As a result of the total degradation of the ceiling of the highest floor, the above impact was transferred in a straight line to the ceilings of successive floors causing their destruction, as illustrated on Fig. 3a and 3b.

Fig. 3. Damage to ceilings of successive floors caused by the local impact of water: a) damage on the II floor, b) damage on the I floor

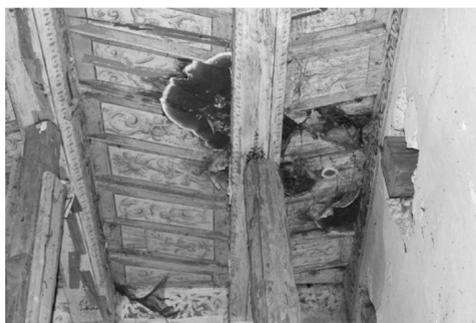
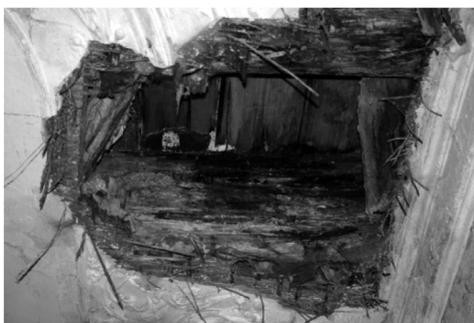
Furthermore, it was observed that a significant part of wooden ceiling elements exhibits local damage caused by biological corrosion. This was caused by many years of use, the absence of the appropriate climatic conditions and of ceiling maintenance, as well as by the direct impact of water. The greatest damage to ceilings is present in areas where elements are supported, e.g. points of support of ceiling beams on walls (lack of the appropriate anti-moisture insulation), and also in other areas, locally. This was confirmed by sagging measurements of selected ceilings.

Fig. 4. Biological corrosion of ceilings: a) corrosion caused by a lack of the appropriate atmospheric conditions, b) corrosion caused by the direct impact of water

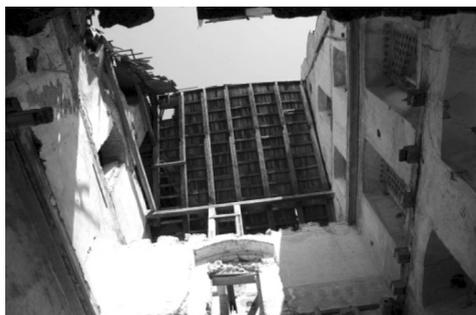
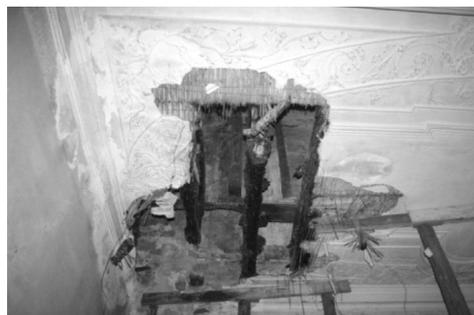
The main cause of most of the registered damage was the harmful impact of water on structural elements, including, above all, on the historical wooden ceilings. This was caused by many gaps in the roofing and by the complete lack of a roof on the central part of the palace. The absence of a roof is as a consequence of badly performed renovation work. Originally, the palace roofing was made from stone roofing tiles, however, these were replaced with ceramic roofing tiles during renovation work. During renovation, the rafter framing structure was not reinforced despite the biological corrosion present in it. Excessive loading of the rafter framing with material with a greater weight caused this part of the roof to collapse. This, in turn, caused the destruction of ceilings of lower floors found below the collapsed part of the roof (Fig. 5a).

Fig. 5. Ceiling damage: a) absence of ceilings that collapsed along with the roofing, b) fire damage

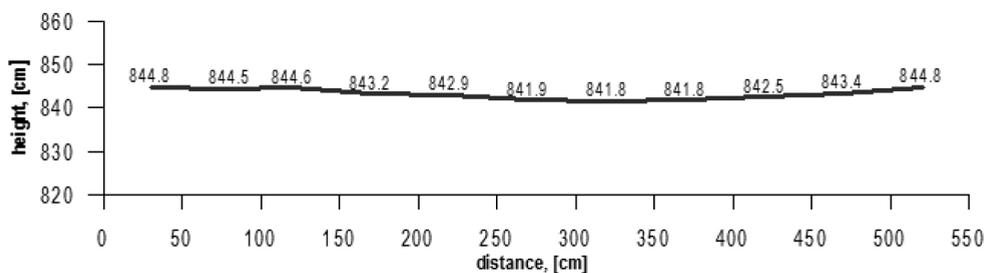
Sagging measurements of wooden ceiling beams were performed for rooms in which ceilings were preserved in their entirety or were not damaged for the most part. 12 wooden beams located in 6 rooms were subject to measurement. Sagging measurement was conducted using laser rangefinders and a leveled geodetic staff. The results of measurements are presented in graphic form on Fig. 6–7. The X axis shows the distance between successive measuring points, and the Y axis shows vertical distance between measuring points located underside of the beam and reference level. Measuring points are located at an interval of every 50 cm over the entire span of the beam, assuming shifting of extreme measuring points from the wall face by approx. 30–50 cm. Conducted sagging measurements and macroscopic assessment made it possible to determine the nature of the operation of beams and places of their deterioration. Based on measurements, two characteristic types of dislocations can be distinguished – sagging in the center of the beam span resulting from own weight and static load, a natural phenomenon for such a structural system, as well as depressions in areas near supports (e.g. seatings of ceiling beams) that may result from deterioration of the wooden element and significant deflections of walls from verticality. The following charts present results of measurements for two ceilings with varying degrees of sagging.

Fig. 6. Exemplary beam sagging at the center of its span

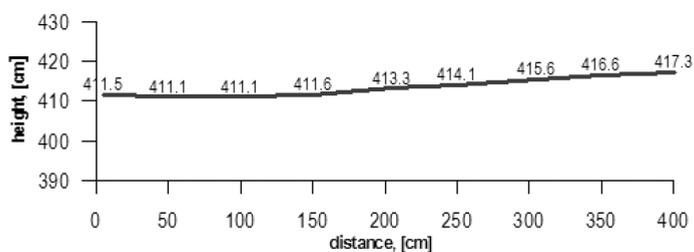
Fig. 7. Exemplary depression in the area near a support

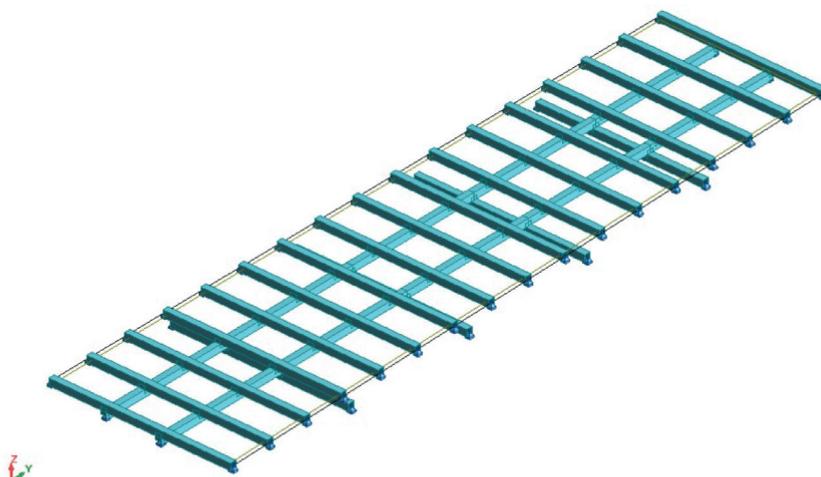
Fig. 15. Calculated model of the ceiling in the “Fireplace” room

For calculations, dimensions of wooden beams of  $14.0 \times 16.0$  cm and a wood class of C18 were accepted based on conducted material tests. In the analyzed ceiling, 3 characteristic groups of beams were distinguished, which were subjected to effort analysis (Fig. 15). Performed calculations of the current ceiling load state (own weight and constant loads from the weight of finishing elements) showed that the efforts of the elements subjected to the greatest load from individual groups of beams do not exceed 100.0%, although the effort of beam no. 2 was as high as 99.0% (Fig. 16).

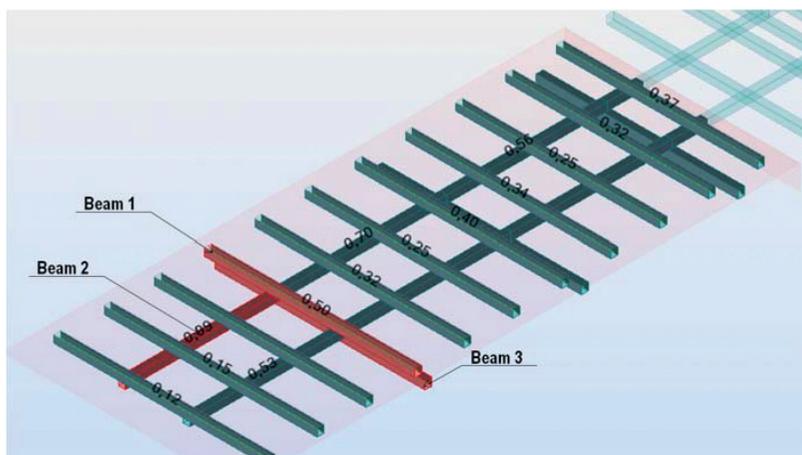
Fig. 16. Efforts of wooden structural elements of the “Fireplace” room ceiling

In the case of the application of additional load to the existing structure, resulting from among other things, the capability of adapting the rooms over the “Fireplace” room as useful rooms, the efforts of the elements carrying the greatest loads were respectively, 77.0% for beam 1, 189.0% for beam 2, and 78.0% for beam 3. This proves that the current technical state of the ceiling does not make it possible for it to carry the additional load relating to the change of use. Furthermore, the current level of effort of certain ceiling beams indicates the necessity of performing additional reinforcing works for the purpose of adapting the analyzed ceiling to modern requirements.

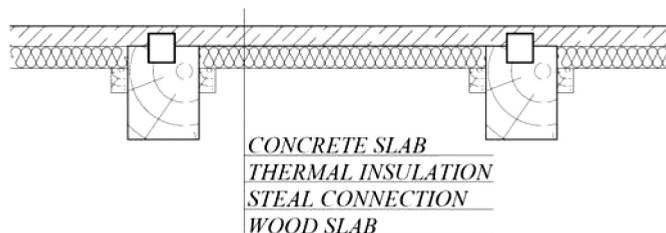
Fig. 20. Direct coupling of the wooden ceiling structure with a reinforced concrete slab

The application of reinforcement of the analyzed ceiling through coupling of its wooden structure with a reinforced concrete slab (Fig. 20) causes excessive load on it, particularly in beam 2, in which effort rose to above 250%. Above all, this is related to a significant rise in the weight of the entire ceiling structure. In such a case, a suspended system should be implemented by resting the reinforced concrete slab on an independent structure e.g. steel (Fig. 10). The efforts of individual wooden elements in this solution are very small and arise only from carrying loads related to their own weight. It must be remembered that the implementation of reinforcement through direct coupling of a wooden structure with a reinforced concrete slab or the construction of an independent reinforced concrete slab in a suspended system causes significant loading of building walls can not always be used.

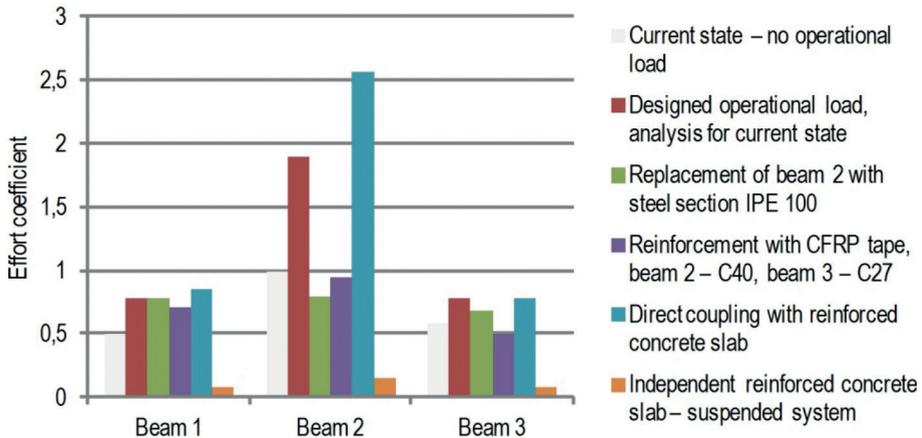
Fig. 21. Results of load-bearing capacity analysis of selected structural elements of the ceiling above the “Fireplace” room depending on the method of reinforcement

A combined list of obtained results of calculations for individual technical solutions has been presented in Fig. 21.

The damage inventory and conducted tests made it possible to determine the current technical state of selected ceilings found in the historical palace in Gorzanów. Based on performed calculations, it can be stated that selected wooden ceilings that have been preserved in a good state due to their historical value can be reinforced by implementing CFRP carbon fiber tapes or other technical solutions. Reinforced structures would be capable of carrying both constant loads as well as operational loads acting on the ceiling. Before the introduction of new operational loads however, load-bearing capacity analysis must be conducted individually for each ceiling – if load-bearing capacity is too low, coupling of wooden ceilings with a modern reinforced concrete slab may be considered. It should be remembered, that the implementation of certain solutions that reinforce the structure of ceilings may result in excessive loading of building walls and cause additional cracking.
