FIRE TESTS WITH DOORS.

A 2-in. FRAMED OAK DOOR, WITH 2-in.
SOLID PANELS.

A 2-in. FRAMED TEAK DOOR, WITH 2-in.
SOLID PANELS.

FIRE TESTS, M AND N, JULY, 5TH, 1899.

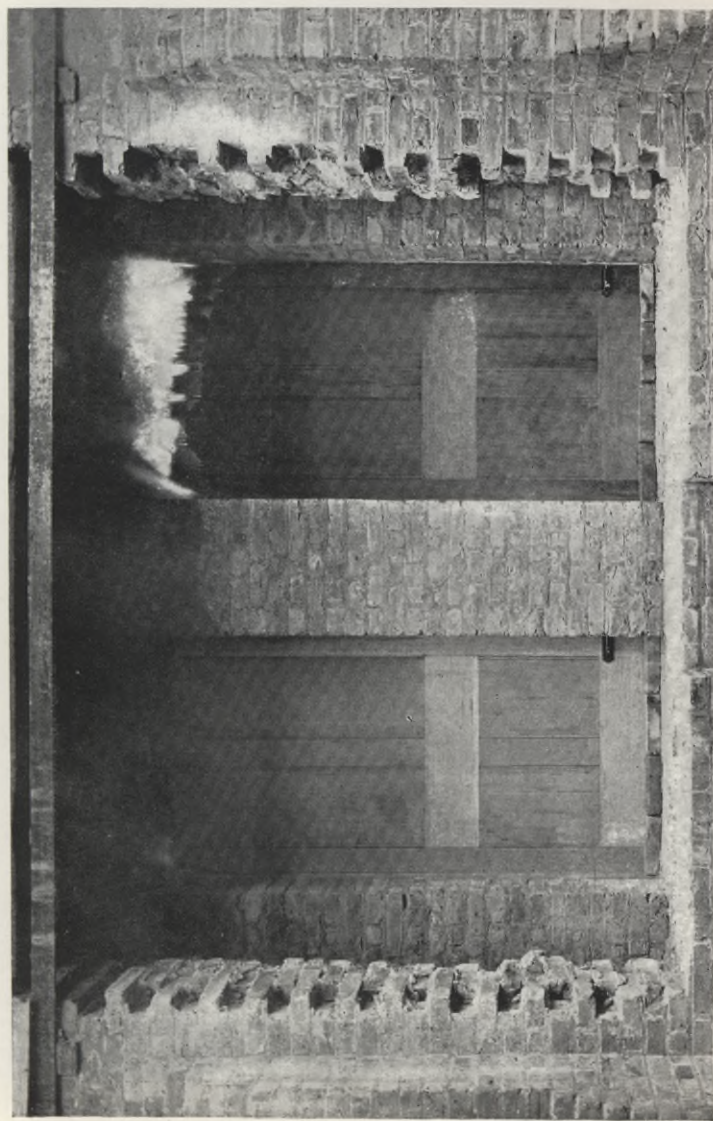
Fig. H. VIEW SHOWING CONDITION OF DOORS AFTER 35 MINUTES.

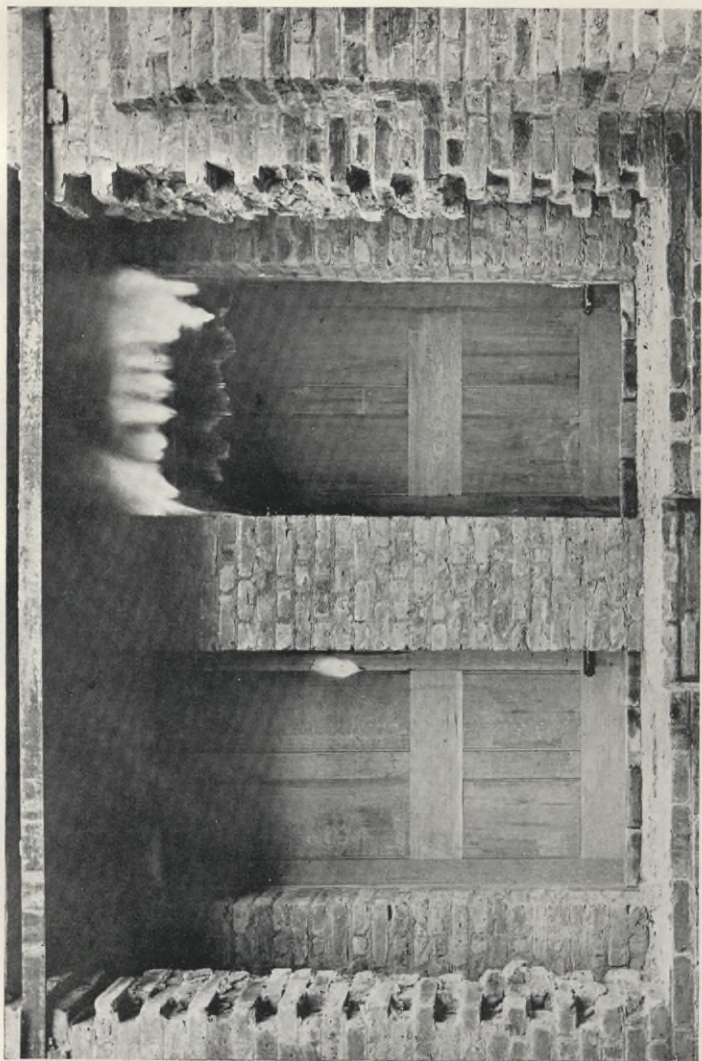
Fig. J. VIEW SHOWING CONDITION OF DOORS AFTER 39 MINUTES.

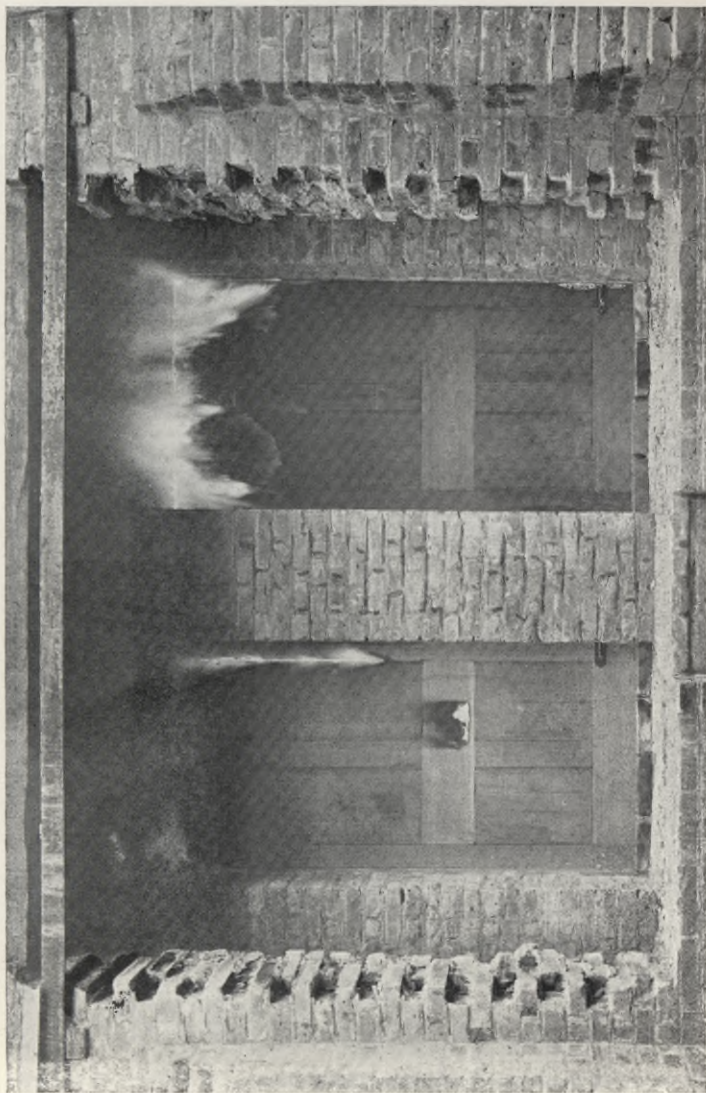
Fig. K. VIEW SHOWING CONDITION OF DOORS AFTER 46 MINUTES.

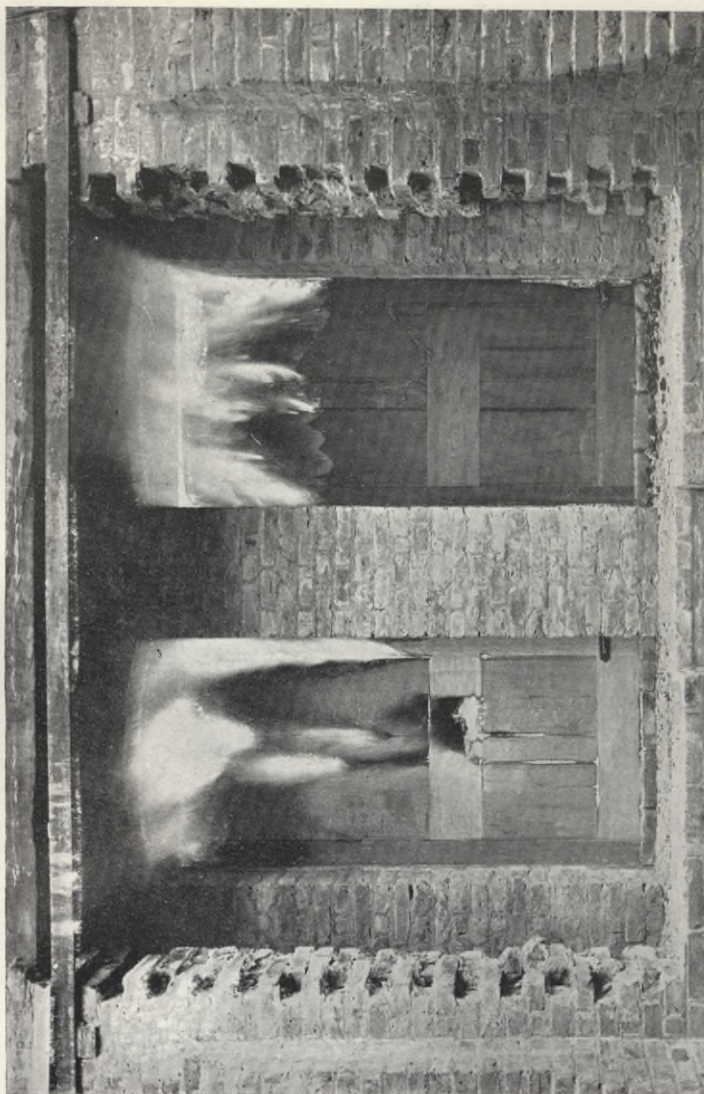
Fig. 1. VIEW SHOWING CONDITION OF DOORS AFTER 53 MINUTES.

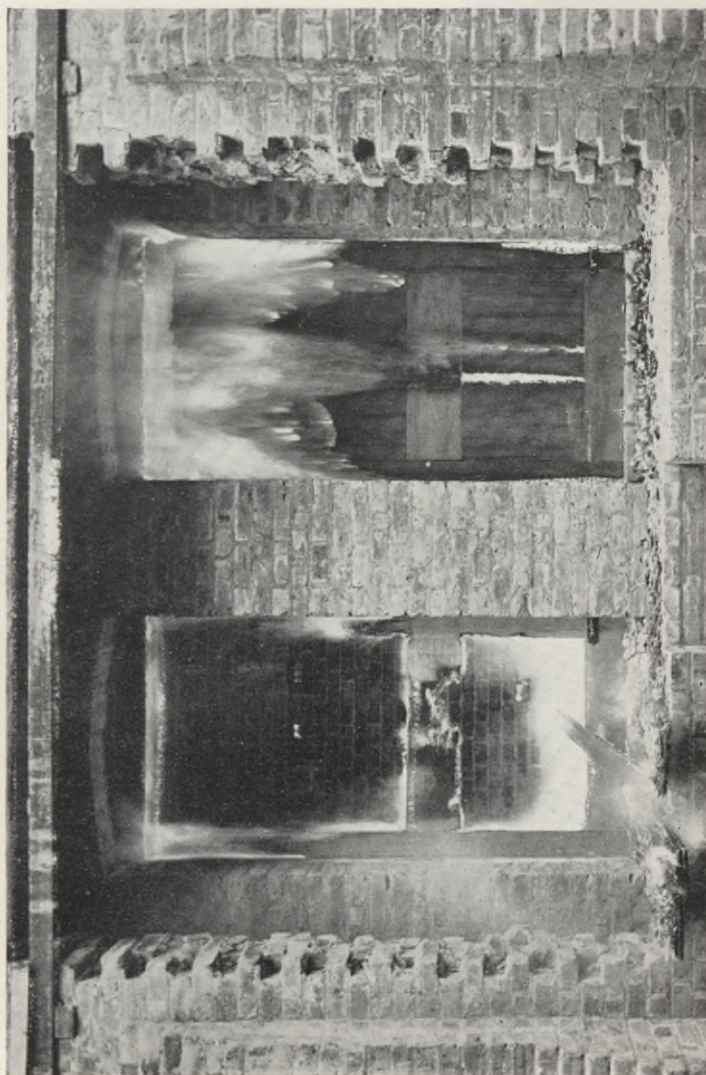
In 55 minutes the 4 panels fell outwards.

At 6.25 p.m. the four panels fell outwards, the lock rail burning but still in position.

Fig. m. VIEW SHOWING CONDITION OF DOORS AFTER 55 MINUTES.

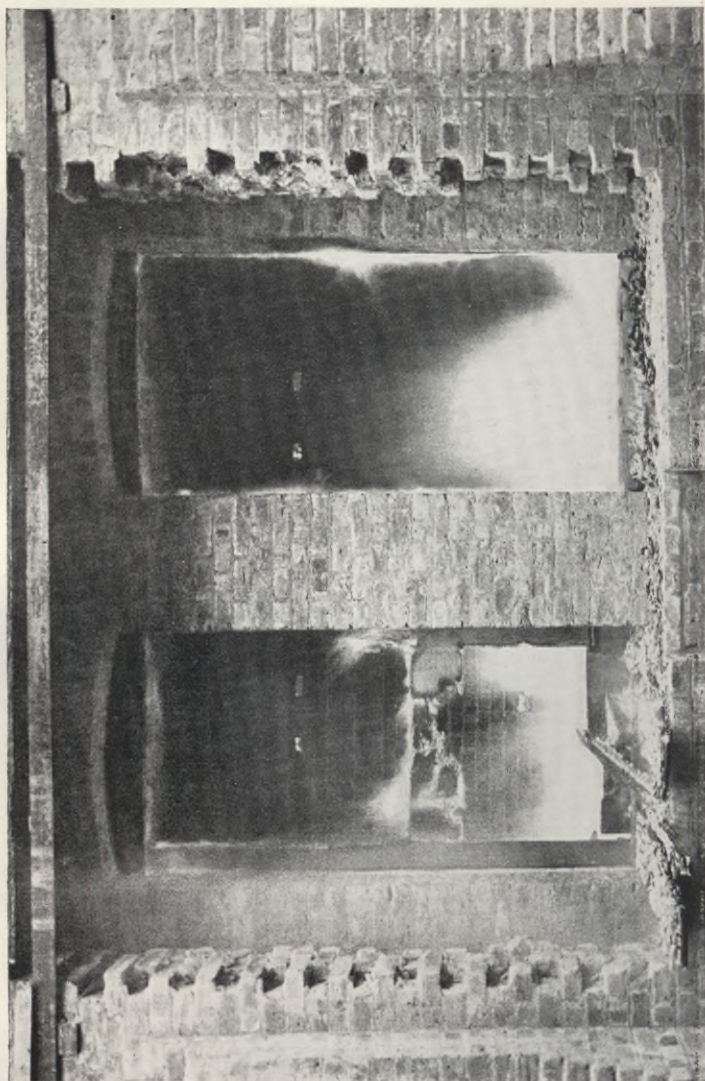
In 58 minutes the door collapsed and fell inwards.

At 6.28 p.m. the door collapsed, falling inwards. See Fig. 12.

Fig. N. VIEW SHOWING CONDITION OF DOORS AFTER 58 MINUTES.
