THE TALL BUILDING

UNDER

TEST OF FIRE.

H. DE B. PARSONS,

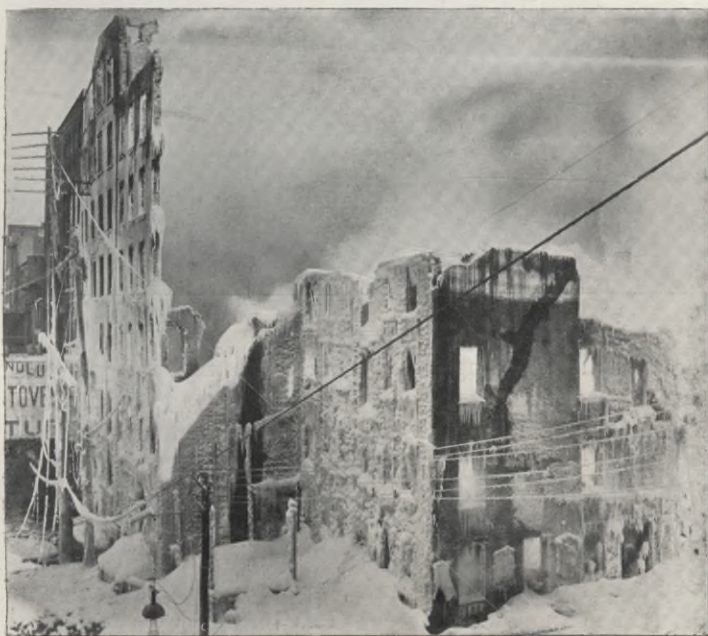
FIG. 1. RESULTS OF A FIRE IN TROY, N.Y.

consumed that four lives were lost, although the fire took place in the day-time. Buildings of this class are totally unable to resist fire.

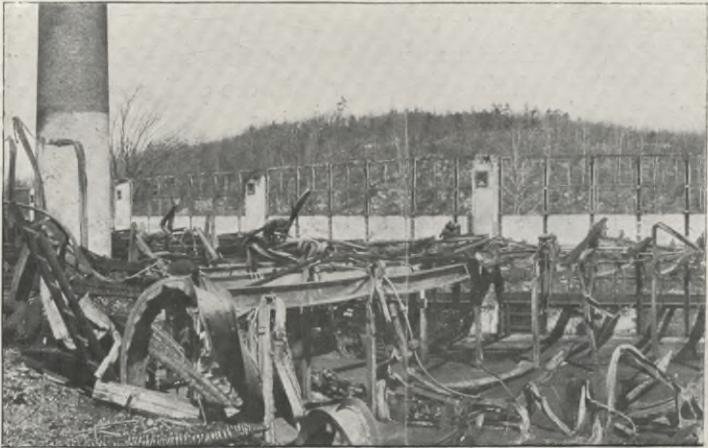
FIG. 2. RUINS OF QUINSIGAMOND MILL, WORCESTER, MASS.

1896. This building was erected on the independent plan, a steel frame supporting the floors and roof. The columns were of built-up steel, carrying floor-beams of the same material. The window-boxes were of steel, and the walls were of brick built in between the frames so as to enclose the whole. Wood was used for the flooring on the "slow-burning" plan. The photograph very clearly shows the result; how could the destruction have been more complete? The building was entirely gutted, and the columns and beams were twisted into an

entangled mass. Witnesses of this fire state that the columns began to yield from fifteen to twenty-five minutes after the fire started, although the floors were not heavily loaded. Had this building been erected on the "slow-burning" principle, it would have resisted the fire much longer. In this type of construction heavy wooden columns and girders are used, which retain for a considerable time, when subjected to fire, sufficient strength to carry their super-imposed loads, permitting the escape of the occupants, the saving of valuables, and the arrival of assistance. Such examples show that plans for all buildings in crowded districts should be intrusted only to the best of designers.

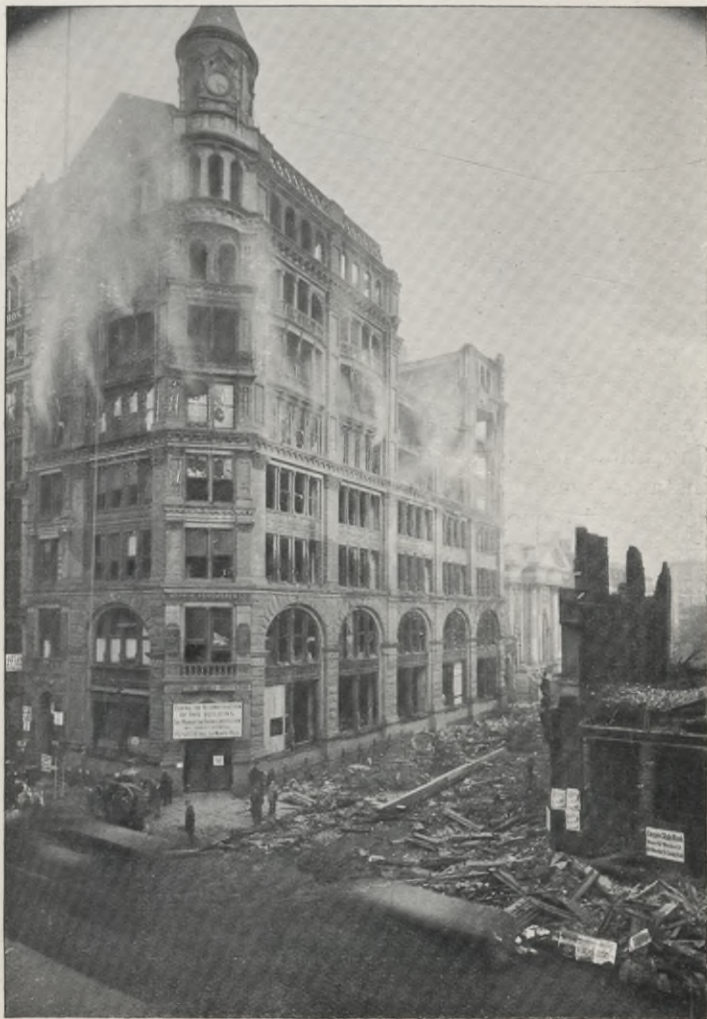
FIG. 3. A FIRE-PROOF BUILDING WRECKED BY A FIRE ACROSS THE STREET.

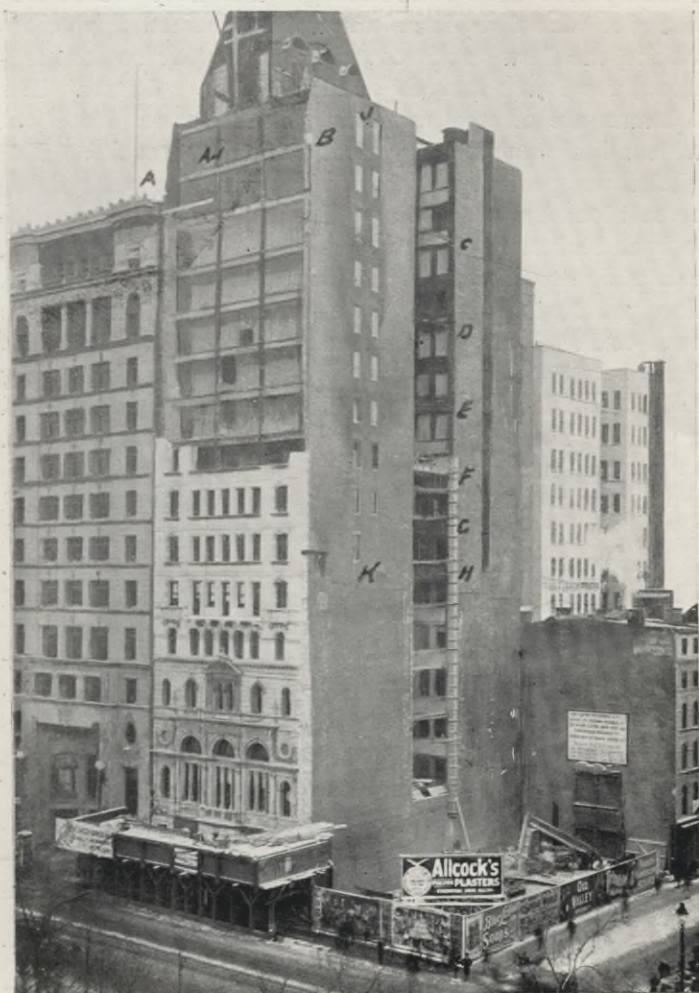
FIG. 4. THE HOME LIFE BUILDING (IN COURSE OF RECONSTRUCTION).

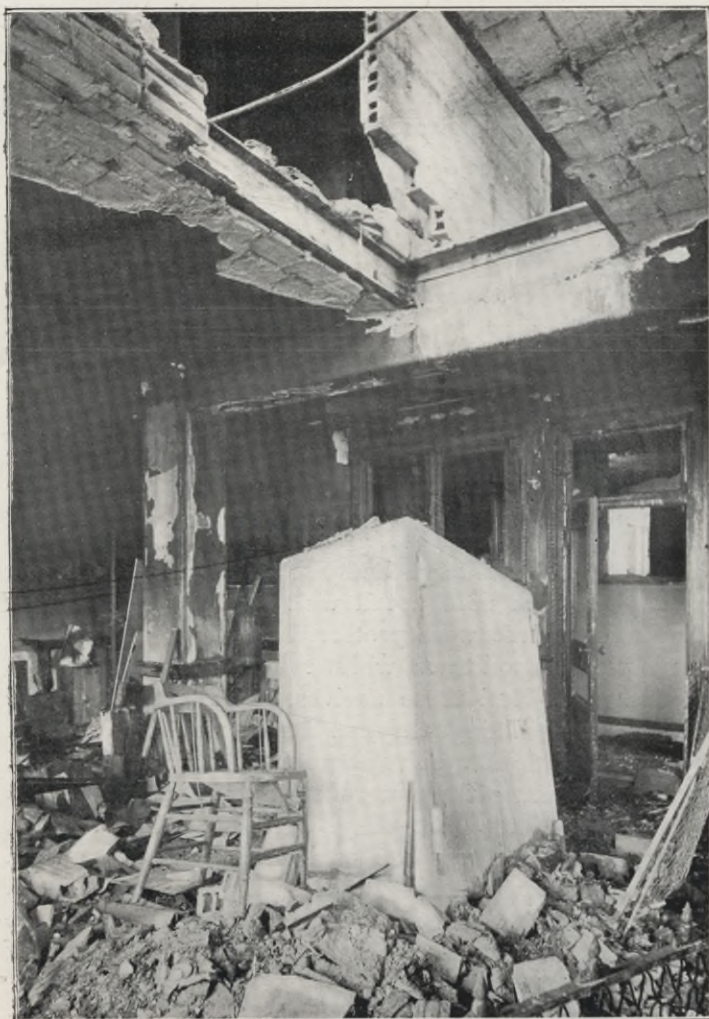
FIG. 5. HOME LIFE BUILDING, 9TH FLOOR—THE LOWEST DAMAGED BY FIRE. The large safe fell from the floor above.

seen a large safe, weighing about 4,000 pounds, which fell from the floor above into a room on the ninth floor, lately occupied by the Rapid Transit Commission. It is reported that the firemen cut a hole in the arch for the passage of a hose, and thus permitted it to fall. Whether this statement be true or not, the ninth floor was sufficiently strong to retain it. The photograph shows the floor beams uninjured.

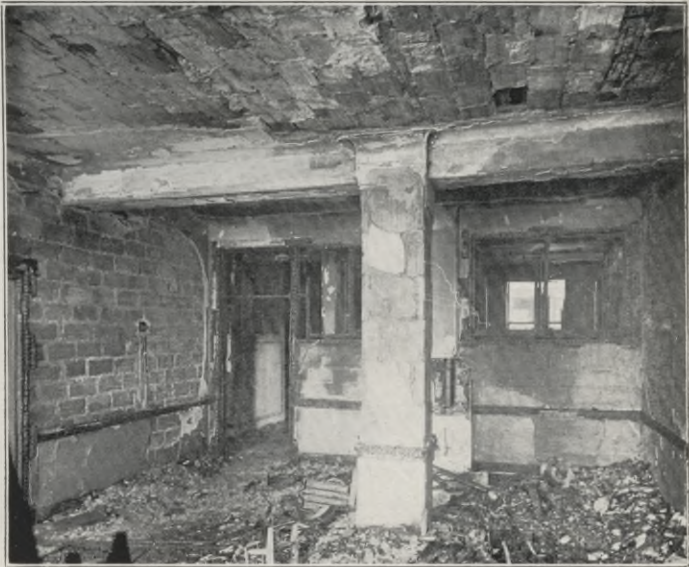
FIG. 6. 10TH FLOOR. COLUMN AND GIRDER COVERINGS AND PARTITIONS INTACT.

Transom windows seen in partition.

building, on the tenth floor. The ceilings and partitions are intact, but the plaster and wood-work were totally destroyed.

The destruction of the wooden flooring throughout the upper stories was largely due to the considerable air-space between the wood and the flat floor arches. This space should not have existed; had it been filled, the floors would have stood much longer.

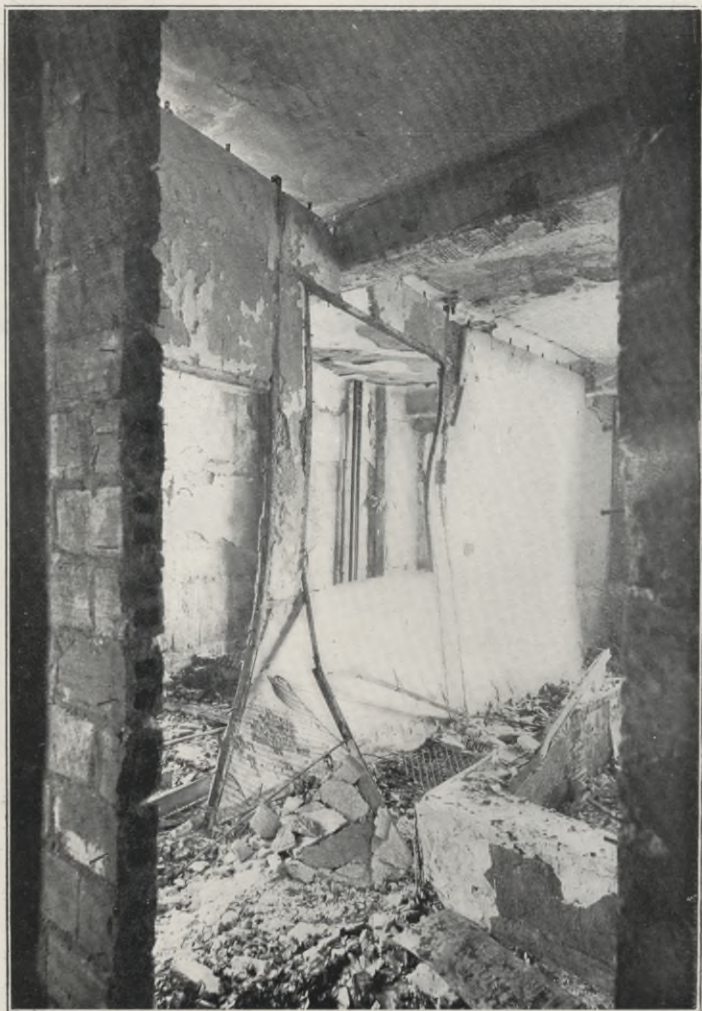
FIG. 7. 12TH FLOOR, FRONT, SHOWING A PARTITION.

Fig. 7 shows a partition in bad condition in a room on the twelfth floor. Some of these partitions were built directly on the flooring, and their failure was caused

principally by the burning of the wood, depriving them of their natural support.

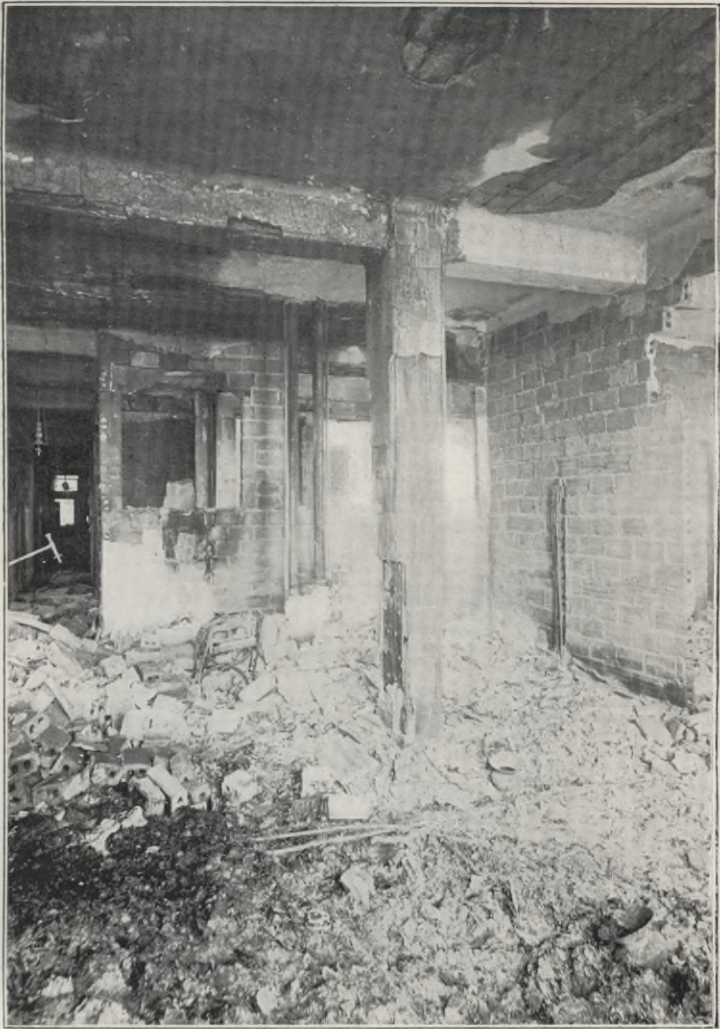
FIG. 8. 13TH FLOOR. THE COLUMN AND GIRDER ARE UNINJURED.

Fig. 8 is a view on the thirteenth floor, showing a column with a portion of the fire-proof blocks removed

in order to make an examination of its condition. As is clearly seen in the photograph, the column was uninjured and still covered with paint, although the heat in the room was sufficient to destroy the expanded metal and plaster covering the pipes placed against the rear column. The ceiling in this room and the partition of terra-cotta remain intact, although all the wood-work was totally consumed.

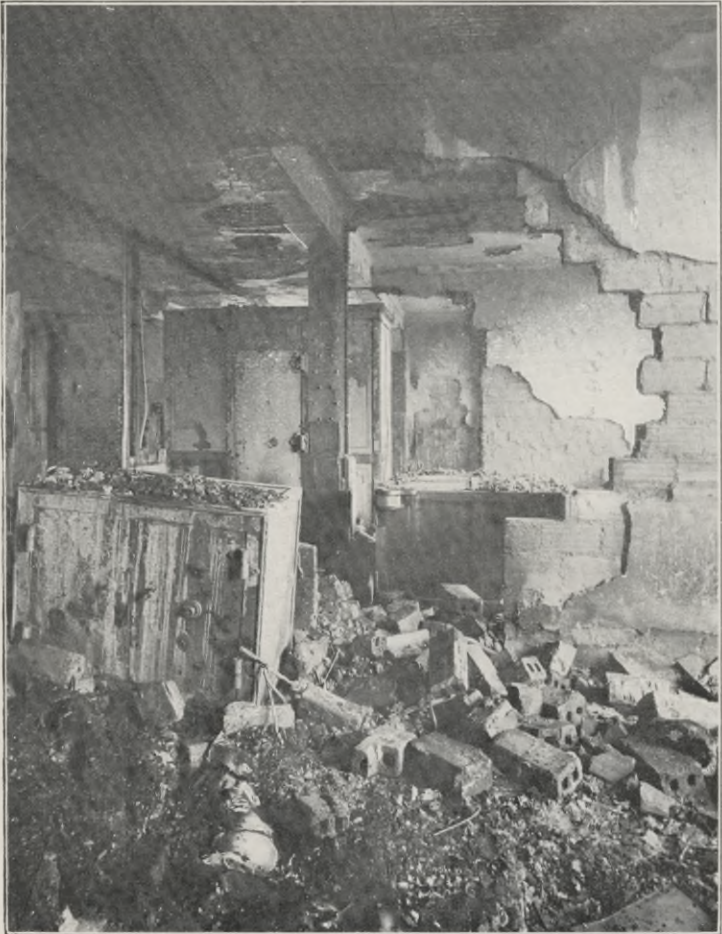
FIG. 9. 14TH FLOOR, FRONT. SHOWS GENERAL DESTRUCTION OF CONTENTS.

Another column is shown in Fig. 9, which is a photograph of a room in the front of the building on the fourteenth floor. The covering had been removed from this column for the purpose of examination. This picture shows the plaster-work completely destroyed, although the partitions and ceiling blocks remain intact. The floor arches also remain unbroken, although the safe shown in the picture fell over on its face, on account of the destruction of the wooden flooring upon which it rested. The partition shown in this picture was torn away by the firemen, in order to facilitate their work.

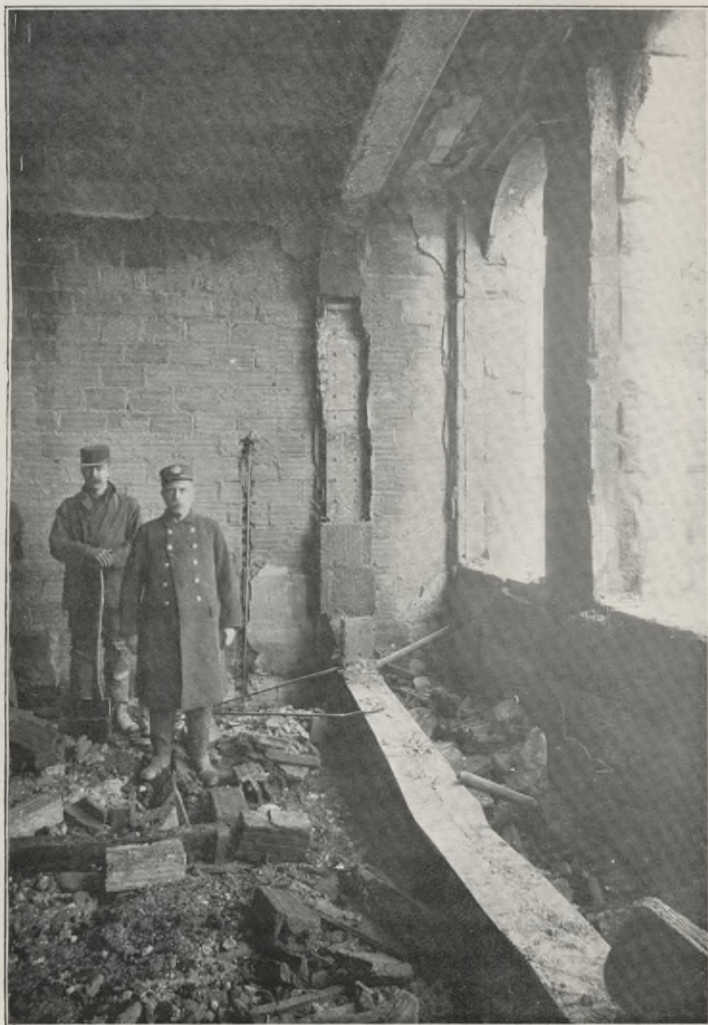
FIG. 1C. 16TH FLOOR. A DISTORTED GIRDER IN THE FRONT OF THE BUILDING.

Fig. 10 is a photograph taken on the sixteenth floor in a front room of the building. The column remained uninjured, as is shown by the subsequent removal of the terra-cotta blocks. The partitions of terra-cotta on this floor remain intact, although the plastering was completely destroyed. The distorted girder probably represents the greatest damage done to any one member of the metallic frame. This was one of the main girders of the building, and was protected on the soffit by terra-cotta blocks and wire lath. It differed, however, from the other girders in having its upper chord project above the floor. The part projecting was not protected by fire-proofing material, but was boxed in with wood, forming an elevation in the floor-space of these rooms. This wood-work, of course, was completely destroyed, leaving the metal exposed to the fire. No doubt this portion of the girder became heated, and buckled on account of being in compression. Had the exposed part been in tension, it doubtless would have

retained its shape, as there is no evidence to show that the heat was sufficient to have injured it under such conditions.

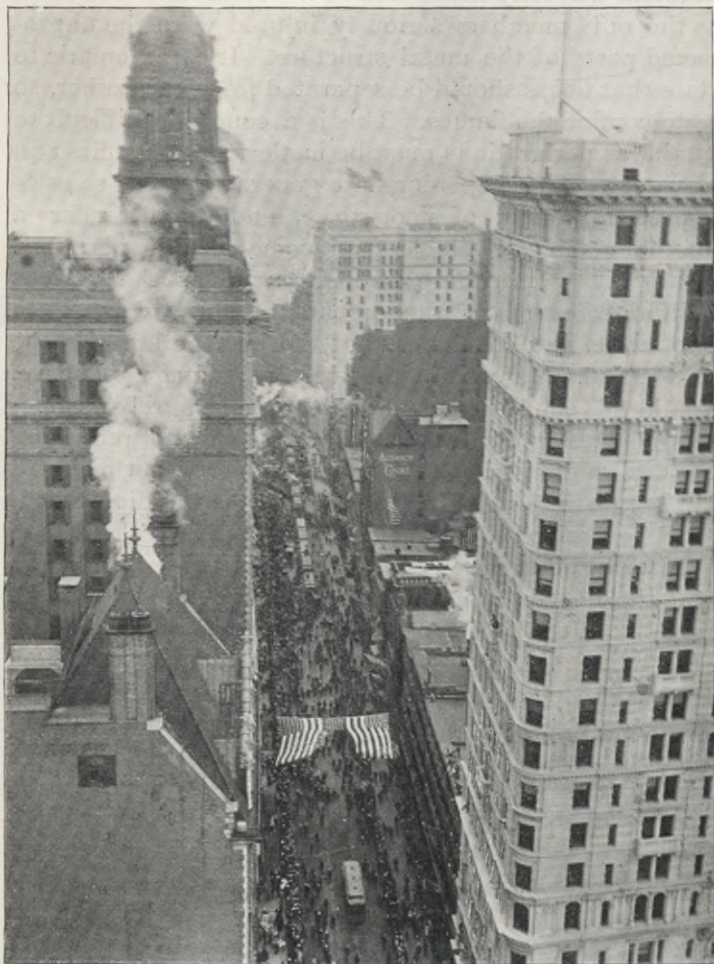
FIG. 11. SUGGESTIVE OF THE DIFFICULTY OF REACHING THE UPPER STORIES OF A SKY SCRAPER WITH A FIRE STREAM.

The difficulty can be inferred from Fig. 10, which is a view of Broadway, N.Y., from one of the upper floors of the American Surety building. Many modern tall buildings are designed with their own pumping plant to supply a roof tank for fire and other purposes, and are equipped with a large stand pipe from six to eight inches in diameter, which is siamesed on every floor for hose connections. This stand pipe is also arranged with a check valve and with siamesed branches at the foot, so that fire engines can be attached, in case of the disability of the self-contained plant. It is well so to arrange the stand pipe that the engines can also operate in conjunction with pumps in the building.

In many cities which maintain a system of fire boats there are laid underground pipe lines of large diameter. As these fire boats are equipped with pumping apparatus far exceeding the power of the largest land engines, they are able to force water under heavy pressures to long distances, provided the mains are made of sufficient area to minimize the friction losses. This system, operated in connection with the building stand pipe, would materially assist the firemen.
