FIRE TESTS WITH DOORS.

A 2-in. FRAMED HONDURAS MAHOGANY
DOOR, WITH 2-in. SOLID PANELS.

A 2-in. FRAMED POPLAR DOOR, WITH
2-in. SOLID PANELS.

FIRE TESTS, V AND W, NOV. 1ST, 1899.

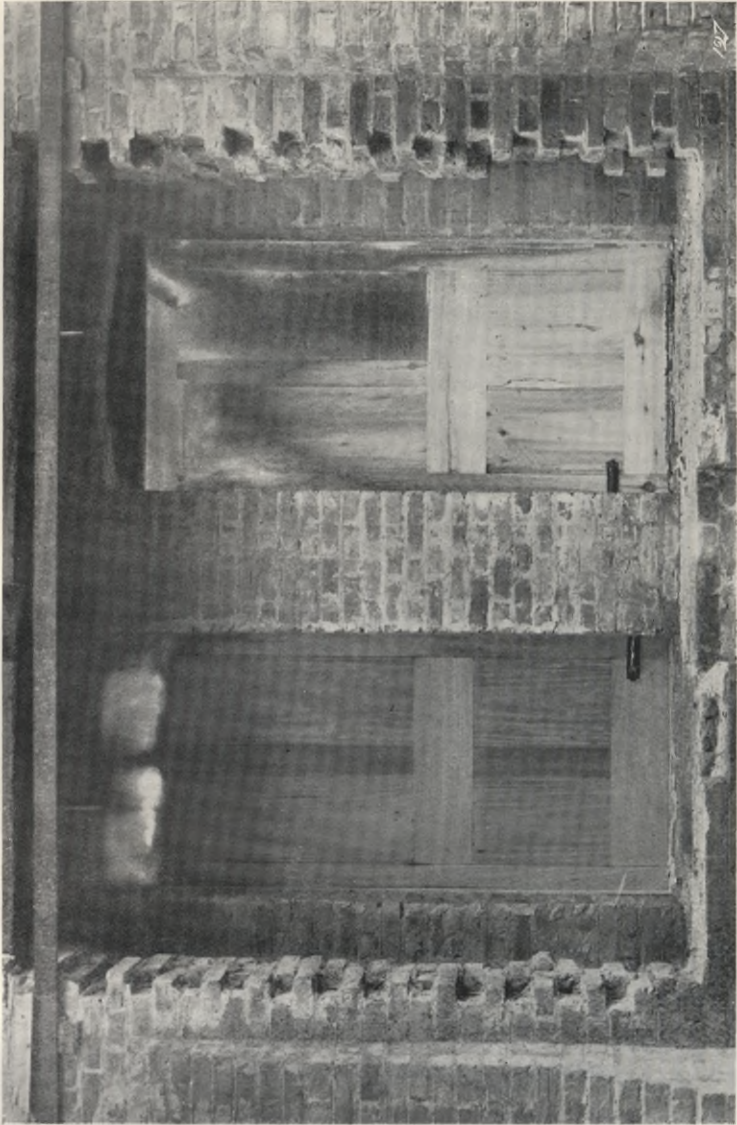
Fig. H. VIEW SHOWING CONDITION OF DOORS AFTER 25 MINUTES.

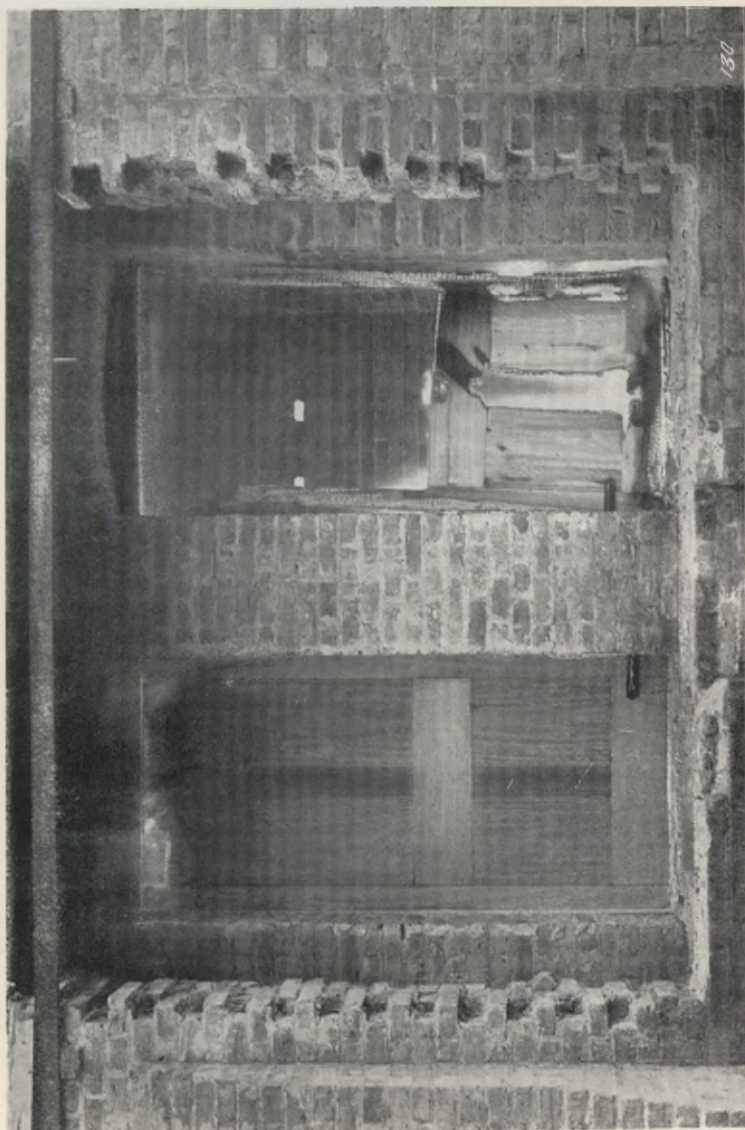
Fig. J. VIEW SHOWING CONDITION OF DOORS AFTER 35 MINUTES.

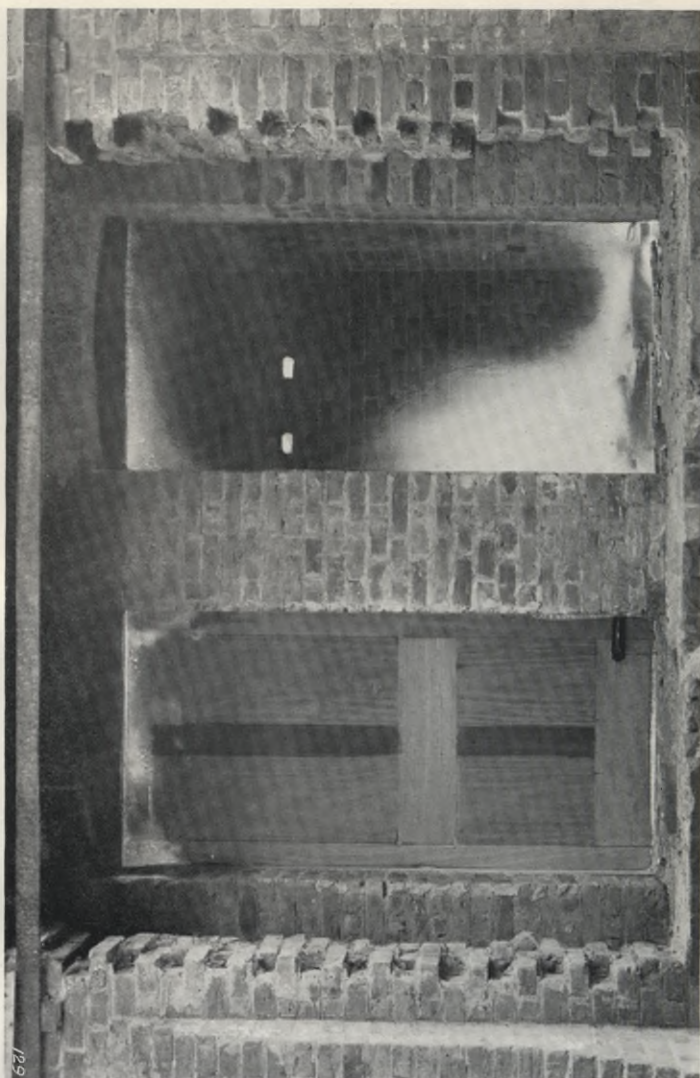
Fig. K. VIEW SHOWING CONDITION OF DOORS AFTER 40 MINUTES.

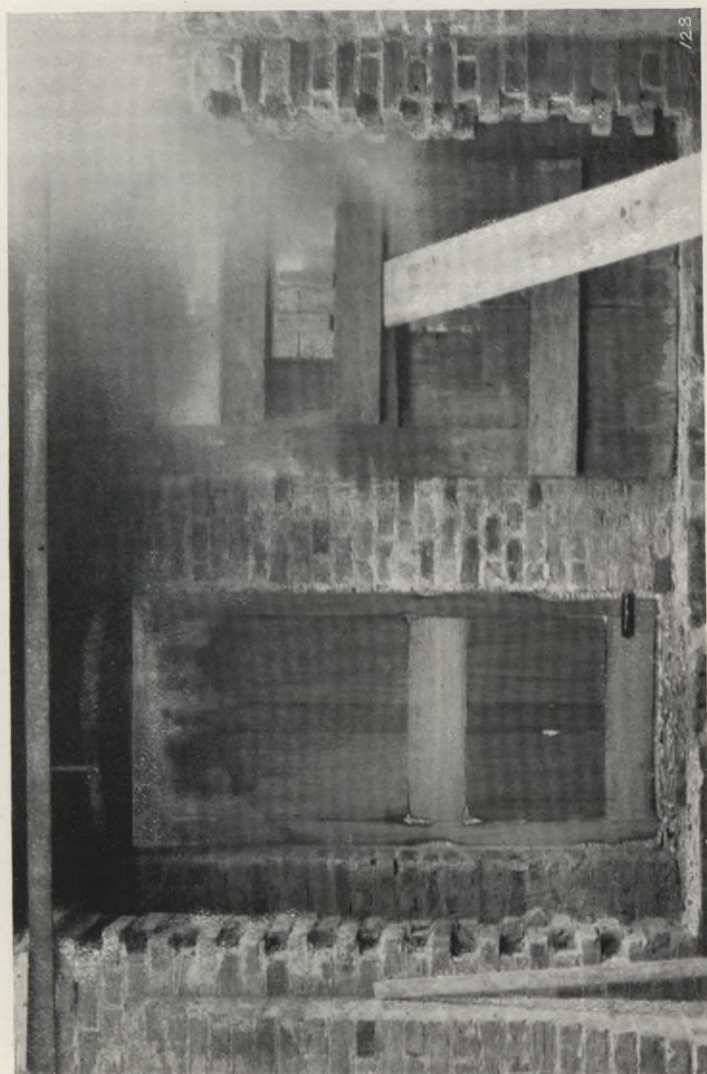
Fig. 1. VIEW SHOWING CONDITION OF MAHOGANY DOOR AFTER 45 MINUTES.

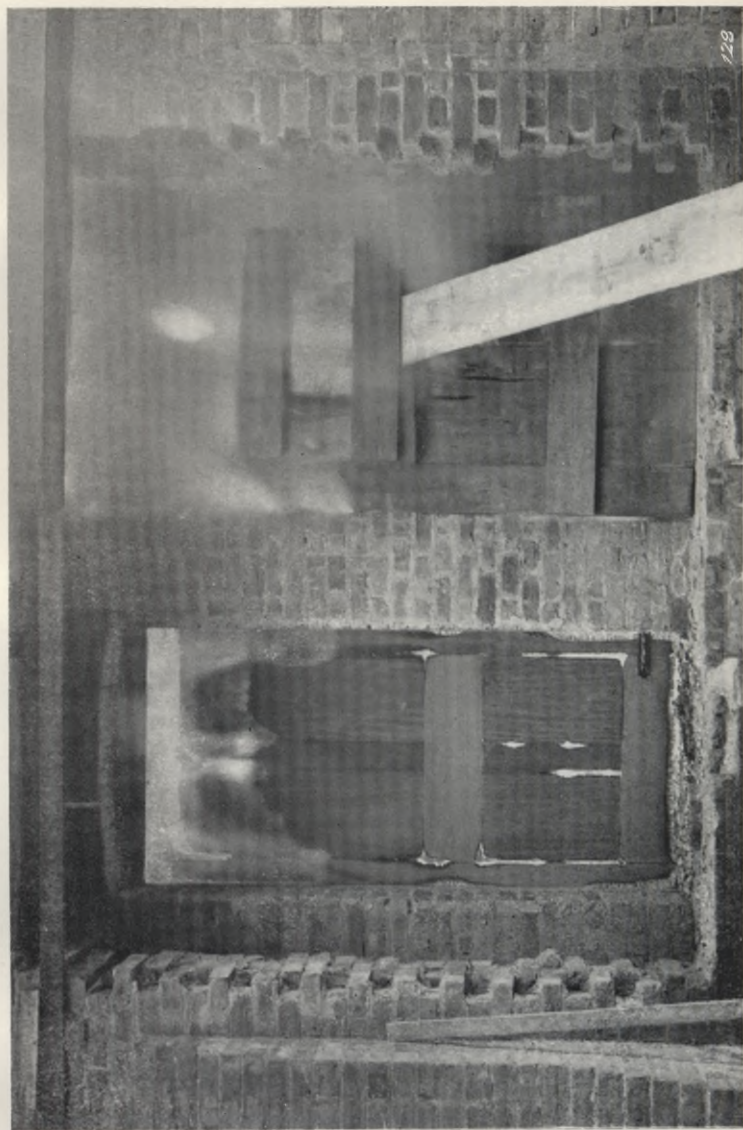
Fig. M. VIEW SHOWING CONDITION OF MAHOGANY DOOR AFTER 48 MINUTES.

After the test the frame was seen to have been burnt very considerably, but no portion of it was burnt completely through or fallen.
