THE
EFFECT OF FIRE.

THE HORNE BUILDING FIRE,
PITTSBURG, U.S.A.

GUSTAVE KAUFMAN, M. AM. SOC. C.E.,
Consulting and Contracting Engineer.

THE
EFFECT OF FIRE
ON THE
Horne Building, Pittsburg, U.S.A.

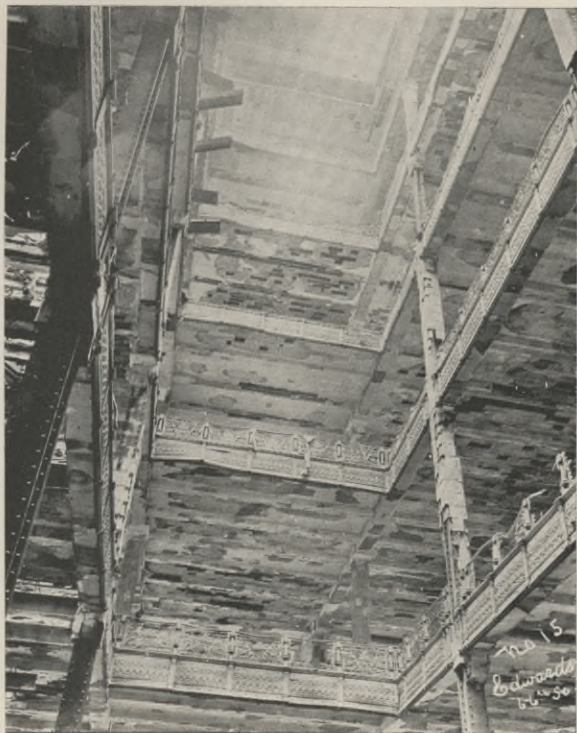
The wreck of the eastern side of the building was caused by the falling of the water tank, weighing when filled 26 tons. This was supported by I beams, the dimensions of which could not be ascertained. The widely published statement that the tank was supported by wooden beams is erroneous. Judging from the warped and weak condition of the remaining ceiling

tees in the western part of the building, a fair surmise would be that the ceiling underneath tank, which was located right outside the elevator shaft, gave way under the heat, which there was no doubt fiercer than at any other place in the building. The fall of the ceiling exposed to the action of the heat, the unprotected columns

of the sixth storey between the ceiling and the roof, and also the roof beams and those supporting the tank. These no doubt yielded on account of their loads and the action of the heat and thus permitted the heavy tank to fall. The tank in falling carried with it to the first floor such columns and beams with which it came in

contact, and which in turn dismantled a number of beams and girders to which they were connected.

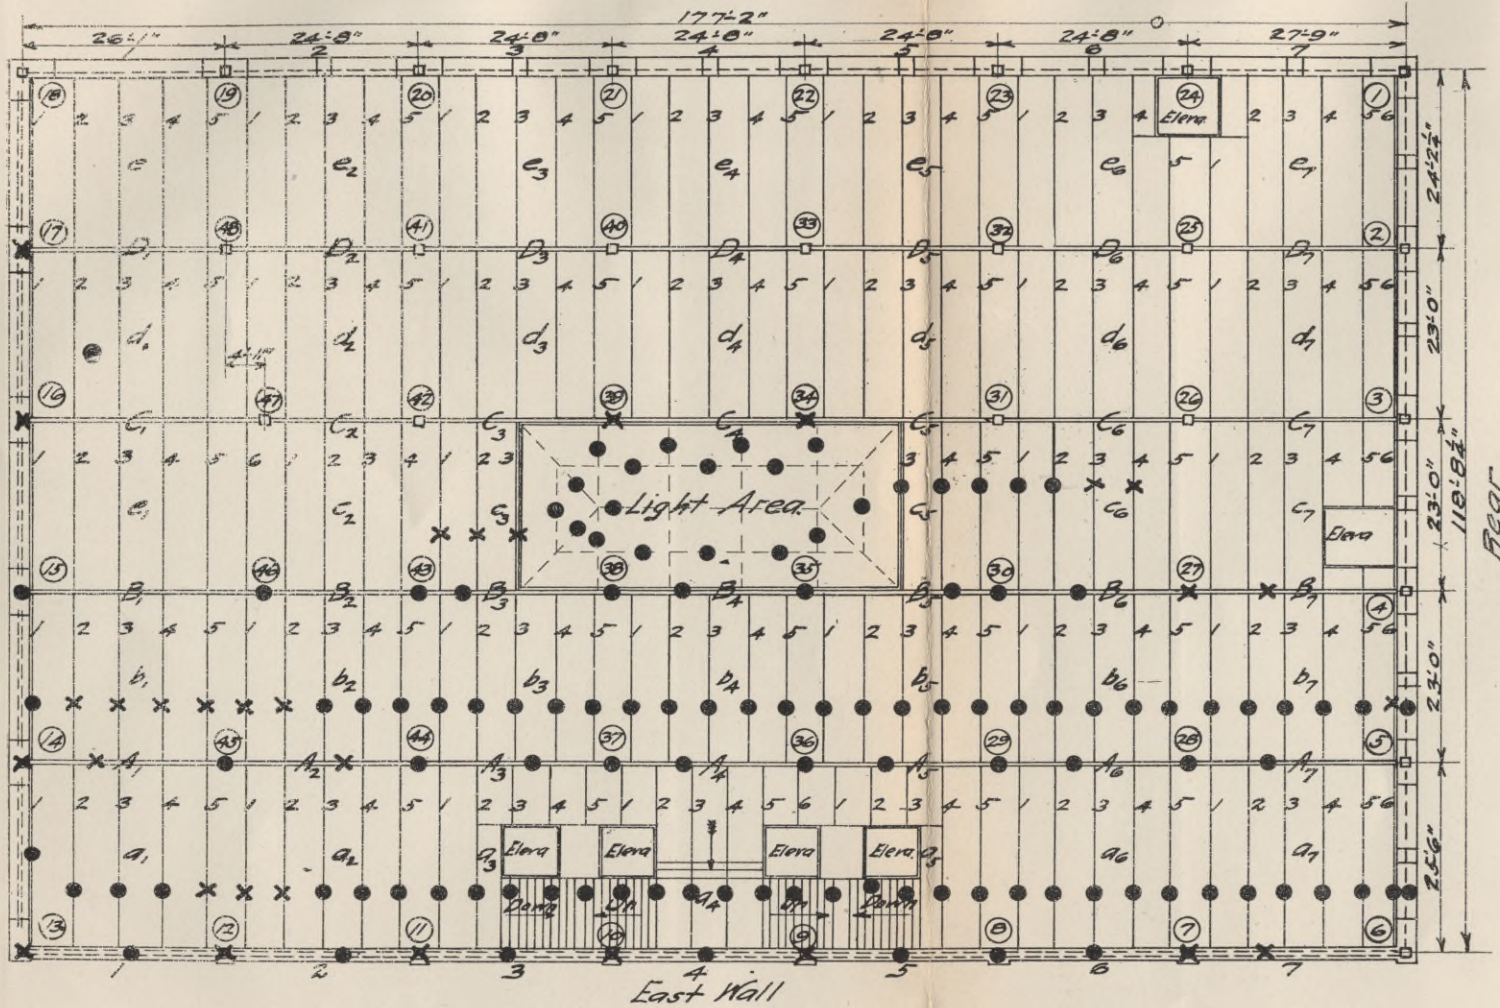
PLATE No. 7

SIXTH STORY AND ROOF

● Indicates new material
X " material to be straightened

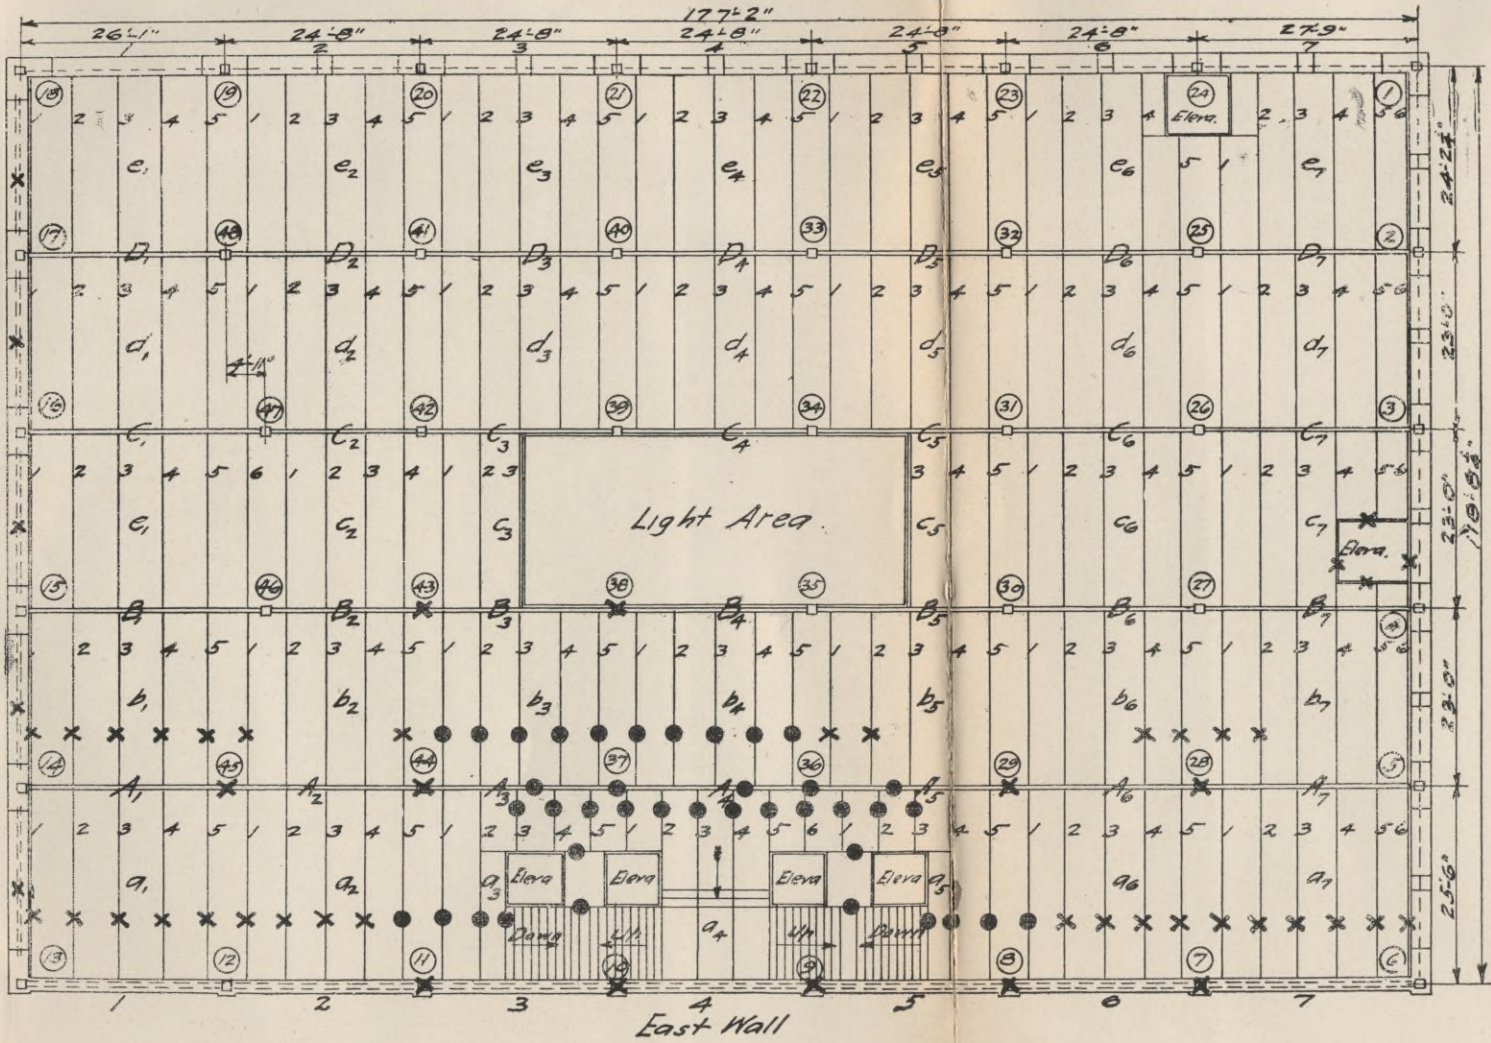
5TH STORY - 6TH FLOOR GIRDERS & BEAMS
 PLATE NO. 8

● indicates new material
 x " material to be straightened

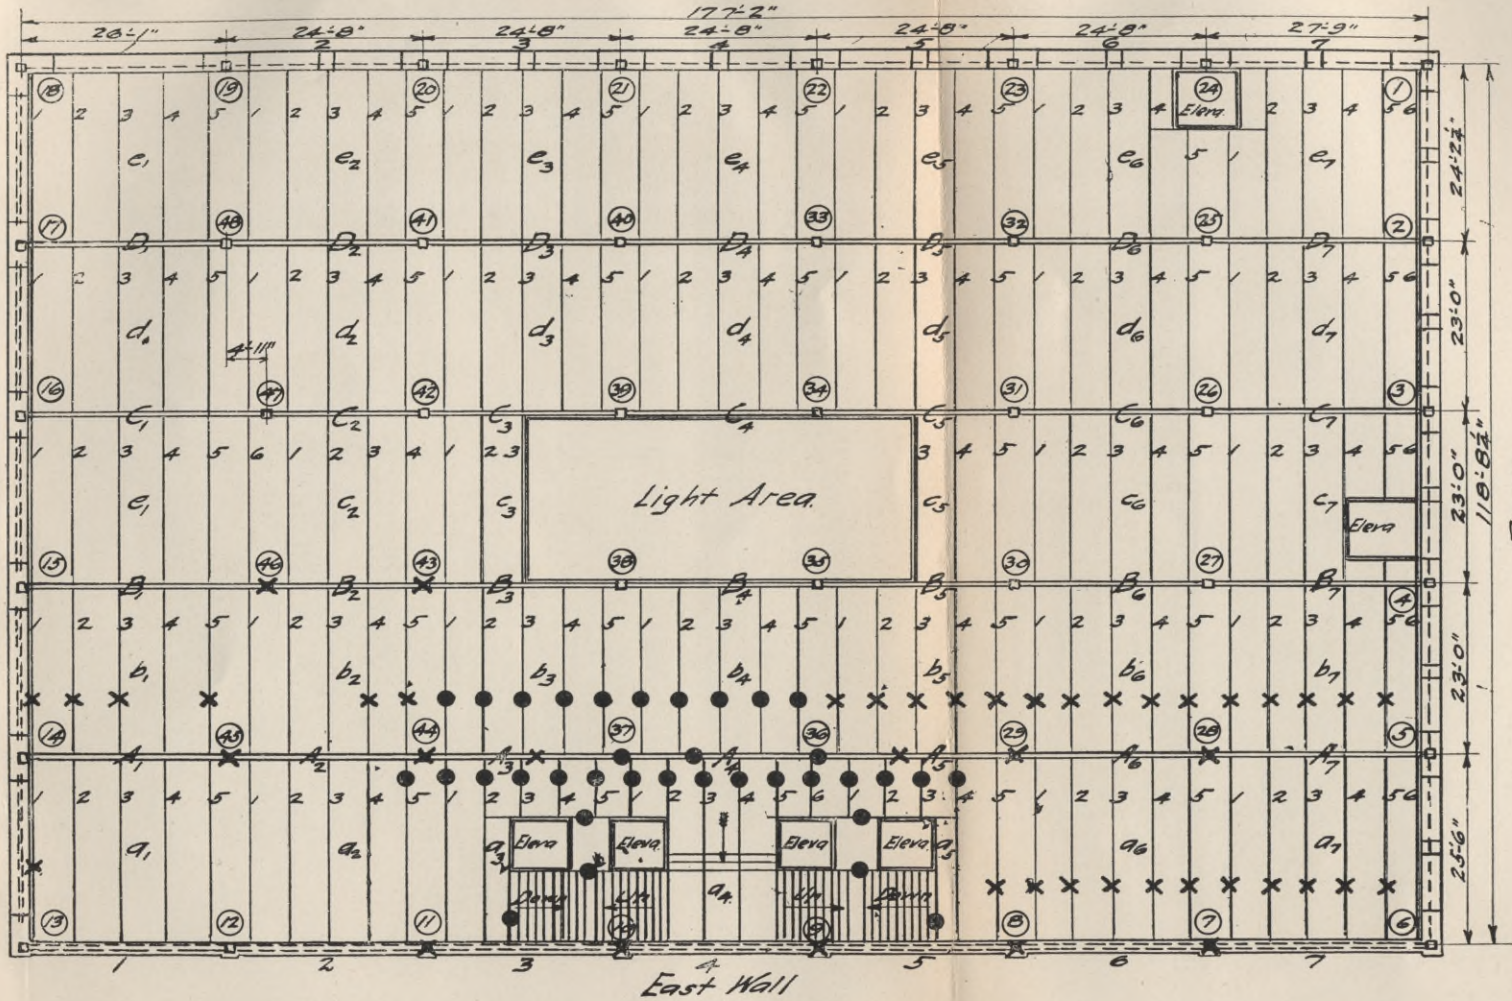
PLATE No. 9

4TH STORY - 5TH FLOOR GIRDEERS & BEAMS

- Indicates new material
- x material to be straightened

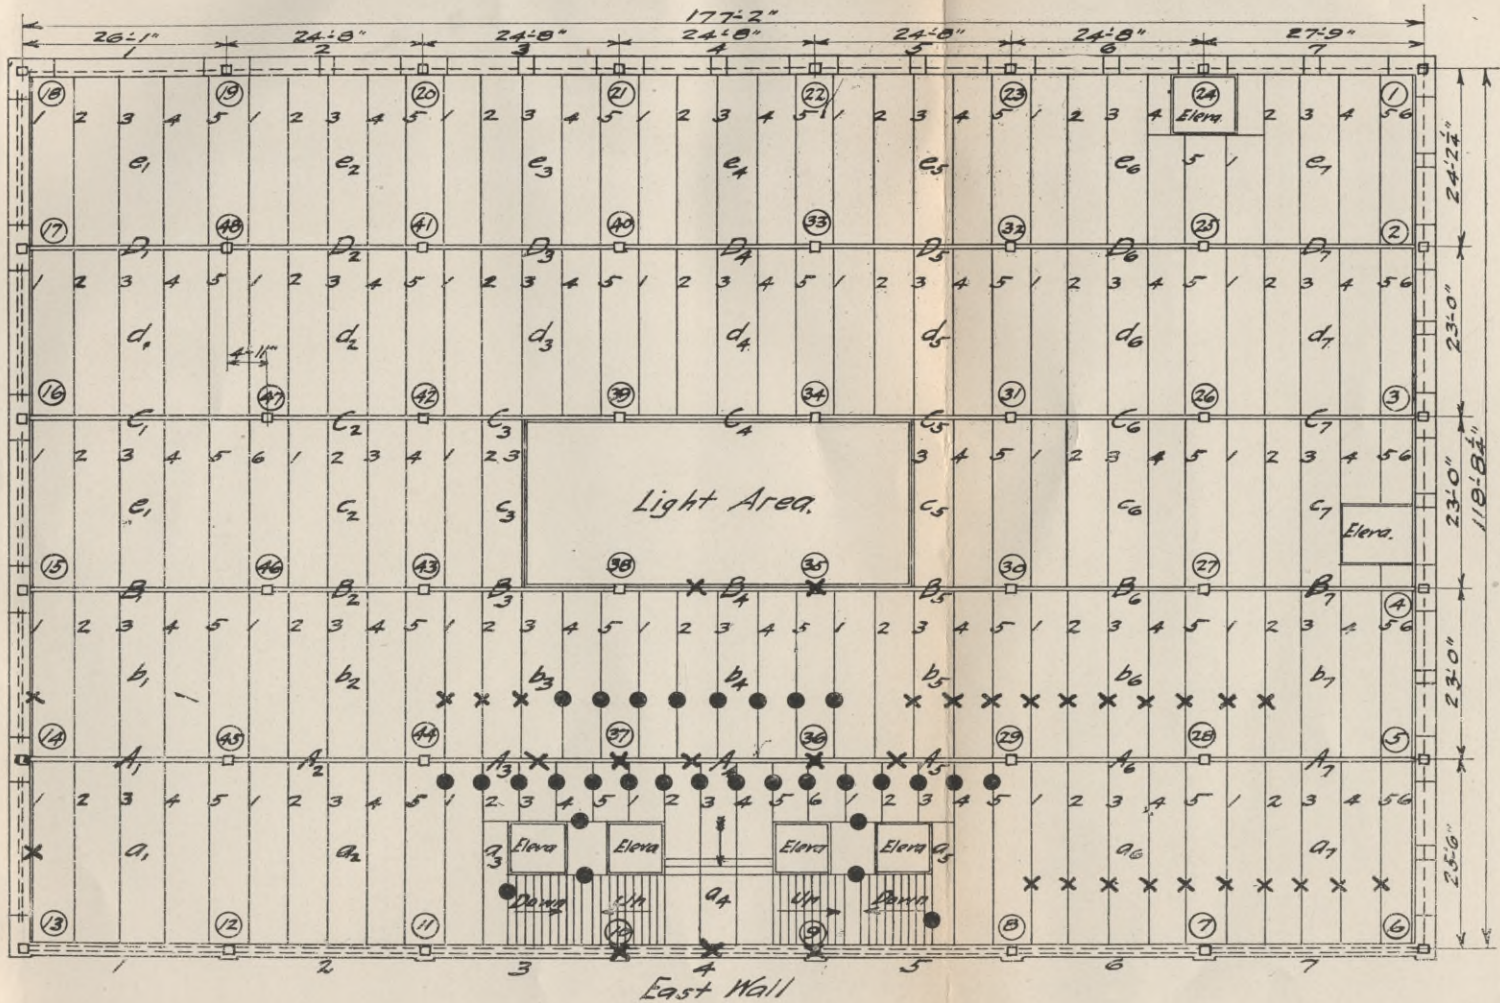
PLATE NO 10

3RD STORY - 4TH FLOOR GIRDERS & BEAMS

- Indicates new material
- x .. material to be straightened

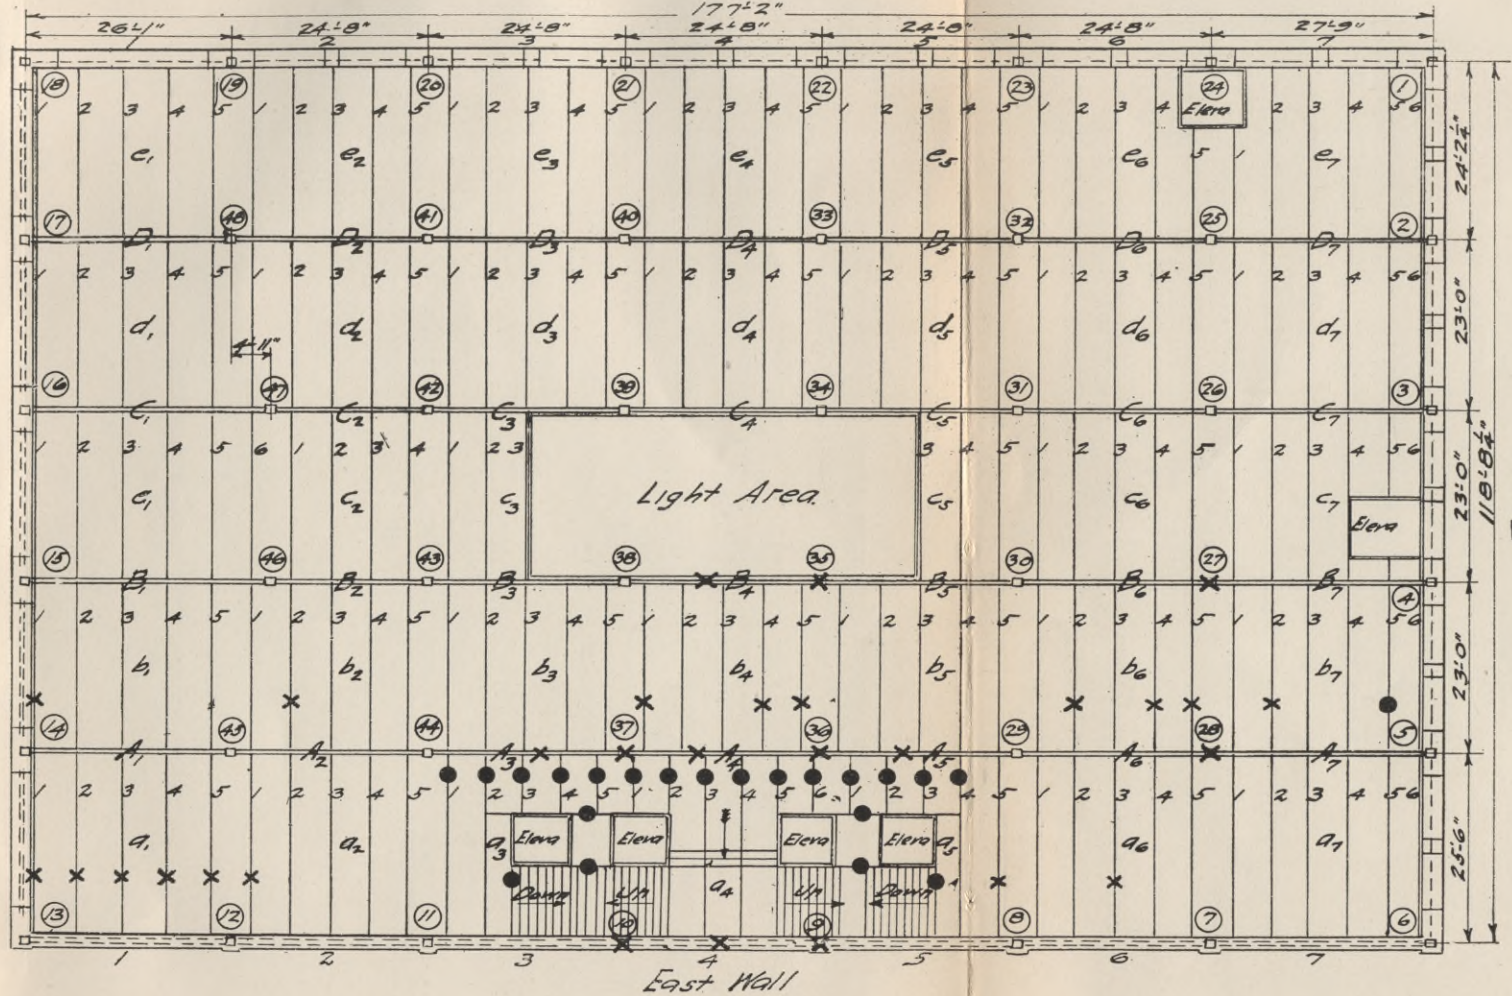
2ND STORY - 3RD FLOOR GIRDERS & BEAMS
PLATE NO 11

• Indicates new material
x " material to be straightened.

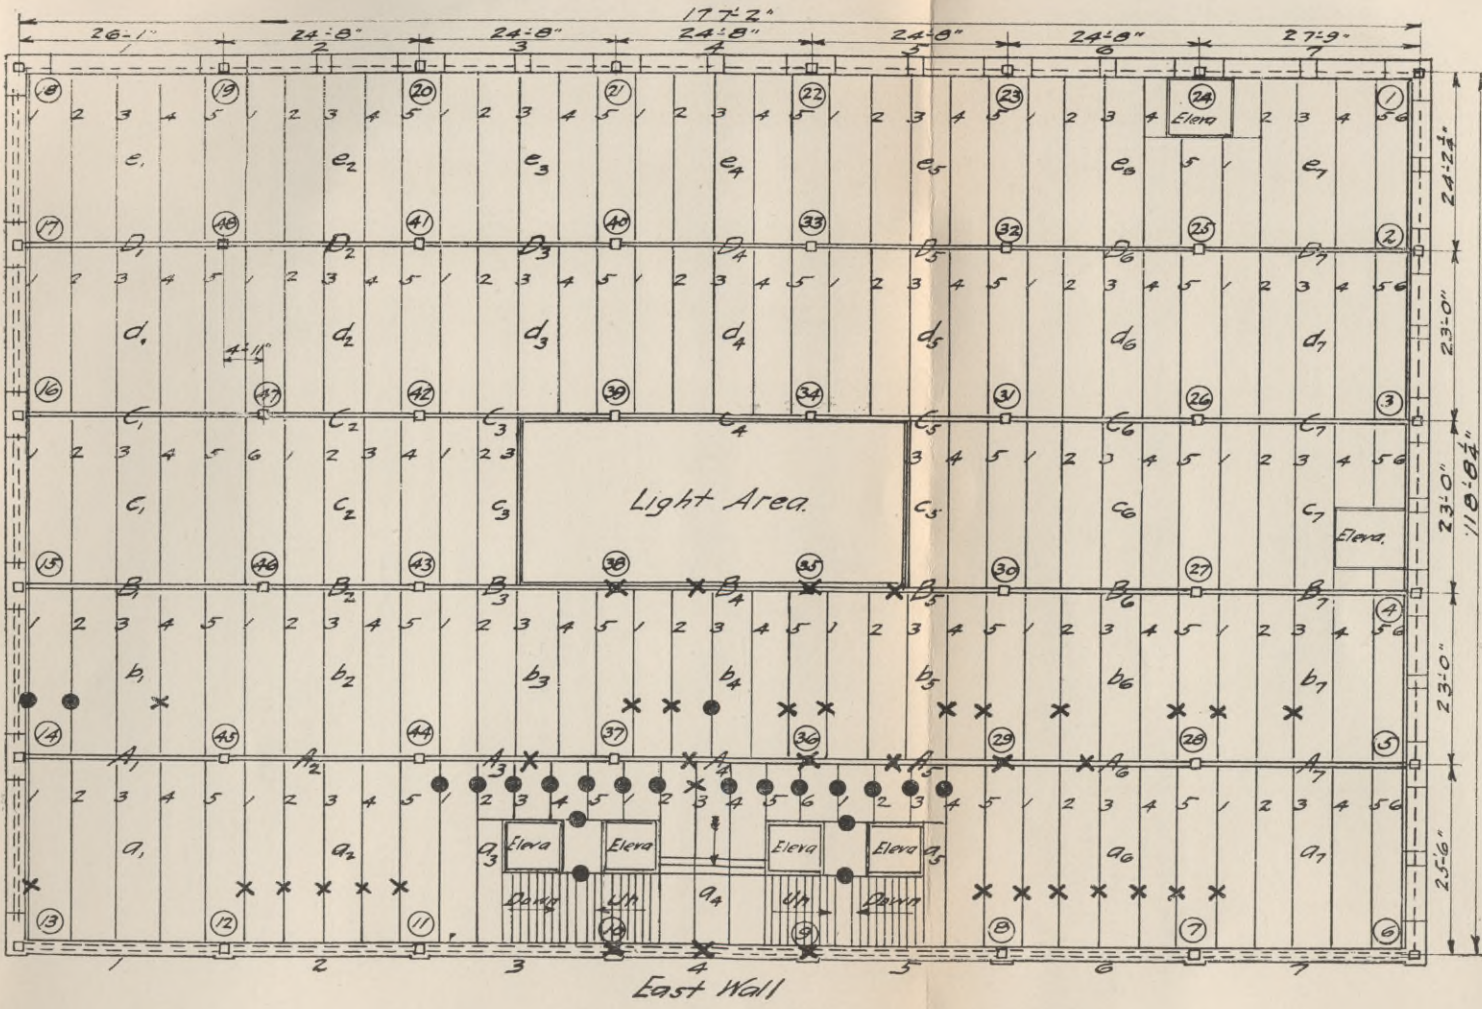
1ST STORY - 2ND FLOOR GIRDERS & BEAMS
 PLATE NO 12

- Indicates new material
- ✕ " material to be straightened.

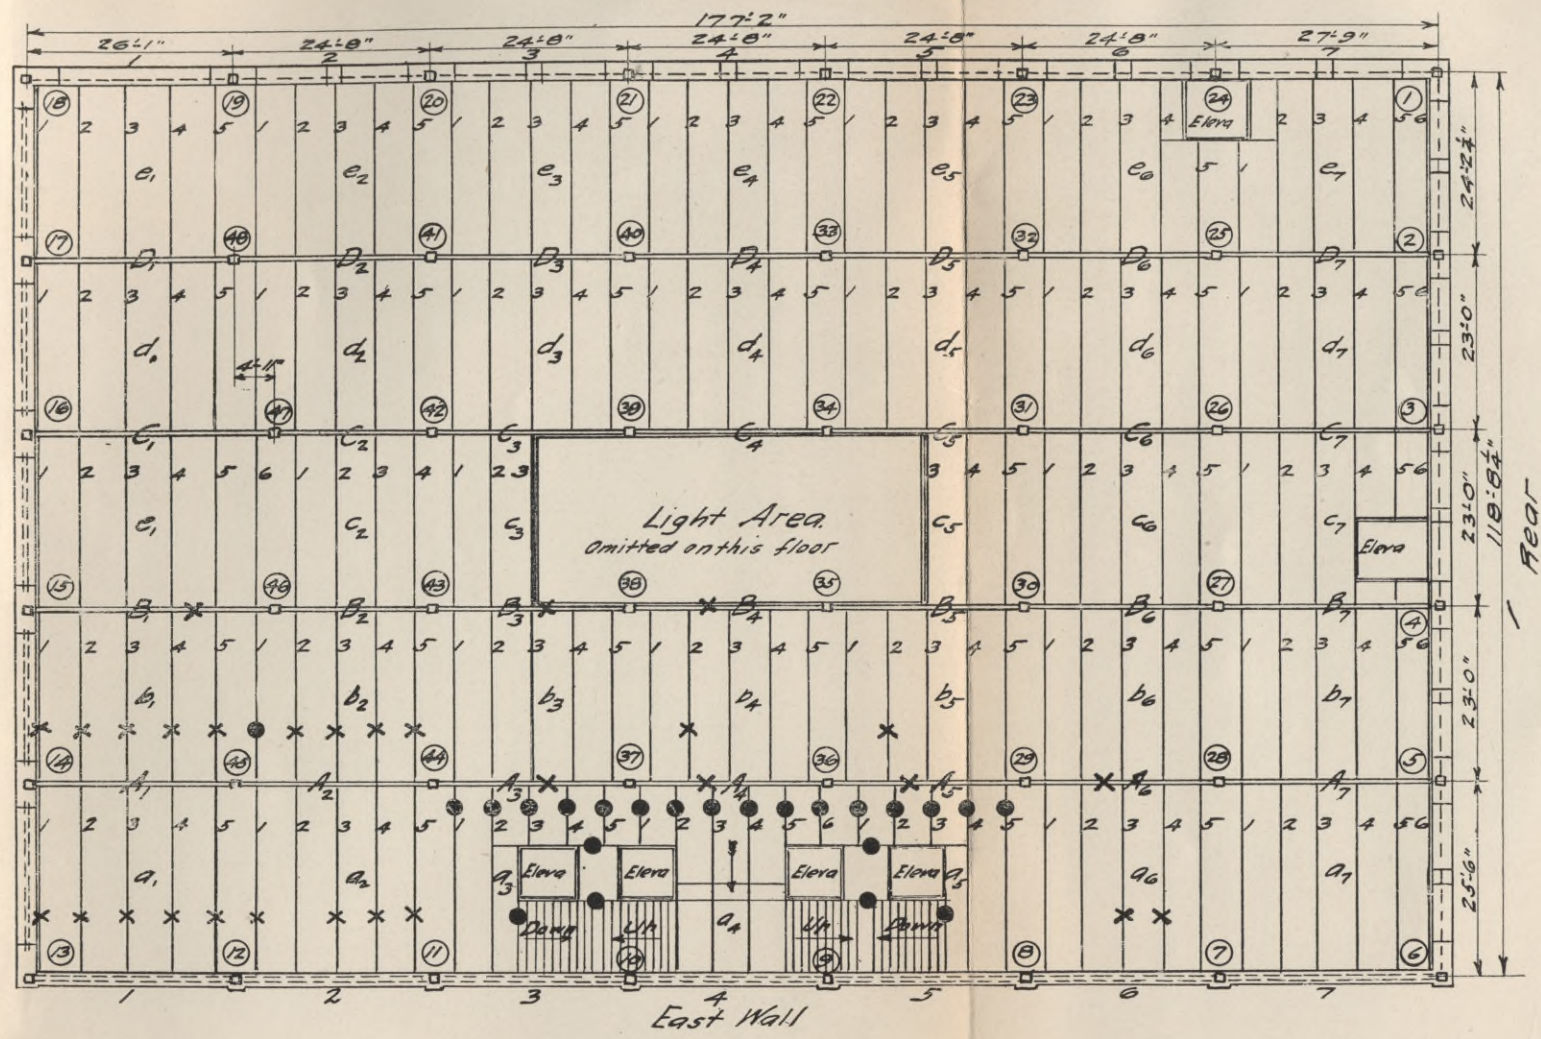
PLATE NO 13

BASEMENT COLUMNS - 1ST FLOOR GIRDETS & BEAMS

- Indicates new material
- x " material to be straightened
