# FIRE TESTS WITH DOORS.

A  $2\frac{5}{8}$  IN. DOOR IN OAK, CONSTRUCTED IN  
THREE THICKNESSES.

A  $2\frac{5}{8}$  IN. DOOR OF TEAK, CONSTRUCTED IN  
THREE THICKNESSES.

FIRE TESTS Fa & Ga.—APRIL, 11TH, 1900.

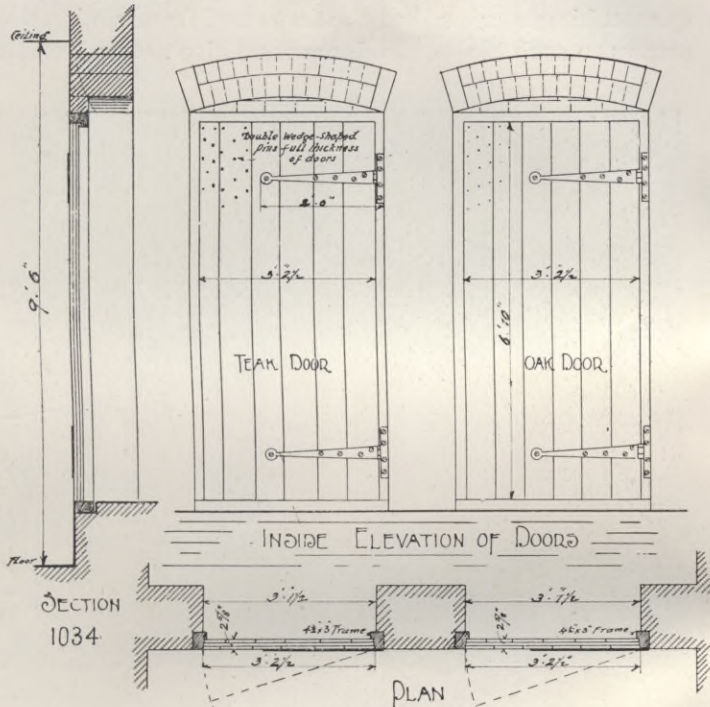
Figs. E, F. DETAILS OF DOORS.

The doors were of the same style and constructed in the same manner, being 6 ft. 10 in. high, by 3 ft. 2 1/2 in. wide, and formed of three thicknesses of 3/8-in. boards, between 6 in. and 7 in. wide.

The boards were not grooved or tongued, but simply butt-jointed; they were secured together by  $\frac{3}{8}$ -in. double wedge-shaped wooden pins of the same material as the doors, driven through the entire thickness of the door, there being about 240 to each door.

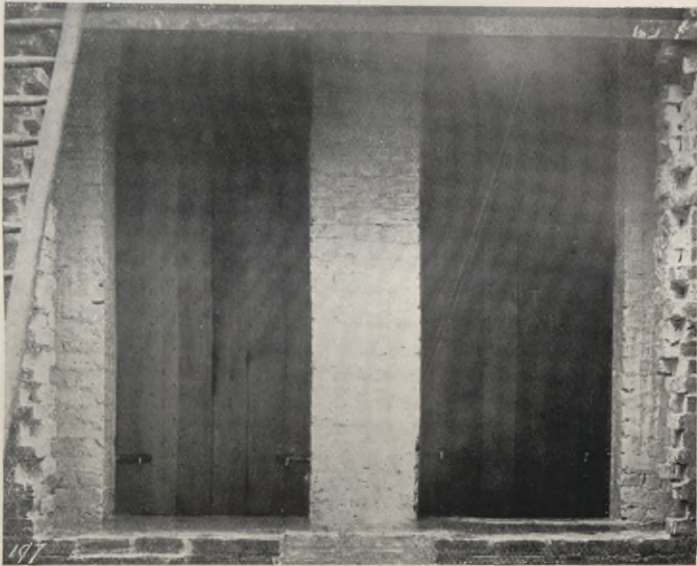
Fig. N. VIEW SHOWING CONDITION OF DOORS AT 5.21 P.M., AFTER THE APPLICATION OF WATER.

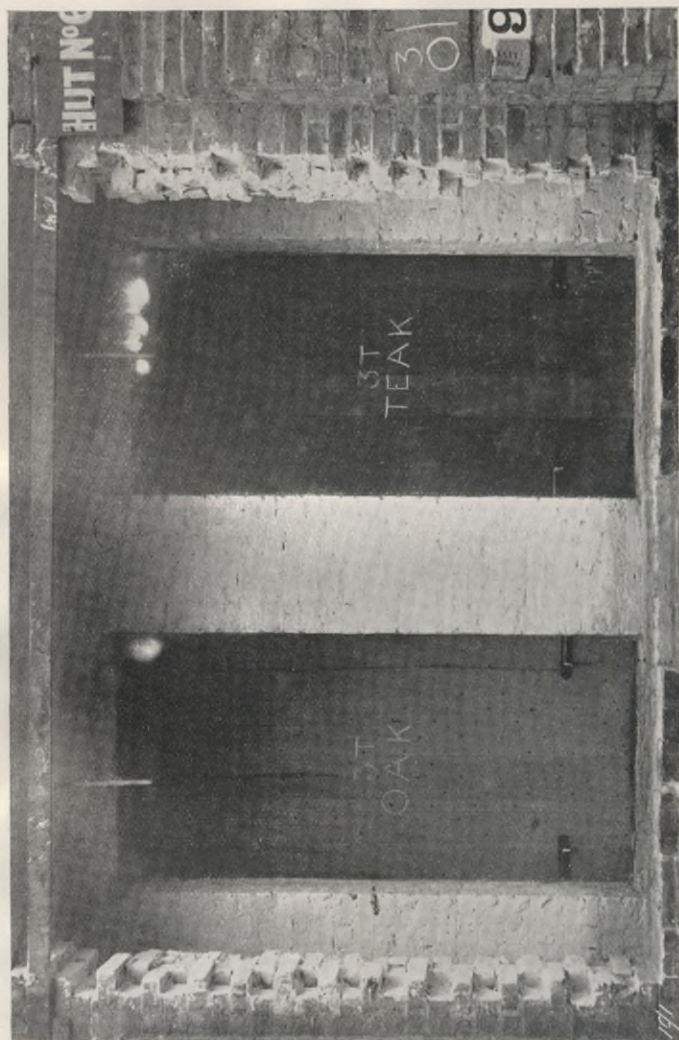
Fig. J. VIEW SHOWING CONDITION OF DOORS AFTER 60 MINUTES.

At 5.1 p.m. flame first came through top western corner, and glow appeared at bottom of door near eastern corner. (See Fig. J, 5.1 p.m.—60 minutes, also Fig. 9, 5.2 p.m.)

At 5.1 p.m. the glow at centre had become stronger, and that at western corner had developed into a hole. (See Fig. J., 5.1 p.m.—60 minutes.)

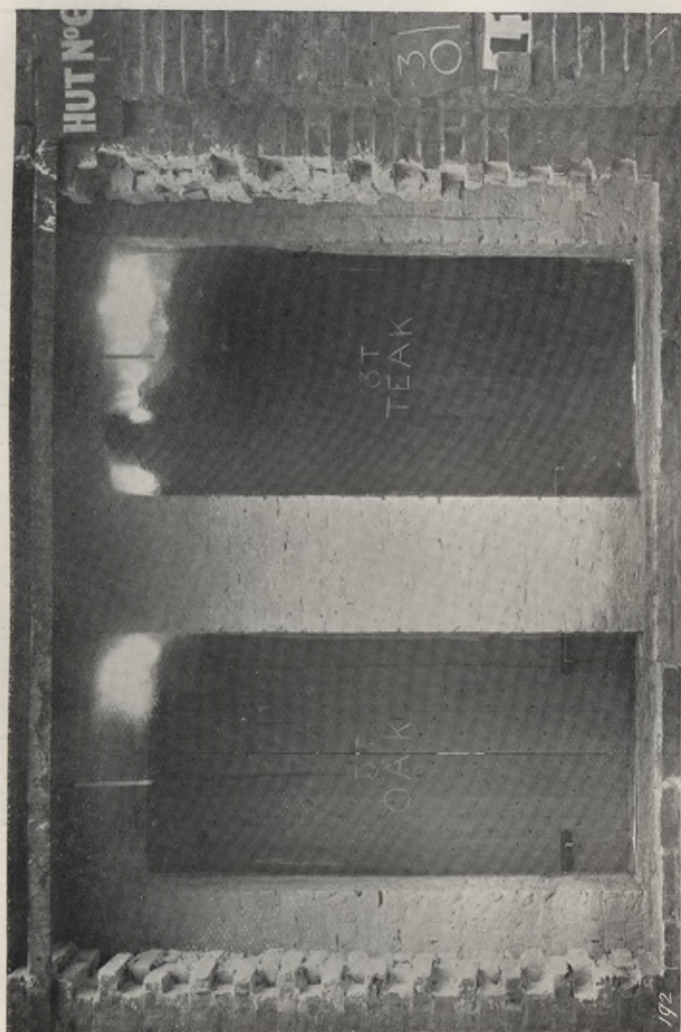
Fig. K. VIEW SHOWING CONDITION OF DOORS AFTER 69 MINUTES.

The glow along bottom of door had become stronger. (See Figs. K, 5.10 p.m.—69 minutes; also L, 5.13 p.m.—72 minutes; and Fig. 11, 5.12. p.m.)

At 5.10 p.m. flame at top of door had increased considerably. Both glow spots at bottom had developed into holes. (See Fig. K, 5.10 p.m.—69 minutes; also Fig. 11, 5.12. p.m)

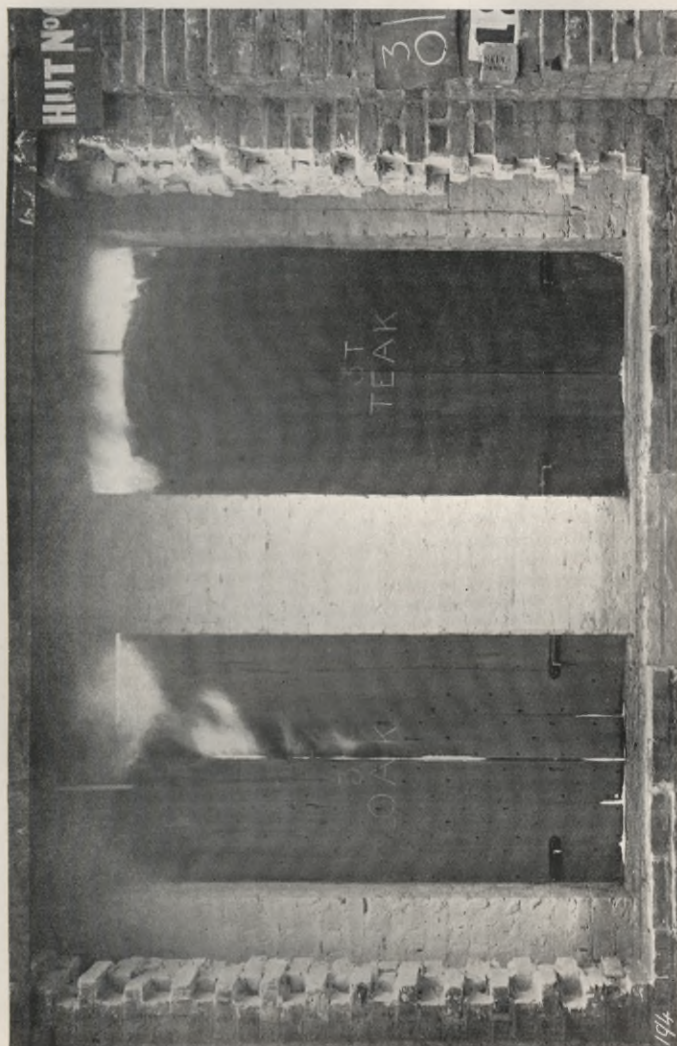
Fig. M. VIEW SHOWING CONDITION OF DOORS AFTER 75 MINUTES.

At 5.15 p.m., in addition to the above, a hole had appeared at eastern lower corner. (See Fig. M, 5.16 p.m.—75 minutes; also Fig. 12, 5.17. p.m.)

At 5.16 p.m. opening of centre joint widening, and flames coming through freely. (See Fig. M, 5.16 p.m. — 75 minutes; also Fig. 12, 5.17. p.m.)

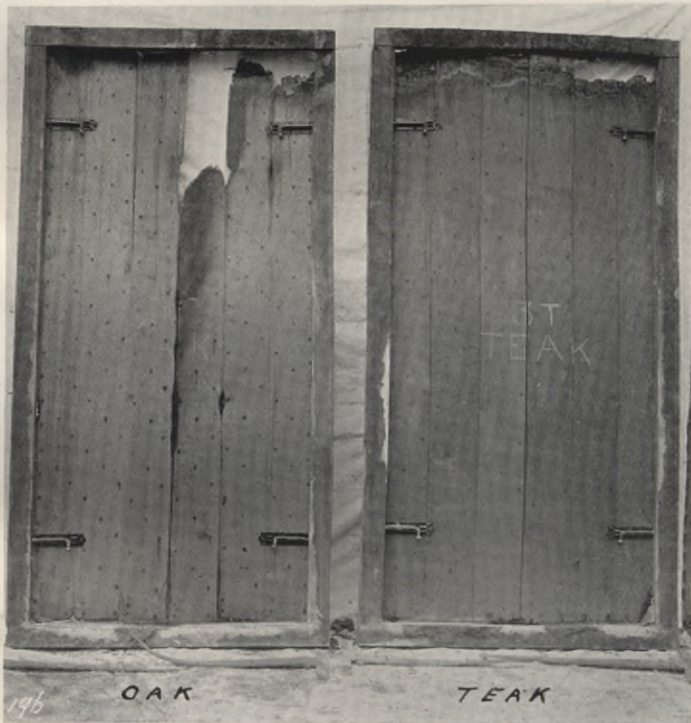
Fig. 0. VIEW SHOWING CONDITION OF THE OUTSIDE OF DOORS  
AFTER TEST AND REMOVAL.

The outer thickness was practically unharmed except for about 4 ins. at the top, where flames had broken through, and for small holes at eastern lower corner, and at centre of bottom of door. (See Figs. O and P.)

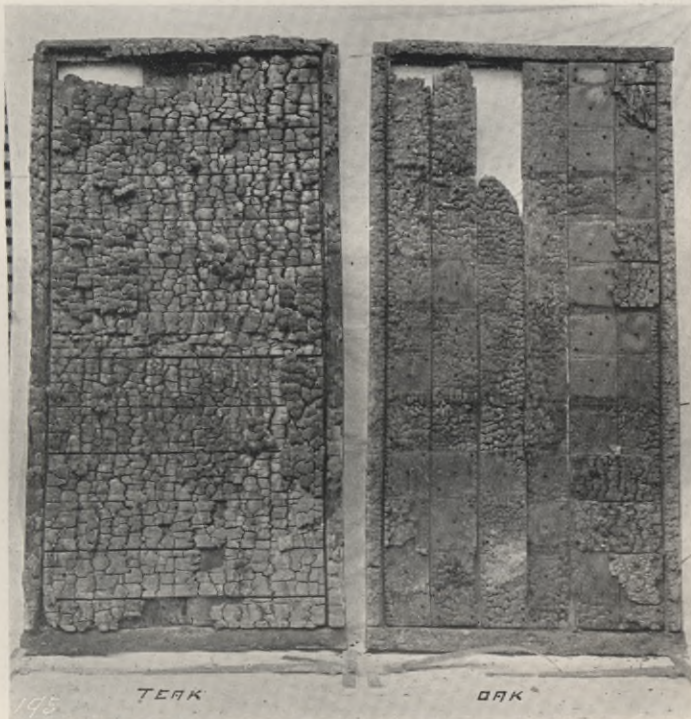
*Fig. P.* VIEW SHOWING CONDITION OF THE INSIDE OF DOORS  
AFTER TEST AND REMOVAL.

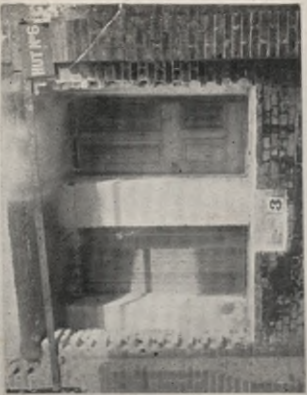
FIG. 3. TIME 4.39. TEMP 1375°

At 4.18 p.m. (17 minutes)  
 flame appeared at western  
 top corner of door. (See  
 Fig. H, 4.22 p.m., and Fig.  
 3, 4.22 p.m.—21 minutes.)

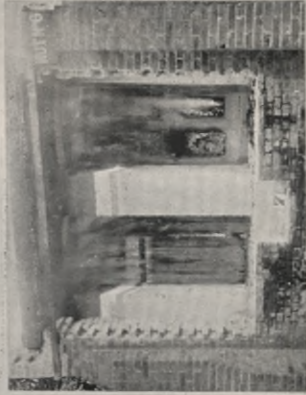
FIG. 5. TIME 4.52. TEMP 1575°

At 4.35 p.m. flame had extended across two-thirds of top of door, and 4 inches down west side. (See Fig. 5, 4.37 p.m.—36 minutes.)
