FAILURES OF SUSPENDED CEILINGS AND EXECUTION ERRORS

When observing the stability of suspended ceilings during operation, sometimes smaller failures are observed, up to disasters, even a few of considerable sizes and serious consequences. The aim of the article is to analyse the causes of damage to a suspended ceiling, with an area of approximately 500 m², as well as testing and checking the applied construction elements. In situ destructive tests as well as tests at the AGH laboratory were carried out. The analyses were carried out in accordance with PN/EN 13964: 2014 (E). It was found that the designed ceiling system solution was correct. Whereas in the performance, an improper spacing of hangers, even by more than 70% of the permissible spacing, and forbidden lengths of brackets from C60 profiles, were applied. Also, about 55% of the connectors had too small diameters of the ends of the mandrels, which allowed for the sliding of broken head and a sudden loss of carrying capacity of the hanger.

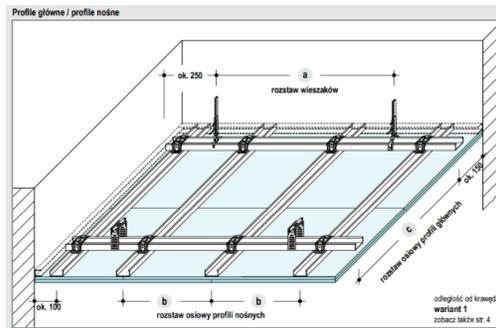
On the basis of a survey, it was found that main runner hangers in the failure area were present with the most unfavourable axial spacing of main runners $c_{\text{Imax}} = 105$ cm and $a_{\text{Imax}} = 130$ cm. The values permissible according to the Knauf system were exceeded significantly. Furthermore, other errors were observed. Due to the location of an access panel, the main runner was not continuous (one cantilever was 120 cm long and the other was 15 cm long). Some hangers were tensioned and subjected to significant loads, some were less tensioned, and a few were completely loose (this could have been caused by rectification of the floor slab level only in respect of selected hangers, with the adjacent ones remaining unadjusted). A small number of hangers were fixed with an approx. 15% tilt from the vertical due to conflicts with installation routes.

Fig. 2. Geometric parameters according to Knauf NIDA WGN 20
