Historical church diagnostic with regards to impact of traffic included vibrations

Krzysztof Koziol^{1,*}

¹Cracow University of Technology, Institute of Structural Mechanics, 31-155 Kraków, Warszawska 24 St., Poland

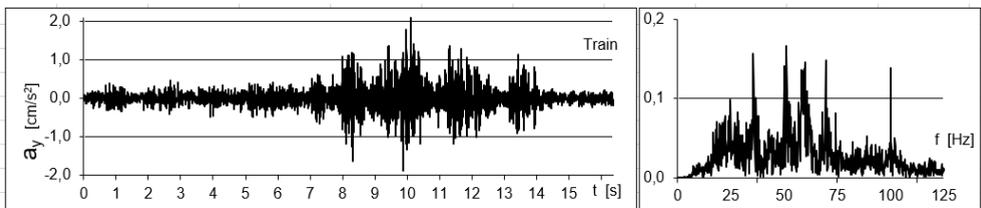
- at the ground level (foundation): component “x” - 1,25 cm/s^2 , component “y” - 2,12 cm/s^2 (vibro-acceleration shown on fig.2) component “z” - 1,34 cm/s^2 ,
- at the level of the wall's top: component “x” - 4,64 cm/s^2 , component “y” - 7,73 cm/s^2 , component “z” - 4,72 cm/s^2 .

Fig. 2. Vibro-acceleration (and its frequency spectrum) of foundation in the direction of y.

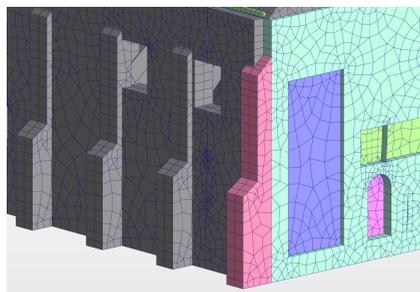
Dimensions and distribution of finite elements were adopted in accordance with the available documentation, including its verification during the damage inventory. Applied calculation model also takes into account the larger damage occurring in the construction,

Fig. 4. Part of a FEM model with enlarged mesh density around visible damages.

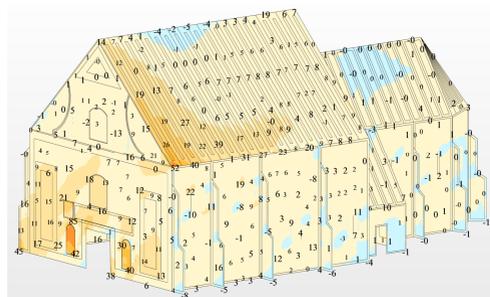
Fig. 5a. An exemplary map of the maximum main stresses (values in Pa, should be treated as variable sign) - caused by vibrations generated by train passage.

Basing on the calculations, it was found that the analyzed dynamic action induces tensile stresses with the following values: in the vaults they did not exceed 22 Pa, in longitudinal walls (sideways, perpendicular to the railway track) they reached 45 Pa and in the presbytery and in the front wall they did not exceed 43 Pa, with the exception of the window opening in the front wall, where they reached the value of 85 Pa.

The stress values obtained from calculations do not indicate that the vibrations caused by currently occurring trains and cars passes could be primary cause of damage to the structural elements of the church. However, they can lead to the disclosure and development of damage caused earlier by different causes.

- indication that there is no need to strengthen the ground under foundations,
- indication - in the current traffic and rails conditions – as the most appropriate solution causing reduction of vibrations transmitted to the structure by applying vibration isolation in the construction of railway tracks, which are passing in the vicinity of the church (within the section about 150m – 75 m north and south from the presbytery of the church),
- the level of stress caused by the loads caused by the passage of trains and cars showed that they do not affect the safety of the structure
- indication of the need to repair damage observed in the walls and provision of the protection works scope.

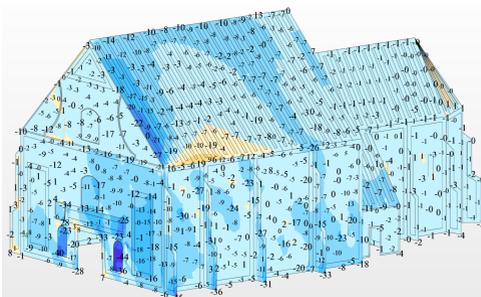
The level of vibrations caused by passing cars along Kopernika st. was several times smaller than the values given above.

Fig. 5b. An exemplary map of the maximum main stresses (values in Pa, should be treated as variable sign) - caused by vibrations generated by car.
