Faculty of Mining and Geoengineering, AGH University of Science and Technology

Jastrzębska Spółka Węglowa S.A.

THREATS OF FLOODING OF SELECTED MINING AREAS – REPAIR MEASURES

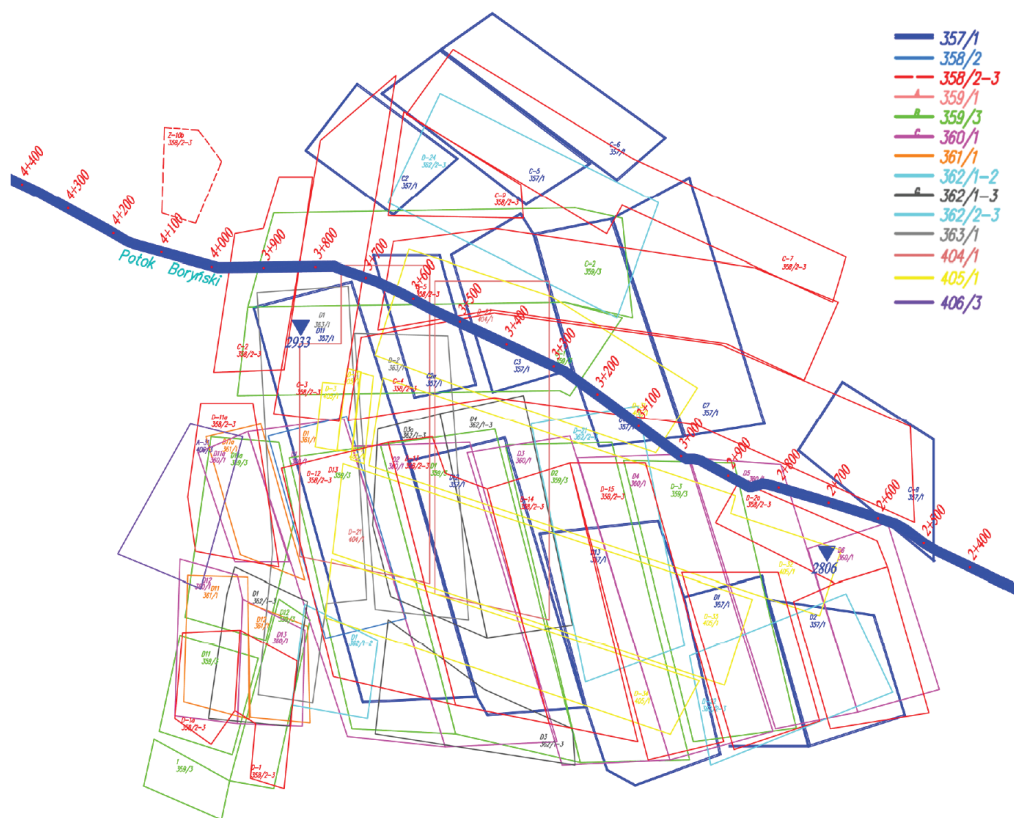
Fig. 3. Mining in the Boryński stream area in the period 1972–2018 and the location of benchmarks

In the area of the Boryński stream, mining has been conducted in seventy longwalls in fourteen seams since 1972. These are: seam 357/1 of walls D1÷D2, D11÷D13, C2a, C2÷C4, C7, C9; seam 358/2 of wall E4; seam 358/2 – 3 of walls C2÷C5, C7, C9, D1a÷D2a, D2, D11a, D12÷D14, Z10b; seam 359/1 of walls E1÷E2; seam 359/3 of walls 1, C1÷C2, D1÷D3, D11a, D11÷D13; seam 360/1 of walls D1÷D6, D11a, D12÷D13; seam 361/1 of walls 1, D11a, D11÷D12; seam 362/1 – 2 of walls D1; seam 362/1 – 3 of walls D1, D3a, D3÷D4; seam 362/2 – 3 of walls D21÷D22, D24; seam 363/1 of walls D1÷D2; seam 404/1 of walls D21÷D22; seam 405/1 of walls D1÷D3, D11÷D34; seam 406/3 of wall A31. Figure 3 presents the locations and shapes of the individual mining parcels.

The height of the mined longwalls ranged from 1.15 to 3.2 m, and usually exceeded 2 m. The highest mining intensity was in the 1980s, and in this period, forty – one longwalls were mined in the area in question. Between 1990 and 2018, 22 more longwalls were mined.

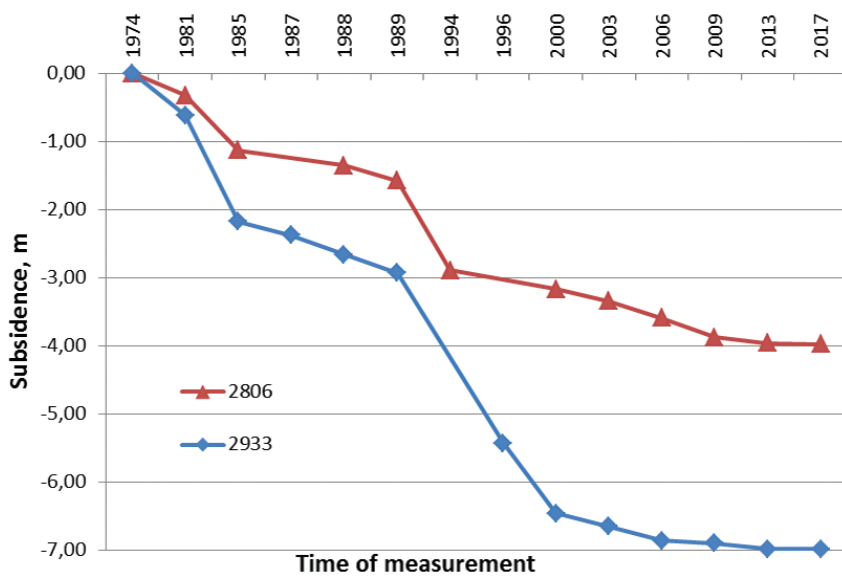
Fig. 4. The subsidence of points located in the analysed region in the period 1974–2017

The values of subsidence caused by mining in the area in question are documented by the geodetic surveys performed from October 1974 to June 2017. The article presents subsidence occurring at two characteristic measuring points 2806 and 2933 – wall benchmarks. At measuring points 2806 and 2933, the subsidence levels observed over 43 years are 3.97 and 6.98 m, respectively. These values illustrate the effect of coal mining in the referenced region. The course of subsidence over time at the selected benchmarks are presented in Fig. 4.

The mining operations of 1978 to 2019 resulted in category IV to V surface deformations. The smallest subsidence was observed in the locations of gravity flow, while the greatest occurred near a pumping station, where the hydraulic continuity of the stream was interrupted.

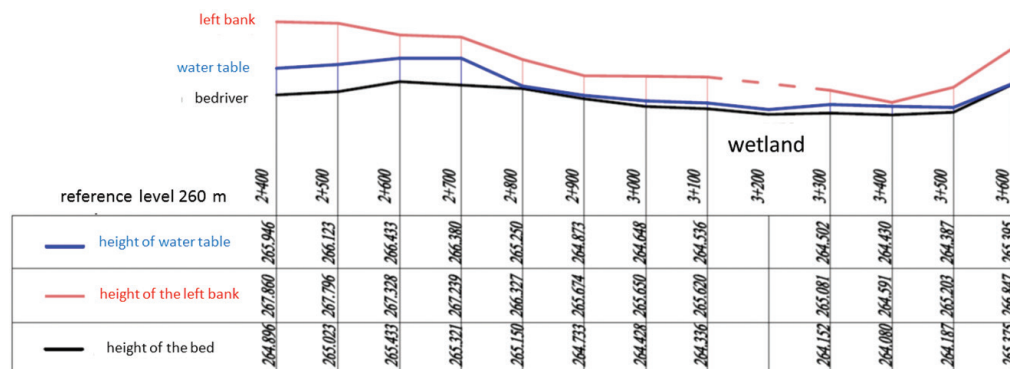
The longitudinal section of the analysed section of the Boryński stream illustrates that the riverbed of the stream is slanted in the opposite direction to the outflow of water from the catchment area (Fig. 6). This results in no outflow from the catchment area and the emergence of overflow land. The existing pumping station is unable to effectively pump out the water flowing within the Boryński stream riverbed. The outlet of the pressure piping of this pumping station is permanently flooded due to the lack of runoff.

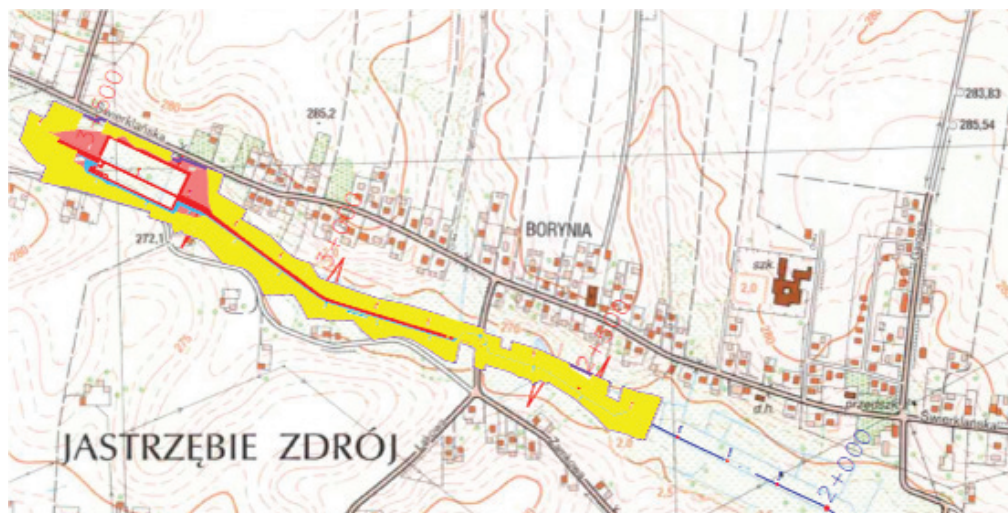
Fig. 7. A layout plan showing location of repair measures in the Boryński stream area

The mining – induced damage which occurs in the analysed region causes interruptions in the outflow of surface water. An interior basin formed at the 2+400 to 3+600 km section of the Boryński stream riverbed. It is drained using the pumping station on Zamkowa Street. The outlet of the pressure piping of this pumping station is at 2+710 km (above Łąkowa Street level). The pumping station is unable to effectively pump out the water from the basin, especially in the case of heavy rainfall.

Interruptions to the outflow of water along the Boryński stream riverbed have been observed for many years. Unfortunately, the technical facilities made in 2006–2007 are becoming ineffective in the case of heavier precipitation. The interior basin which forms between the Zamkowa and Świerkłańska Streets fills up with water during heavy rainfall and results in the flooding of areas and buildings adjacent to the riverbed. In order to solve this problem, it is necessary to change the subsidence trough drainage system.

In order to ensure the correct waterflow in the riverbed and to maintain appropriate technical and hydraulic parameters, appropriate construction works were planned [7] (Fig. 7), including:

- ▶ the construction of a pumping station equipped with two pumps with a capacity of $Q = 55 \text{ dm}^3/\text{s}$ and one pump with a capacity of $Q = 300 \text{ dm}^3/\text{s}$;
- ▶ the creation of a retarding reservoir in the Boryński stream riverbed with dimensions of $71 \times 160 \text{ m}$ and a volume of $27\,650 \text{ m}^3$;
- ▶ the installation of pressure piping with diameters of 355 mm and lengths of 1210 and 1166 m along the stream riverbed, up to the location of gravity flow;
- ▶ the installation of a decompression chamber at the pressure piping outlets;
- ▶ Boryński stream riverbed improvement along a section of 1220 m;
- ▶ elevation and development of degraded area for agricultural purposes.

The designed retarding reservoir is to be located in the deepest depression of the Boryński stream riverbed from 3+318 to 3+456 km. This reservoir collects water from subcatchments located downstream of 2+400 km. Water from the reservoir will be gravitationally discharged to two wells with pumps. Up to a height of 265.00 m, the reservoir will have vertical walls of steel sheet piles topped with caps. The bottom of the reservoir will be profiled accordingly and provided with a 6‰ slope towards the axis of the Boryński stream.

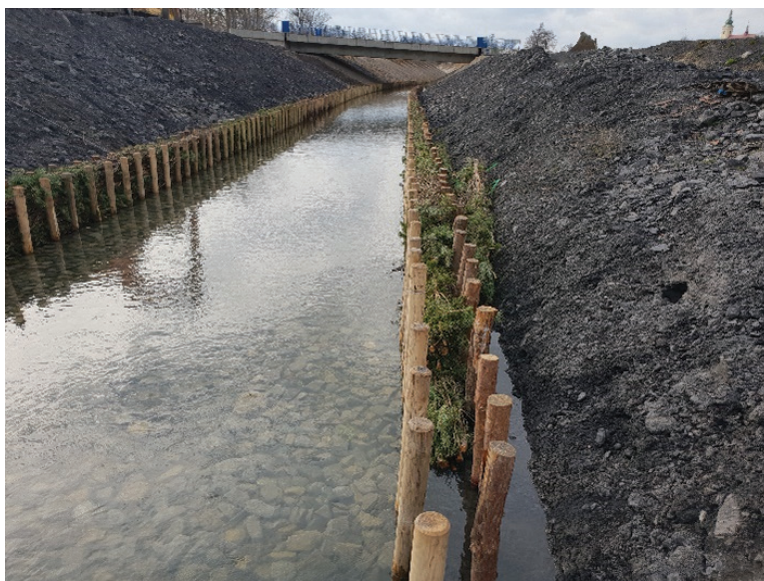
Fig. 10. Works related to the incorporation of fascines and humus – covering the scarps along the Pszczynka river

Due to the formation of a stagnation area caused by the uneven subsidence of the Pszczynka riverbed, into which the Boryński stream flows, the riverbed was reinforced over a distance of 1 km [6, 9]. As part of reprofiling, the riverbed was reinforced with riprap, assuming a riverbed with a maximum bottom width of 4.0 m (Fig. 10).

The works performed in the Pszczynka riverbed focused on natural restoration and made it possible to restore the width of the riverbed to its original condition, prior to its subsidence.
