TECHNICAL TRANSACTIONS 11/2019

Anna Martyka (D) orcid.org/0000-0001-7582-78280

The second life of a shooting range — the conservation and adaptation of the historic shooting range at Wola Justowska in Krakow for its new function

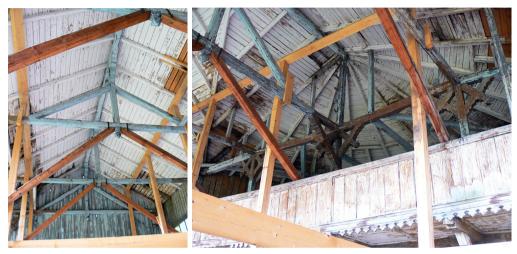
Fig. 8. Interior of the middle segment - view of the western wall - the open roof truss, single-frame with struts and king posts supporting the ridge. A view of the interior of the avant-corps – the closed balcony balustrade, the avant-corps roof truss and secondary reinforcement of the original structure are visible. This is the condition before the adaptation of the pavilion (Source: Author's archive)

The southern elevation of the central section, including the avant-corps, is glazed with two rows of windows placed between the ground floor posts and the mezzanine floor. The single loom windows have several quarters. The colour of the wooden frame is clearly distinguishable on the northern façade and is darker than the wall surface elements (Fig. 5). The carpentry of struts and crosses was also designed in a decorative way. The avant-corps has an exposed frame, and the post heads are profiled. Its roof is multi-hipped and flattened and the surfaces of gable roofs are topped with decorative wooden pinnacles. The central section is entirely open to the south. High construction posts sitting on pedestals have decoratively finished capitals. At the turn of the 20th and 21st century, the upper part of the building was supported, which preserved the stability of the original wooden frame [2] (Fig. 8).

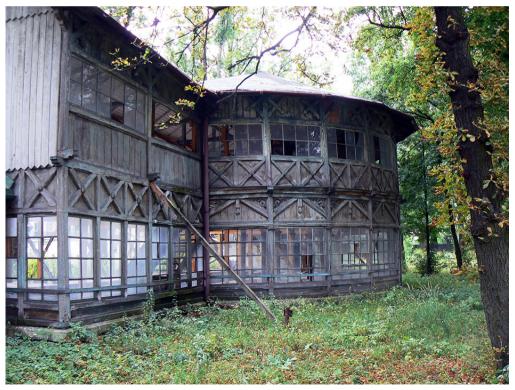
The main cause of the poor condition of the wooden framing was leaky roof coverings and damage to the metal-sheet work. In many places, the wood had darkened and was covered with stains; white patches of salt were apparent on the borders. (Fig. 9). The mould had spead on the structural frame elements, the decorative details and the covering boards. Significant changes to the geometry of the wooden frame system were visible (22 cm deviation from the perpendicular position of the posts). Deformations, breaks, numerous cracks and the delamination of oil paint coatings were also spotted. The window and door wings were warped, and the glazing was destroyed. The ironwork elements were corroded and incomplete [2].

Fig. 9. The critical condition of the shooting range pavilion showing a view of the central section from the southern side. This shows the condition before the adaptation of the pavilion (Source: Author's archive)

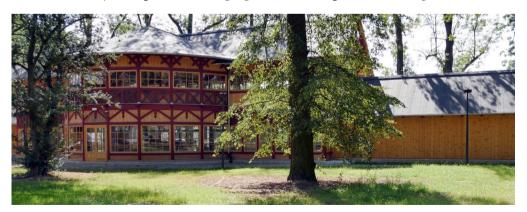
Fig. 11. View of the central segment of the pavilion with the apse from the southern side. This shows the condition after adaptation (Source: Author's archive)

brick paint and the wall surface sections were left the colour of natural wood. The preserved elements of the original ironwork were subjected to metal conservation. The roof surface was insulated from the outside in order to keep the elements of the roof truss visible from the inside. The wooden decorative detail was reconstructed in the original form and vertically planked. Decorative constructions of the avant-corps and the apse were also made [2] (Figs. 11–14).
