An inventory of selected sources of light pollution in Tarnów

Keywords: light pollution, Tarnów, inventory of lighting, improper lighting

2. Tarnów – inventory of artificial lighting sources in selected areas

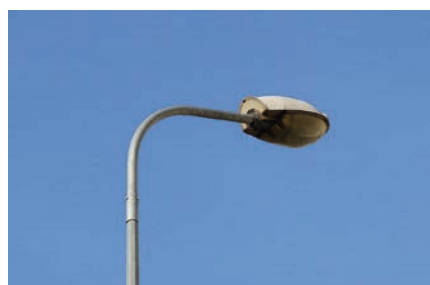
In the category of street lamps, the primary identified problems are with improperly constructed, convex covers upon which the light is dispersed. The second identified problem is the source of light being positioned too low in the shield. Such a difficulty is encountered in the case of the sodium lamp shown in Fig. 3. Sometimes, another harmful effect appears when the lamp cover is not mounted horizontally. As a consequence, most of the emitted light goes not to the streets or the pavements, but to the surroundings above. This causes, among other effects, light to permeate through the windows of residential buildings, where it disturbs people's sleep. Sometimes the lamps are located on poles that are too high and in effect, the pavement at the foot of the light source is poorly lit and a large amount of light is dispersed.

Fig. 3. HPS lamp with an older type of shield, which are very common on Tarnów streets (photo by: I. Esmund)

First of all, street lamp covers should be replaced by flat covers which do not scatter the light. Their complete replacement with LED lamps should also be considered. However, for all types of lighting, including that used at the car park, care should be taken to position the enclosures correctly (i.e. parallel to the ground) so that the light is directed downwards, where it is needed. The height of each individual lamp pole is also important. It should be ensured that it is adapted to the place where the lighting is located. The presented actions will minimise, among other effects, light-trespass.

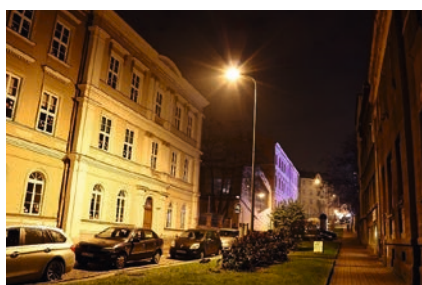
Figure 4 shows a situation in which an improperly shielded light propagates in all directions. Such propagation is an unfavourable phenomenon which is associated with wasting electricity and, consequently, is a waste of money. Furthermore, the permeation of light through windows by incorrectly directed light poses a problem. Such light disrupts the circadian rhythm of the inhabitants, causing problems with their sleep. Figure 4 presents this exact situation. The facade of the building is brightly lit and this includes the area above the lamp. The

Fig. 4. Street lamp with an older, inappropriate shield on Kopernika St. (photo by: I. Esmund)

light freely reaches the windows. External light permeating through the windows constitutes a problem for inhabitants of the residential building. Fortunately, in this case, this is just a school, so people do not stay there at night.

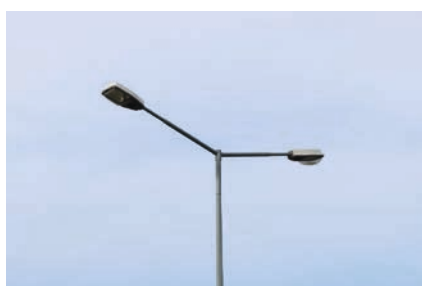
There is also another type of sodium lamp with a newer design on Tarnów streets, which contributes less to light pollution (Fig. 5). The filament is wholly hidden within the shield, but the lamp cover is still convex, so the light scatters on it.

Fig. 5. A lamp with a newer shield type but still with a convex cover (photo by: I. Esmund)

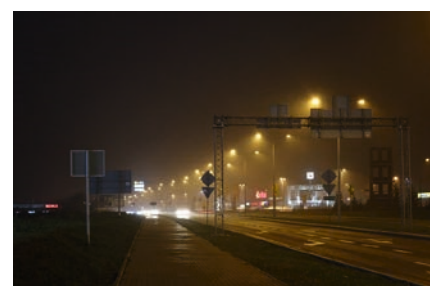
Figure 6 shows the weaker upward emission of light from the newer lamps. Most of the light rays indeed illuminate the street, which is connected with the correct lamp setting. The factor that causes light pollution is, in this case, the convex cover upon which the light rays scatter. Insufficient lighting of the pavement on the street is another noticeable issue. Placing lamps between two lanes only makes the road well lit. However, the problem should not be solved by, for example, lifting the lamp shields. Such an action would increase the excessive lighting of the area, while at the same time deteriorating the illumination of the road.

Fig. 6. The effect of using lamps with newer shields, Błonie St. (photo by: I. Esmund)

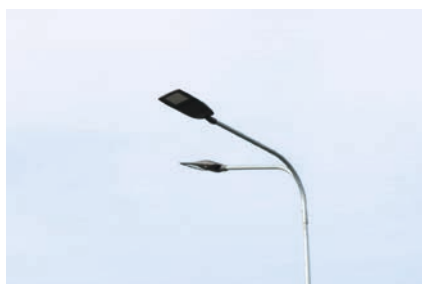
Tarnów also boasts examples of correct street lighting. These include LED lamps (Fig. 7), located on newly built or renovated street sections. These lamps have a flat shield, in which the LED panel is completely hidden. The construction used does not allow light to escape upwards. Furthermore, the lamps are positioned correctly, i.e. the lamp cover plane is parallel to the horizon.

Fig. 7. LED lamp of an appropriate construction (photo by: I. Esmund)

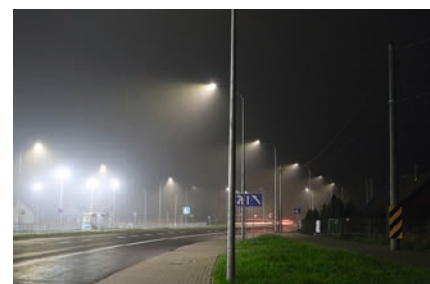
Fig. 8. Light directed in different ways on Błonie St. (photo by: I. Esmund)

Figure 8 shows LED lamps located on Błonie St. on the outskirts of Tarnów. This proves that the proper construction of artificial light sources, as described above, brings positive effects. The foggy weather demonstrates that the light is only slightly scattered below the line of the horizon. Incident light illuminates a specific space, only the street and pavement, nothing more. It should be noted that not all LED lamps are mounted in the right way. It may be even noticed that the orientation of each differs slightly from the orientation of the next. As a result, light is spreading at different angles. Lamps on the left side of the street are positioned more correctly.

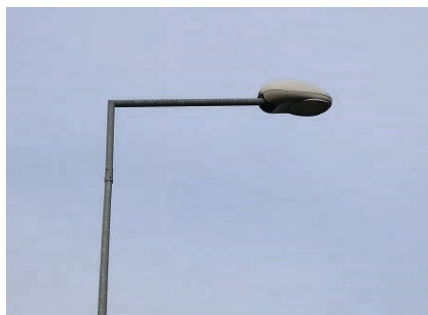
Lamps with a sodium light source (HPS) (Fig. 9) located on the section of Jan Paweł II Ave. leading to the city borders can also be considered as examples of proper lighting. They are characterised by their correct shields, good positioning and an appropriate intensity of light, which does not dazzle drivers on busy traffic routes. The correctness of lighting is confirmed by the light shafts visible in Fig. 10, which fall mainly down on the street.

Fig. 9. A lamp with the correct construction on Jan Paweł II Ave. (photo by: I. Esmund)

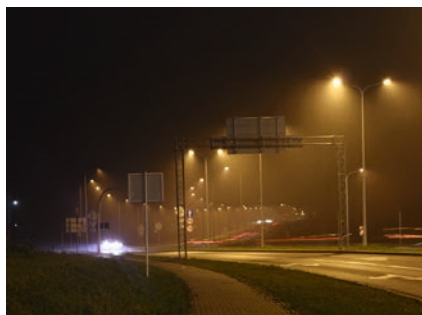
Fig. 10. The use of lamps with the correct construction on Jan Paweł II Ave. (photo by: I. Esmund)

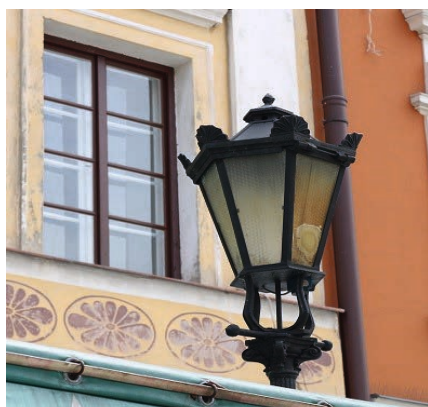
Within the Old Town, stylish lighting takes the form of lanterns with a sodium light source (HPS). Although they differ from each other, they are kept in the same style. These are either stand-alone lamps (Fig. 11) or they are attached to the walls of buildings (Fig. 12).

Fig. 11. A stylish free-standing lantern in the Market Square (photo by: I. Esmund)

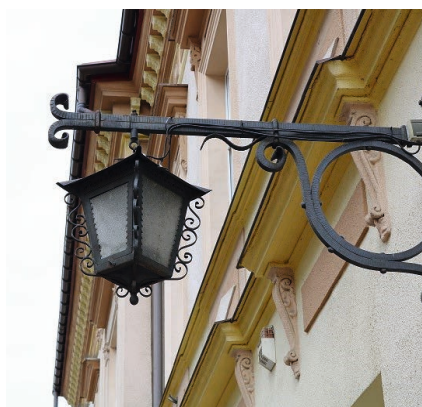
Fig. 12. A stylish lamp attached to the building on Wałowa Str. (photo by: I. Esmund)

The stylish lamps are shielded from above with flat visors, so the upward escape of light rays is limited. However, it is difficult to say in which part of the shield the filament is placed because the opaque cover does not make this visible. The best solution would be with the filament located just below the visor. This would mean that the light would be directed towards the ground, where it is needed. The height of both the free-standing lamps and those attached to buildings is adequate. The environment is illuminated evenly, but the level of luminance is rather low. When the light reaches the ground, it no longer scatters too much in the atmosphere.

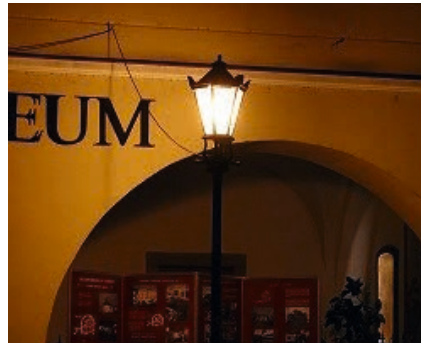
The night-time photos of these lanterns (Figs. 13 and 14) suggest that the filaments are placed too low in the shield. This is a disadvantage of this kind of light source. Figure 13 shows that the lantern illuminates the adjacent wall better than the ground. In Fig. 14, light is emitted in all directions. However, the use of such lanterns has also positive aspects. The wall lamps are mounted at the appropriate height, and the free-standing lamps are arranged with an appropriate frequency. The light intensity is correct, which contributes to both electricity savings and municipal finances. Numerous other examples of stylish lighting are sodium lamps located on Krakowska St. and the adjacent Sobieski Sq.

Fig. 13. A stylish lantern on the Market Square (photo by: I. Esmund)

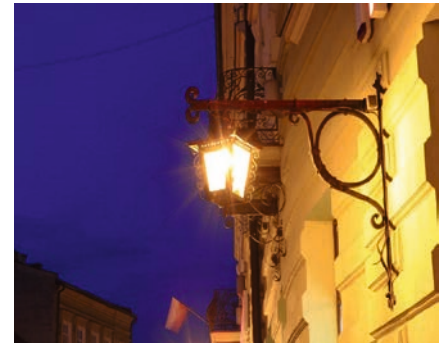
Fig. 14. A stylish lamp at night on Wałowa St. (photo by: I. Esmund)

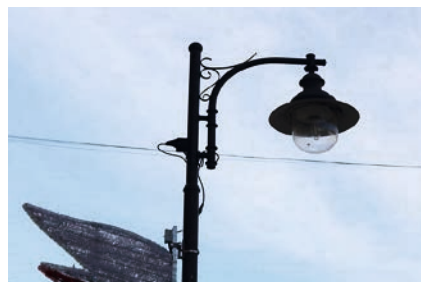
Lanterns, like the one in Fig. 15, are usually of an improper construction despite their striking appearance. They have round, transparent covers diffusing the light and shields in the form of a visor. However, the visors are too small and do not prevent the light from being directed upwards.

Fig. 15. A stylish lamp on Krakowska St. (photo by: I. Esmund)

Another solution is the use of opaque shields that will allow the light to stay below the horizon line, thus protecting the night sky. This solution applies to, among other types of lighting, park lamps with spherical covers. However, in the case of other examples of lighting, it is enough to slightly increase the size of their shields in relation to the location of the filament in order to stop excess light rays, e.g. in the case of stylish lamps.

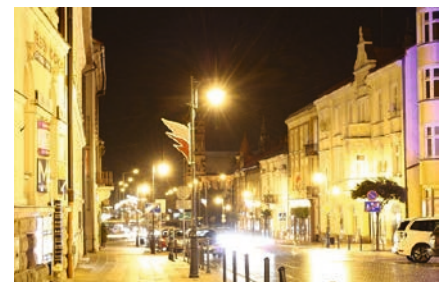
The photo of these lamps at night (Fig. 16) shows that the shafts of light are distributed evenly in all directions, including upwards. This distribution confirms the incorrect construction of the lanterns. Furthermore, the intensity of their light is too high, which can dazzle drivers. Acting together with illuminated advertisements and illuminations of buildings, lighting chaos arises that distracts users of the space, not only drivers of cars but also pedestrians. Another problem worth noting is the brightly lit facades of buildings (Fig. 16), not only below the elevation of the described lamps. This phenomenon also indicates that the light rays are escaping upwards. This effect contributes to the light-trespass effect. This effect consists of lighting places that do not need to be illuminated, in this case, windows of buildings.

Fig. 16. Stylish lamps on Krakowska St. at night. (photo by: I. Esmund)

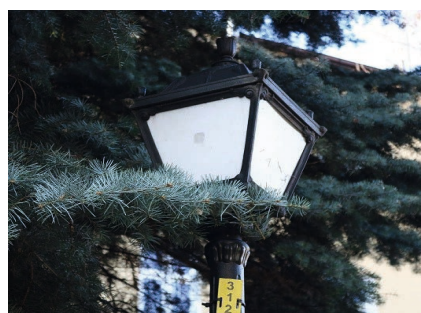
Fig. 17. A park lamp in Sándor Petőfi Sq., on Krakowska St. (photo by: I. Esmund)

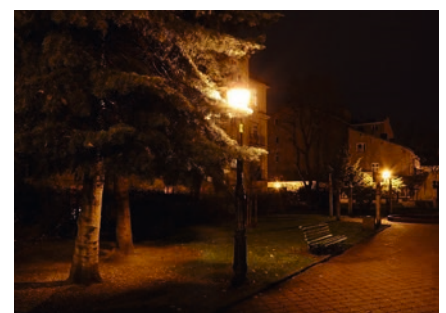
One of the inventoried examples of park lamps are those found on Sándor Petőfi Sq. on Krakowska St. (Fig. 17). In addition to the problems discussed earlier, Fig. 18 shows new issues worth addressing. First, grass and tree trunks are illuminated as strongly as the pavement. Even the shadow cast by one of the trees is visible. In this case, there is a phenomenon the light-trespass – light reaching places that it should not enter or where it is entirely unnecessary. However, the nearby pavement could be better illuminated. Worth noting is the darker area at the base of the lamp and the lighter area under the trees.

Fig. 18. A park lamp in the square at night (photo by: I. Esmund)

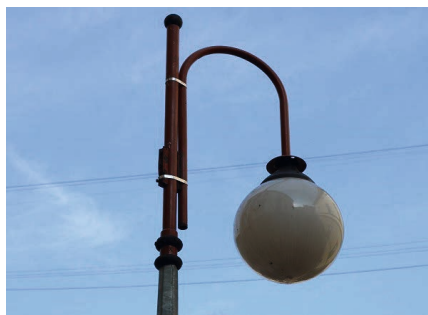
Fig. 19. Park lamp with spherical cover, Staszica St. (photo by: I. Esmund)

Another type of park lamp is the one with a spherical cover, without a top visor. An example of such a lamp can be found on Staszica St. (Fig. 19). The photograph of this lamp taken at night (Fig. 20) confirms that as a result of the lack of any cover, lighting causes the excessive emission of light into the environment and the pollution of the night sky with artificial light. As well as the ground, the lamp illuminates a fragment of the wall visible on the right. This is the most harmful and improper type of park lamp.

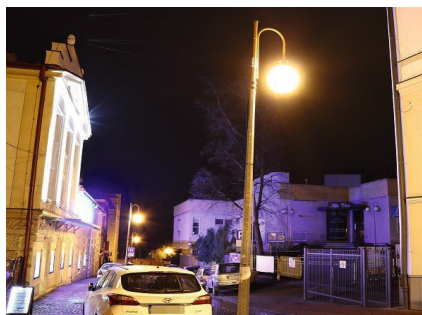
Fig. 20. Lamp with a spherical cover at night, Staszica St. (photo by: I. Esmund)

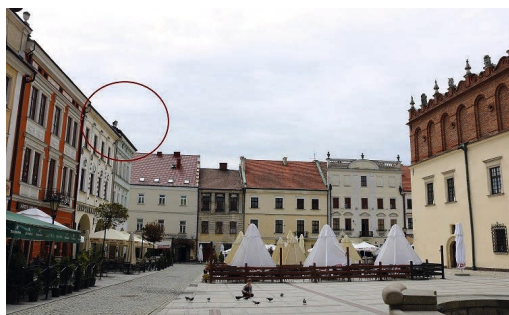
Spotlights represent illumination lighting on the Tarnów Market Square. Their task is to outline the body of the Town Hall building and enable it to be admired after dusk, and maybe especially at night. The spotlights are located on the roofs of tenements surrounding the main city square (Figs. 21 and 22). They can also be found at the Town Hall itself.

Fig. 21. View of Tarnów Market Square with the spotlight marked (photo by: I. Esmund)

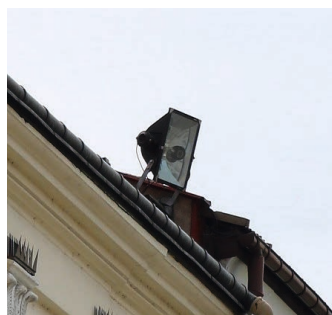
Fig. 22. The circled spotlight from Fig. 21 in close-up (photo by: I. Esmund)

The reflector presented in Fig. 22 is one of several that illuminate Tarnów Town Hall. Their construction is correct. Models with flat or even concave covers were used, as well as opaque shields; as a result of this, light is directed in only one direction. In this case, the light pollution is caused by the improper, practically vertical alignment of the reflectors. The light propagates horizontally instead of downwards. In this way, it is dispersed, and a large part of it is dispersed upwards.

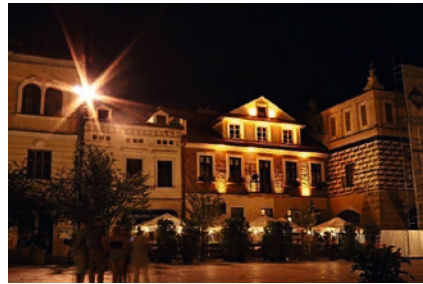
Excessive lighting often enters the surroundings and becomes a component of light pollution (Fig. 23). The light is also directed through the windows of buildings, some of which are residential. Furthermore, high-intensity light is used, which may well illuminate the Town Hall but at the same time dazzles the users of the adjacent urban space. Instead of enhancing the architectural shape of the object, the light only illuminates its walls. The photo also shows frontage buildings with their illumination. This consists of bottom-up spotlights mounted

Fig. 23. View of the Market Square at night with a reflector illuminating the Town Hall (photo by: I. Esmund)

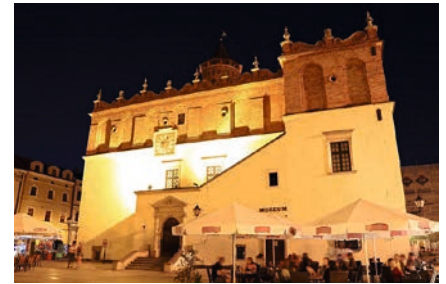
Fig. 24. Reflectors lighting from below to illuminate Tarnów Town Hall (photo by: I. Esmund)

on their walls, arranged so that the light spreads on the walls from the bottom up. As a consequence, it escapes into the environment and is dispersed.

Bottom-up reflectors are also mounted directly on the walls of the Town Hall (Fig. 24). They are directed straight up. Light travels a vertical path to the atmosphere above, where it disperses.

Another solution is the complete removal of architectural sidewalk lamps, illuminating buildings from below, because they do not comply with legal standards that are in force in Poland. They cause discomfort to space users who are dazzled by these reflectors. As for bottom-up lamps, it is proposed to change their setting to top-down so that the light travels from top to bottom. Thanks to this, the floodlights will neither contribute to the creation of artificial sky glow, nor will they cause glare.

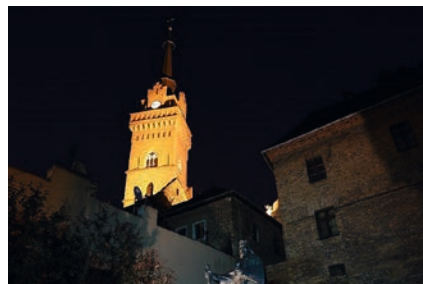
Reflectors of the same type are used to illuminate the Cathedral Basilica. As in the previous case, the lighting devices are mounted on the roofs of the neighbouring buildings (Fig. 25). They are directed towards the tower of the object. This arrangement is not completely vertical and light rays stop on the barrier, i.e. the walls of the cathedral tower. Moreover, part of the light is dispersed into the atmosphere before it reaches the illuminated object.

The conclusion is that the spotlights are too intense. It is true that, in effect, the walls are very clearly visible, but the architectural qualities of the building have not been emphasised in any way. It would be worth thinking about discrete lighting, highlighting the body of this building.

Fig. 25. The brightly lit tower of Tarnów Cathedral, shot from Wałowa St. (photo by: I. Esmund)

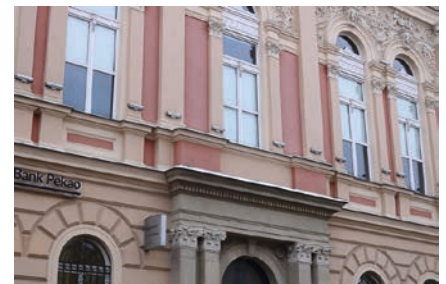
Fig. 26. Bottom-up lamps located on the building of Tarnów City Hall, Wałowa St. (photo by: I. Esmund)

Another example of improper illumination is lighting installed on the “building with a mirror room” at Wałowa St., where sessions of the City Council are held. Two types of architectural lighting illuminate it. The first are wall-mounted bottom-up floodlights (Fig. 26) in the form of elongated lamps situated on the walls of buildings and directed upwards. The second type represents lamps installed on the pavement, often called sidewalk lamps (Fig. 27). In Tarnów, they take the form of LED panels located on pedestrian routes, covered with tempered glass.

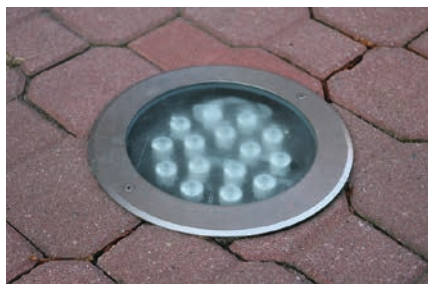
The presented reflectors (Fig. 27) are the worst example of architectural lighting. First of all, the streams of light are directed straight up; some of them are stopped, for example, by a ledge of the building. Lamps of both types significantly contribute to the formation of light pollution. By their arrangement, they dazzle users of public spaces. This remark applies mainly to sidewalk spotlights, which provide too much light. This situation is dangerous because they temporarily disturb visual perception. Additionally, these lamps should not be used at all to illuminate outdoor spaces. They do not conform to the requirements of paragraph 293, item 6 of the Regulation of the Minister of Infrastructure of April 12th, 2002 on the technical conditions to be met by buildings and their location. It says that external lighting devices cannot be the cause of a nuisance to space users. Sidewalk spotlights do not meet this condition. Both types of lamps emit light above the horizon, where it diffuses. The scattered light contributes to the formation of an artificial sky glow.

Fig. 27. Sidewalk spotlight at Tarnów City Hall, Wałowa St. (photo by: I. Esmund)

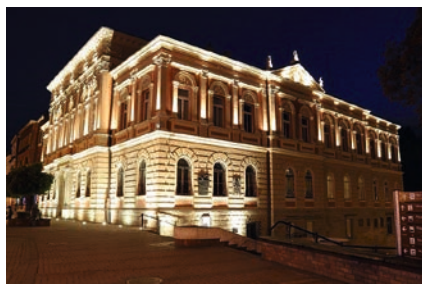
Fig. 28. Tarnów City Hall building at night (photo by: I. Esmund)

Figure 28 shows that too much light is emitted into the environment, especially from sidewalk lamps. The surface of the walls is illuminated, which does not serve to emphasise the body of the building or its architectural details. Lamps attached to the walls seem better in this respect. Their improper construction is associated with bottom-up lighting so that the light is directed upwards. It is worth noting that the top of the building is very brightly lit. The reason for this is the ledge blocking some of the light emitted both from wall reflectors and lamps in the pavement.

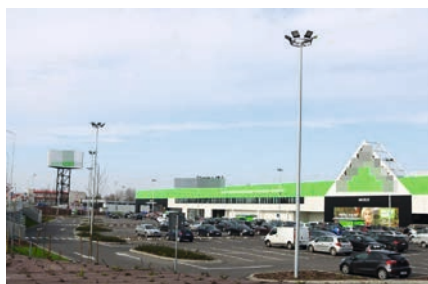
Figure 29 shows an example of a newly created commercial space with an accompanying car park. It is located in the outskirts of the city, on Błonie St.

LED floodlights mounted on very high poles (Fig. 29) are used to illuminate the aforementioned car park. Such an installation allows the use of only a few sets of reflectors and the entire area is properly covered by light. However, this is not a valid method of lighting.

Fig. 29. Car park next to a large area store, Błonie St. (photo by: I. Esmund)

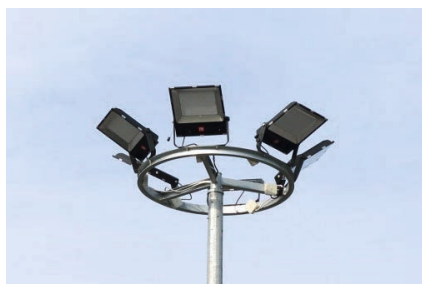
Fig. 30. Close-up of a set of floodlights illuminating the car park (photo by: I. Esmund)

The poles used are too high, which reduces the control over the distribution of light, leading to light of too high intensity. A large number of reflectors were used which emit very high intensity light; furthermore, the floodlights were misdirected. The planes of their covers are not parallel to the horizon, which makes the lighting dazzling for people (Fig. 30). The results of this design are such categories of light pollution as glare or intensification of the sky glow. Moreover, the light that leaks into space constitutes significant losses of electricity and, therefore, of money.

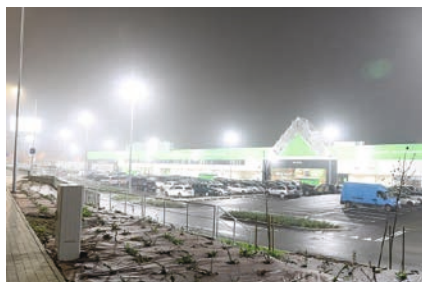
A view of the described car park at night is presented in Fig. 31. The applied light is so intense that it causes the phenomenon of glare. Our eyes are dazzled; a long time often passes before they adjust to the changing lighting conditions. This situation is hazardous, especially for drivers who suddenly reach this area from less-lit places. During the period while their eyes are adapting to the new light intensity, an accident or collision may occur. Additionally, a light-trespass

Fig. 31. View of the car park at night time (photo by: I. Esmund)

phenomenon occurs – the lighting of surfaces that should not be illuminated. This light illuminates the grassy roadsides and pavement by the main road, which is also lit by street lamps. These surfaces are therefore illuminated twice, which is entirely unnecessary. The floodlights used also contribute to an increase of the phenomenon of artificial sky glow, i.e. the light glow over the city. Therefore, all three categories of light pollution occur in the described area.

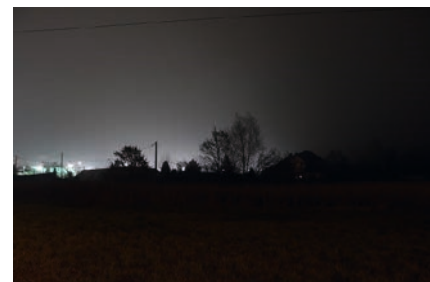
Fig. 32. Parking lighting effect visible from a greater distance (photo by: I. Esmund)

The effects of excessive and improper lighting, accompanied by autumn fog, are very clearly visible in Fig. 32. Moving away from the car park area allows one to notice the scale of the excessive lighting of this place. First of all, there is a glow from the parking space. It is also noticeable from more distant places than the point from which the above photograph was taken. Distinguishing each the lighting sources in it is not possible. The artificial glow comes from the entire parking space.

The phenomenon of artificial twilight occurs in the described area. Natural darkness, resulting from the season and the day, is disturbed by artificial external lighting. This phenomenon is harmful to the natural environment, including man. Brightness occurring at the time when it should be dark disturbs the circadian cycle of organisms. In humans, this causes problems with sleeping. When the body is exposed to night-time brightness for a long time, other health problems also arise. Such issues related to light pollution may arise in inhabitants of single-family houses surrounding the described area.

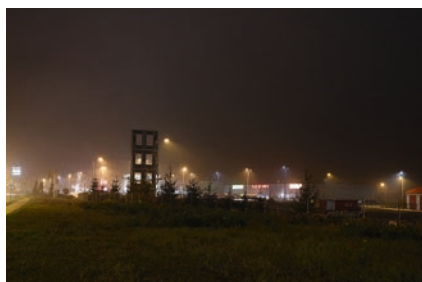
Lamps used in the car park (Fig. 33) are correctly constructed. As can be seen in the photo, the light shafts are directed to the ground. There is no visible glare effect when looking at this area from a distance. The lamps used have the correct light intensity. They light up the car park sufficiently, without the effect of lighting the neighbouring city and significant energy (and thus financial) losses.

Fig. 33. View of the square near the shopping space at night, Błonie St. (photo by: I. Esmund)
