Sven Hübner\*

## Restoration of the Emmerich Family Vault on the Nikolaikirchhof in Görlitz

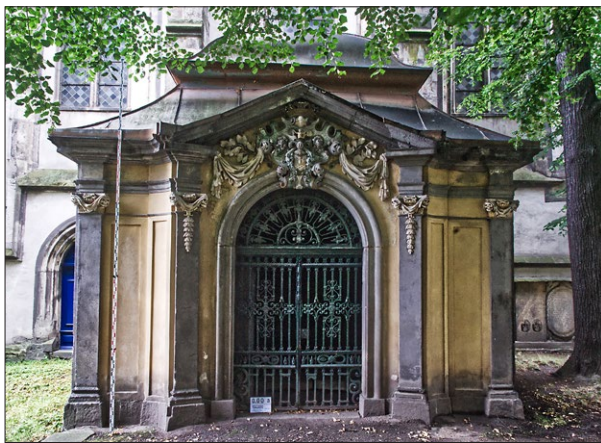
Fig. 1. View of the Emmerich family vault, as seen before the restoration, 2021; all photos by S. Hübner

In August 2021, the restoration of the Emmerich Tomb at the Nikolaikirchhof in Görlitz began. The initial measures included a detailed survey and emergency conservation of damaged plaster, particularly the remaining ceiling plaster. In parallel, a conservation concept was developed based on comprehensive investigations of both the interior and exterior, which also defined the conservation objectives. To support the planning, scientific analyses were conducted: the Institute for Diagnostics and Conservation of Monuments in Saxony and Saxony-Anhalt (IDK), Dresden, performed quantitative salt analyses on building material samples. In addition, pigment and paint layer samples were examined from the interior, the family coat of arms above the entrance portal, and the entrance grille. In 2023, a significant private donation enabled the continuation of the project. Consequently, in 2024, the coat of arms, the entrance grille, and the wooden winter closure were restored. Current work focuses on the facade (Fig. 1).

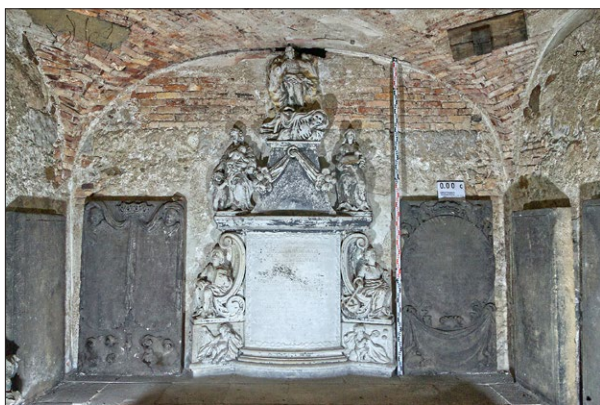
Fig. 4. South wall with the main epitaph, previous condition, 2021  
Ryc. 4. Ściana południowa z głównym epitafium, stan przed renowacją, 2021

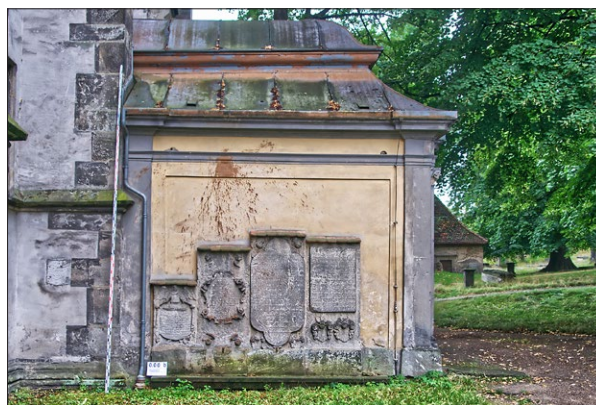
Fig. 5. East facade, previous condition, 2021  
Ryc. 5. Elewacja wschodnia, stan przed renowacją, 2021

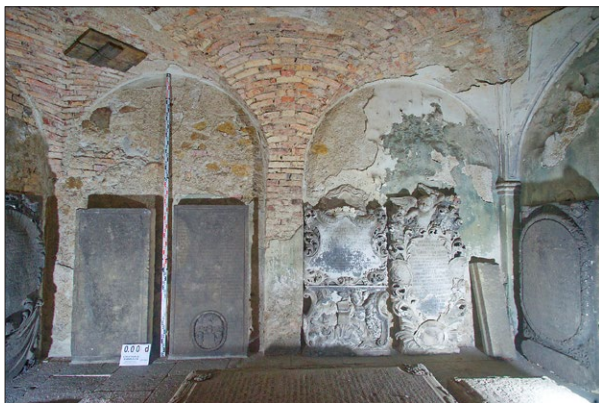
Fig. 6. West wall, previous condition, 2021

Within the interior of the tomb, larger remnants of what is presumably the original plaster survive only in the front third of the room, on both the walls and the vault surfaces. Stratigraphically, the plaster diminishes toward the center of the space. In particular, relatively stable lime plaster is still preserved in the reveals of the entrance opening. On the other wall surfaces, however, the plaster layer is progressively deteriorating (Fig. 6):

- beginning with flaking of the paint layer and blistering of the fine finishing coat, followed by superficial sintering,
- and culminating in the exposure of the coarse undercoat and complete loss of plaster.

The bedding mortar of the mixed masonry, composed of rubble stone and brick, has lost structural cohesion. In the front part of the room, larger coherent plaster areas still survive on the vault, where the arrangement of articulated plaster fields and remnants of stucco profiles remains legible. In the rear sections of the vault, plaster remnants are considerably reduced. Due to the weakened mortar, surface-parallel cracks have developed in these few fragments, and in some cases the plaster has detached up to 2 cm from the substrate. The bedding and joint mortar of the brick vault surfaces is likewise severely weakened. In some areas, mortar loss extends to half the width of a brick joint, creating a risk of individual vault bricks becoming loose. The cause of these damage patterns most likely lies in air turbulence at the entrance,

which caused the damp plaster to dry more rapidly. By contrast, in the rear section of the building, weathering-related alteration of the mortar continued unhindered under persistent damp conditions, leading to premature plaster loss. In the southern lunettes of the rear vault section, concrete patches reinforced with iron were identified, presumably dating from the renovation phase around 1980. Whether these concrete fillings close former ventilation openings, or whether individual bricks were removed and replaced during roof repairs, cannot be conclusively determined. Their position, however, suggests that they cover former ventilation openings. From a building-physics perspective, their significance for air exchange within the structure is minimal.

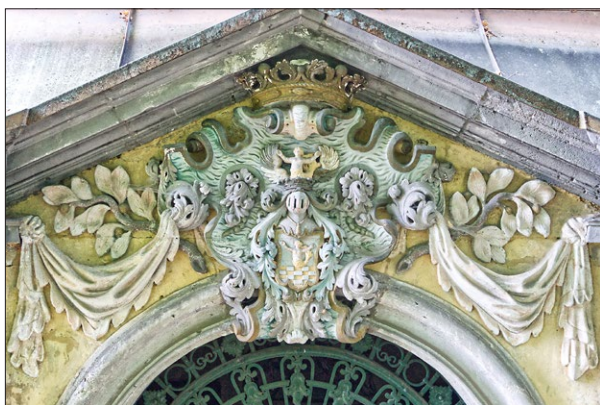
The book *Old Görlitz Families and Their Coats of Arms* depicts three coats of arms of the Emmerich family. The coat of arms located on the Emmerich Crypt belongs to the “Emerich-Georg Line.” It differs from the Emmerich family’s ancestral coat of arms in that the siren in the central or heart shield sits on a checkered shield base. The coat of arms of the “Emerich-Wenzel Line” is very similar to that of the “Georg Line”; only a crown on the siren’s head and a mirror in her right hand were added. The coat of arms was also reworked polychromely during the final renovation phase. Examination revealed it to feature a white pall and white laurel leaves. The supporting shield appeared blue to green due to paint and pigment residue.

Fig. 7. Coat of arms, previous condition, 2021

This is presumably the first version, as no other paint variations were found that could be attributed to the renovation layer. Scientific examinations of the blue-green pigment confirmed the suspicion of the use of azurite. This blue pigment can transform over time into the green pigment malachite through weathering processes—pseudomorphism. Furthermore, several indications of gilding of various design elements were found. These now appear greenish-dark because they were bronzed during the last renovation phase. Gold bronze consists of metallic pigments from a copper-tin alloy, which loses its metallic luster over time. Due to the corrosion products of both metals, the surface now appears gray-green. The acanthus leaves were all painted gray. Structurally, the coat of arms consists of six assembled, sculpturally worked stone blocks, which are attached to the masonry via iron anchors. The three lower stone blocks also form the round-arched portal jamb. All iron anchors are heavily corroded; as a result, the lime mortar covering has become loose and has already been blown off in places. The upper large crown of leaves and pearls, a so-called crown of leaves, is missing the central leaf tip, apparently due to mechanical influences. (Fig. 7)

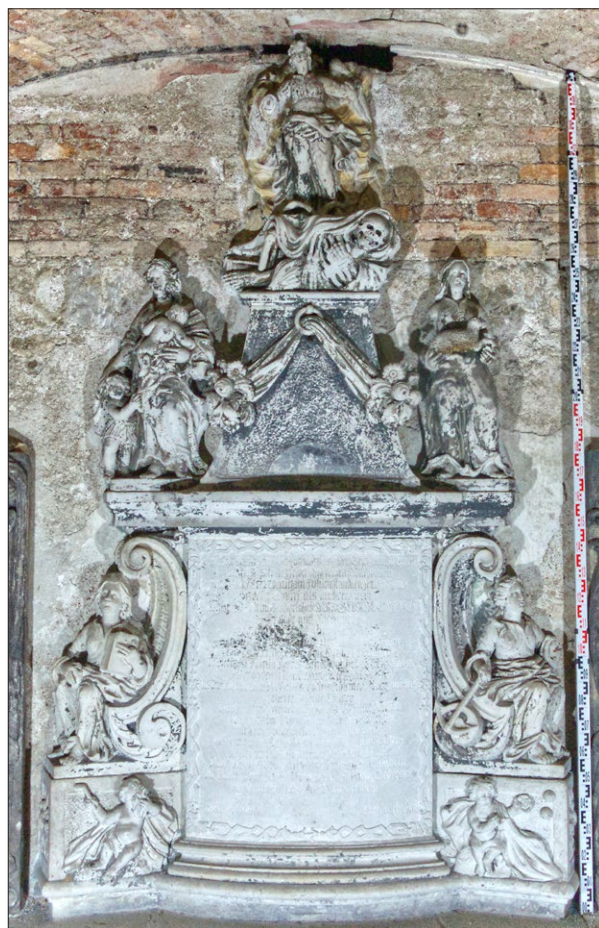
The main epitaph is essentially well preserved. Only the cloud motif, which is executed as a stucco application in lime mortar next to the crowning angel figure, has detached from the substrate, with some fragments already lost. Traces of a yellow or ochre paint layer remain on the cloud motif. Remains of a paint layer, presumably a light oil paint, are preserved over the entire surface of the epitaph and on the figures. This paint layer is heavily soiled, weathered, and largely flaked off, lying loosely on the sandstone. Investigations show that the polychromy consisted of only a few colors. Black or dark gray dominated the architectural elements. The inscription panel was also painted black or dark gray, while the gilded lettering and the gilded braided border with floral corner ornaments were the most important decorative elements. Due to heavy soiling, the figures appear dark gray overall. However, lighter gray remnants of the paint layer are visible in the depressions of the folds of the robes. This was confirmed by carefully removing surface dirt with a fiberglass eraser. No flesh tones could be detected; only one figure shows minimal contour traces at the eye and hints of a contoured pupil. The hair shows no color differentiation; the paint layer remnants are too unstable. The skeleton separating the upper central section from the crowning angel is painted a slightly more colorful grey. Brushstrokes in the recesses of its slab show distinct color variations despite heavy soiling. Considering the light grey of the garments and funerary cloth, the skeleton was likely depicted in an ivory-like tone. Between its legs, the skeleton holds an hourglass, which was originally gilded.

The plinth zone is dominated by two lateral figure reliefs. Only minimal, loosely adhering dark grey remnants of the paint layer remain here, and their analysis was not possible (Fig. 8).

Fig. 8. Main epitaph, 2021

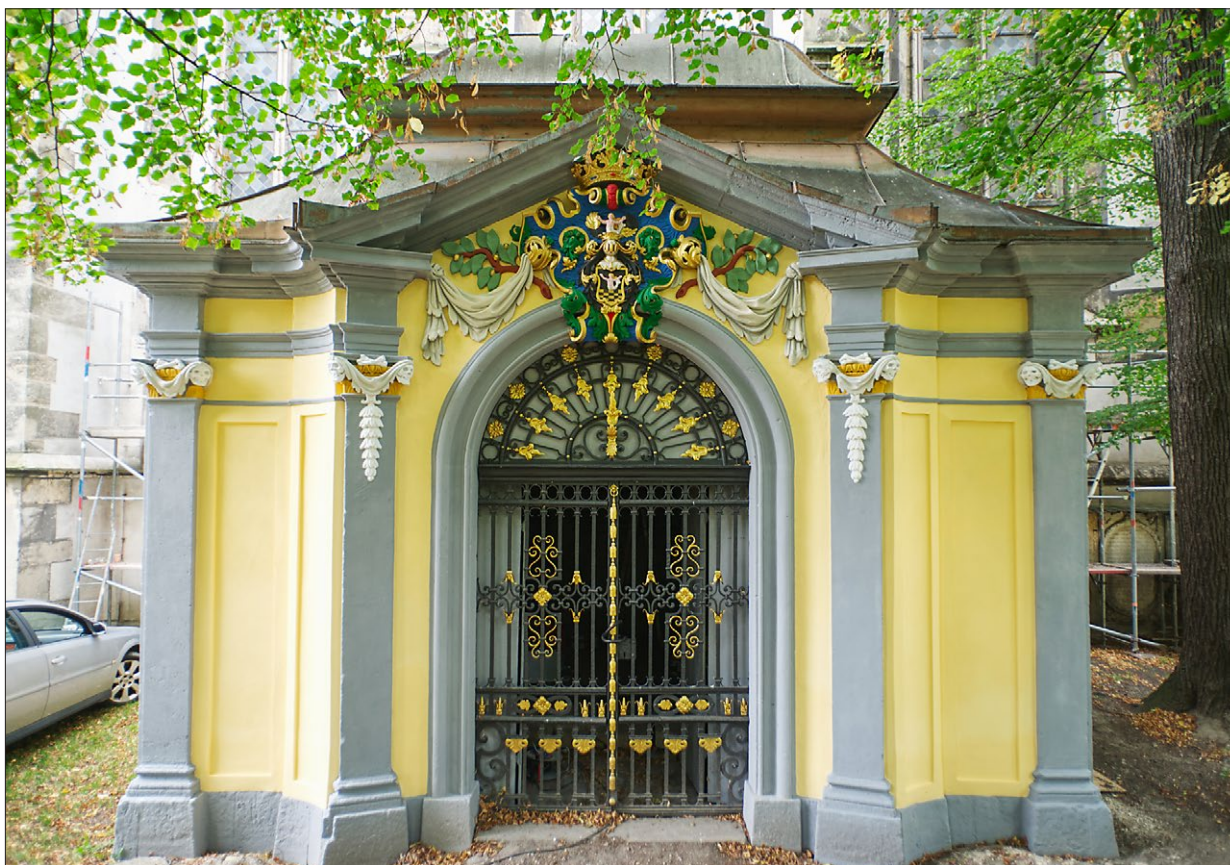
*Fig. 9. Emmerich family vault, as seen in 2025*

chanically cleaned with a stainless steel brush and then treated with OWATROL—first diluted with substitute turpentine, then undiluted for permanent conservation. The vertical and horizontal joints were repointed with the natural stone repair mortar Mineros 2000, whose grain and color match Silesian sandstone. Detached original lime mortar fragments were reattached in their original positions over the corrosion-treated iron elements using epoxy resin (AKEPOX 5010). On the sculptural relief itself, only minor mechanical damage was found. For the reconstruction of the larger loss at the top of the leaf crown, a stainless steel anchor was bonded into the stone with AKEPOX 3015 Rapid Bond to serve as reinforcement. The missing leaf was then reconstructed with Mineros 2000, based on a historic photograph from around 1900. Smaller losses on the laurel leaves were filled with a synthetic resin-based filler. The new paint layer was applied using REMMERS silicone resin paints. Despite the challenging con-

ditions, a paint layer was achieved that meets both conservation requirements and practical on-site conditions (Fig. 9).

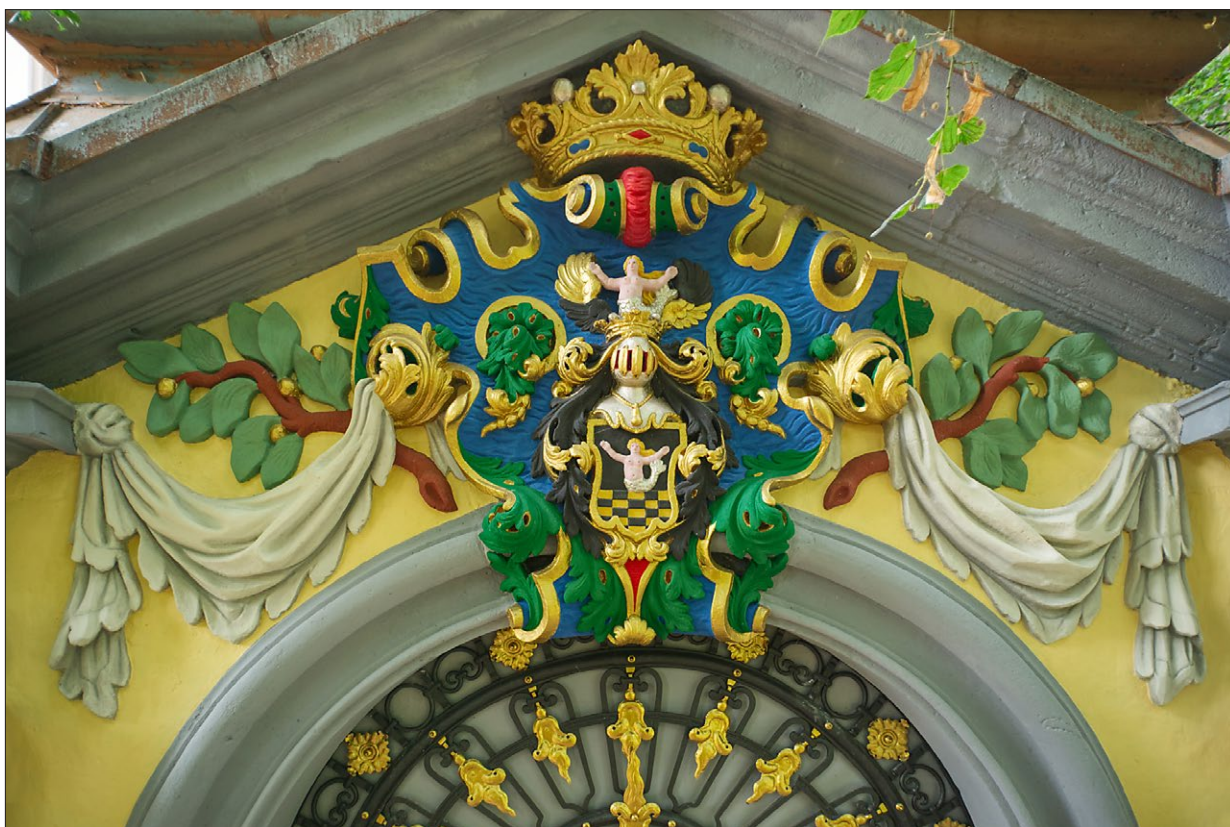
*Fig. 10. Coat of arms, as seen in 2025*

In May 2024, the restoration of the coat of arms was commissioned. Before the work began, additional tests of submitted pigment samples were carried out by IDK Sachsen. The results provided valuable information on the original coloration of the coat of arms. The blue pigment azurite was clearly identified on the cartouche. Since the surface is heavily chalking, a water-based binder is assumed; an oil paint layer can be ruled out, as azurite in oil would turn a dark greenish tone. The resulting intense blue corresponds to the heraldic color referred to as “azure.” The funerary cloth was painted with lead white, slightly toned with small amounts of iron oxide pigments in red, ochre, or black. The laurel leaves were presumably painted with green earth and then lightened or broken up with lead-tin yellow. The preserved paint layer largely corresponds in color to dried laurel leaves. The shoulder piece of the helmet could not be clearly identified; analyses indicate a shiny metallic surface, which differs in color from the clearly documented gilding on the helmet bars, collar, and hem. The helmet lining was painted vermilion, which corresponds to the heraldic designation of red as vermilion. The coloring of the curved acanthus leaves on the sides of the cartouche remained unclear. However, differentiated paint layers could be identified for the helmet decoration and the framing acanthus leaves: the inside was gilded, while the top was black, presumably with iron oxide black.

For this reason, the decision was made to use silicone resin paints for the reconstruction. Because this paint dries to a very matte finish, traditional oil gilding was deliberately avoided. Instead, newly available metallic interference pigments from Kremer Pigments were used, embedded in a suitable binder. These pigments offer a long-lasting alternative to classic gold bronze, as they neither corrode nor tarnish. They consist of fine aluminum flakes coated with iron oxide and silicon dioxide, providing a color-stable and visually high-quality solution.

The restoration began with dry cleaning the surface with a soft brush, followed by vacuuming. The heavily chalky paint layers from the 1978 renovation were removed using micro-steam cleaning, preserving the original paint layers. The azurite paint layer on the cartouche remained intact after cleaning. In the undercuts, the thick paint layers from the last renovation were removed with a scalpel and a fiberglass eraser. This allowed re-examination and the collection of suitable material for pigment analysis. Damage was also observed on the ashlar blocks, joints, and iron anchors. Loose mortar in the vertical and horizontal joints was carefully removed with a small chisel. Exposed iron anchors, whose corrosion had spalled the surrounding lime mortar, were me-

The restoration of the Emmerich Tomb demonstrates how careful analysis, conservation objectives, and practical measures work together to preserve an important witness to Görlitz history. Despite prior renovations and damage, key findings on the original coloration, furnishings, and construction history were successfully documented. Through the restoration of the coat of arms, the grille, and the winter closure, as well as ongoing work on the facade, the building's authentic architectural character is being preserved and its historical impact reinforced. In this way, the tomb remains a visible and tangible expression of Baroque sepulchral culture and a part of the Emmerich family heritage for future generations (Fig. 10).
