Mykola Orlenko

The significance of object restoration in the urban environment and restoration basics

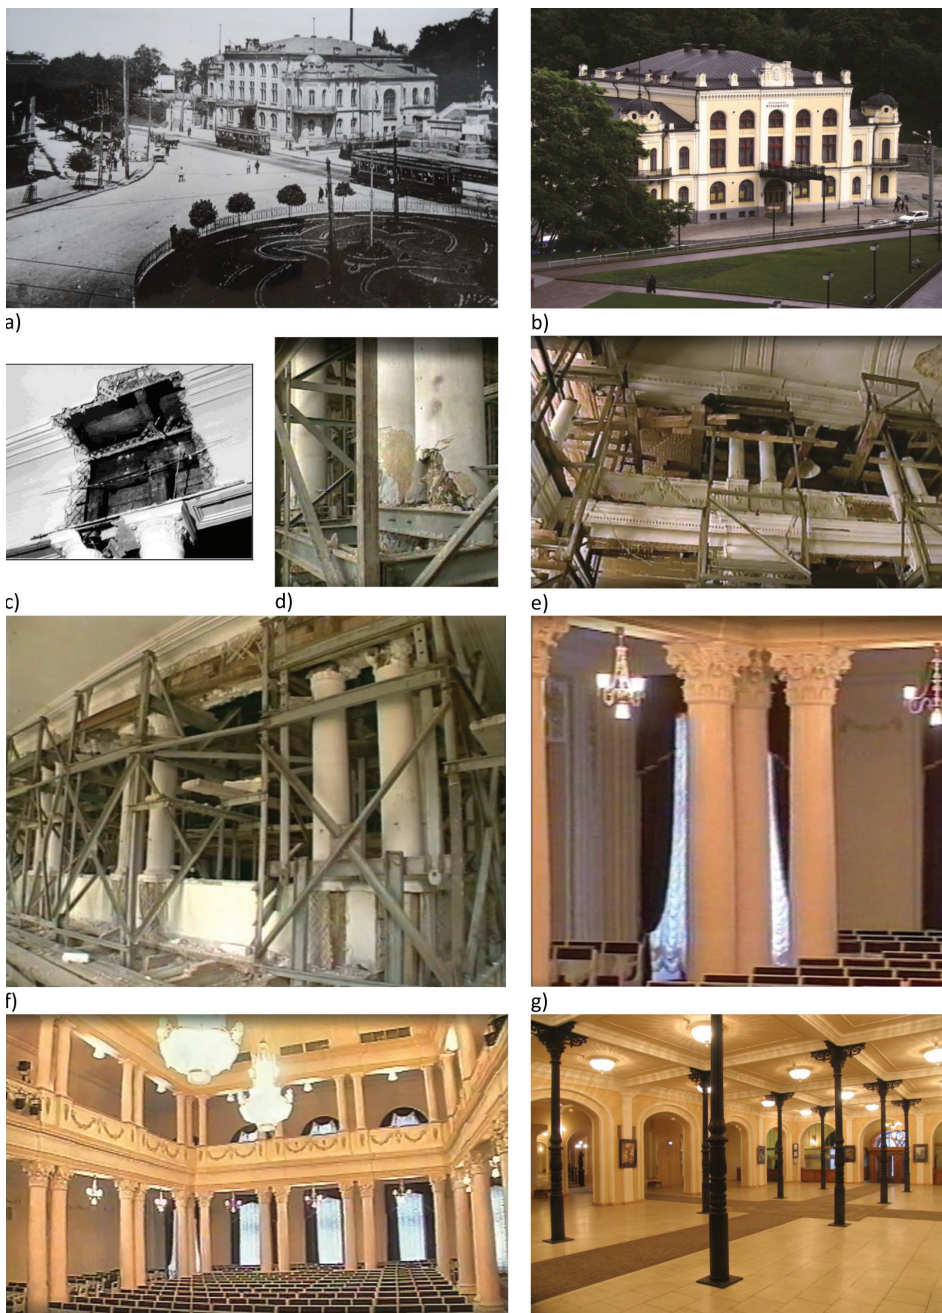
As a result of the above, we can say that the building of the Merchants' Assembly Club is a characteristic object of the second half of the 19th century in its architectural, stylistic and constructive solution and decorative elements and methods of decorating facades and interiors. The problem of its critical state was related to the fact that as a result of accidents of the water supply and sewage systems, the balance of the 'footing-foundation-building' system was disturbed, basement deformation occurred, and this led to the occurrence of through-traversing/full-depth cracks in the exterior walls and deformation of the floors by up to 20 cm vertically⁵. The vaults of the hall and the ceilings of all the rooms were covered with cracks, the plaster crumbled and the destruction of wooden elements was observed⁶. The vaults of the hall and foyer were noticeably deformed with vertical displacement of some sections being up to 20–25 cm. Due to the subsidental deformations of the foundations and basement, subsidence of the gallery columns, ledger strips and tie beams of the gallery was identified; in some places, there was subsidence of up to 30 cm. During visual inspection, it was found out that the wooden elements of the suspended ceiling and the trusses were damaged by wood-destroying insects and, during previous repairs, they were already strengthened by padding overlays and the installation of additional metal and wooden elements⁷. Due to sedimentary deformations, the wetting of roof elements and garret floors occurred.

The original external appearance of the main facade was also mangled: the balcony over the main entrance was demolished, two balconies of the first floor on the corner semi-circular avant-corps were not preserved, the decorative finishes of cupolas were lost during repair and the form of the coating was changed – 30% of the original appearance was lost.

The problems were as follows: the violation of the static of the 'footing-foundation-construction' system because of accidents relating to the water supply and sewage system that led to the deformation of the foundations, and then to the deformation of the walls, vault of the hall, floors and ceilings that were covered with through inclined cracks (mainly in the middle parts), there was a subsidence of the gallery columns, ledger strips and tie beams of galleries, plaster crumbled, in some places, there was a shift of masonry along

the cracks. During the existence of the building, there were losses of some elements of the main facade – 30% of the original appearance was lost. Due to sedimentary deformations, the wetting of roof elements and garret floors occurred, and wooden elements of the suspended ceiling and trusses were damaged by the wood-destroying insects.

Fig. 1. The National Philharmonic of Ukraine: a) archival photos of the 19th century; c-f) before the restoration; b, g-i) a modern look

As priority measures, it was proposed to eliminate deformations of the footings and foundations of the building (taking into account the fact that the base was loose filled soil and the foundations were shallow lying, which resulted in the deformations), to stabilise the deformation processes and to conduct comprehensive repair and restoration work on the monument⁸. The footings and foundations were strengthened with needle piles and jacked piles. In order to restore the firmness of masonry of the walls, it was proposed to use the Italian method 'reticolo cementato' (stitching) - to inject open cracks with mortar and to reinforce masonry. We used the prosthetic method and managed to level the deformed constructions which were not subject to replacement on account of the acoustic properties of the hall (first of all, all wooden columns and beams). On the main façade, all the lost elements and the cartouche with the Archangel Michael on the pediment were restored; the ceremonial marble staircases were decorated with marble figures of Apollo and Aphrodite in decorated niches; a marble fountain with a cherub appeared in the centre of the foyer. In November 1996, the National Philharmonic building was put into operation.

The primary measures were as follows: elimination of the deformation of the footings and foundations of the building by strengthening with needle piles and jacked piles; restoration of solidity of masonry walls by the mortar injection of open cracks, annealing of the deformed structures which could not be replaced due to the acoustic properties of the hall (primarily, all of the wooden columns).
