Institute of Electrical Drives and Machines KOMEL

## INDUCTION MOTORS IN TRACTION DRIVES, SERVICE TESTS

Electric multiple units (EMUs) EN57 are fitted with two cage induction motors to each bogie. Two motors driving one bogie are supplied from a common DC/AC inverter. These motors become damaged after a short service period; the end-rings start to break away, start to break away. The results of service tests conducted during normal train runs are presented in the paper. The investigation possibilities were limited to recording load currents and vibrations of four motors installed at two bogies of one car. It has been concluded that the reason for rotor winding damage may be traced back to the simultaneous impact of four factors: 1) transmission of load torque by mechanical gearbox; there is a backlash between the pinion mounted at the motor shaft and the toothed gear mounted at the drive bogie axle; 2) rigid assembly of the motor in the bogie frame and vibrations transmitted from the drive wheels to motor; 3) variable components of electromagnetic torque generated by higher harmonics of inverter voltage and current; 4) parallel operation of two unmatched motors supplied from comm

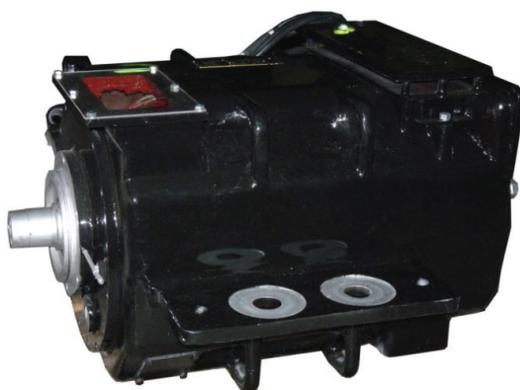
Fig. 2. Induction motor LK 450 X6 [8]

A photo of the LK 450 X6 motor is shown in Fig. 2.

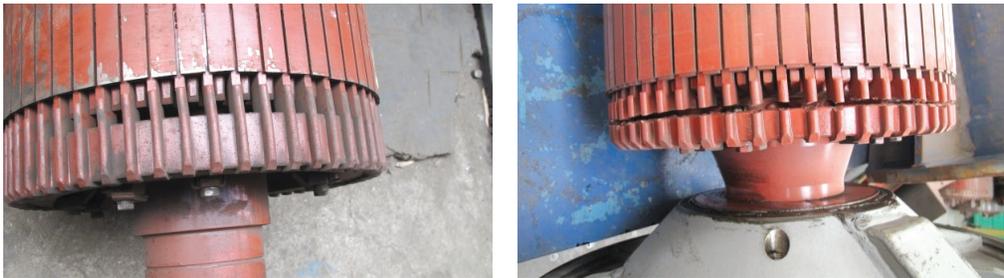
LK 450 X6 motors are subject to numerous failures during operation. The failures are due to breakdowns of end-rings, short-circuiting the rotor bars. When the rotor is rotating, the torn ring damages the stator winding outhangs. Photos illustrating the points of junction of rotor bars to the end-rings, for a new motor and motor with a damaged ring, are shown in Fig. 6 [8].

Fig. 6. Junction of rotor winding bars to end-rings: in a brand-new motor (left) and a worn motor with a torn end-ring (right)

LK 450 X6 motors are fitted with squirrel cage winding rotors consisting of copper bars short-circuited with copper end-rings. The end-rings are mounted on coil supports and they are protected from circumferential motion by wedges. The fatigue tearing of rings is due to circumferential acceleration.

At present, the mechanical structure of the bogie and harmonic components of motors' electromagnetic torque are the fundamental reasons for fatigue failures (breaking off) of end rings, which short-circuit rotor bars. The tearing away of the rings is accelerated by the fact that motors in the bogie are not matched (coupled) properly and that vibrations characterised by accelerations as high as 150 m/s<sup>2</sup> are transmitted to the motor body via drive wheel axles and the bogie frame.

The first proposed solution is to manufacture a rotor with a cast aluminium winding. Design calculations for such a motor have been conducted at the KOMEL Institute. It has been proven that it is possible to manufacture a motor with parameters identical to those of the LK 450 X6 motor, but with a cast aluminium winding. This sort of winding is compact, does not possess any clearances and hence it is more resistant to vibrations.

The second solution is to manufacture a rotor winding identical to the armature winding of a DC motor (without commutator and brushes). The rotor winding in slots is protected with wedges, and coil outhangs are secured with tapes [6]. This sort of protection works properly in DC motors, and therefore it might also be used in an induction motor. The electromagnetic calculations of such a motor have also been conducted at the KOMEL Institute and the motor's parameters have been proved to be identical to those of the LK 450 X6 motor.

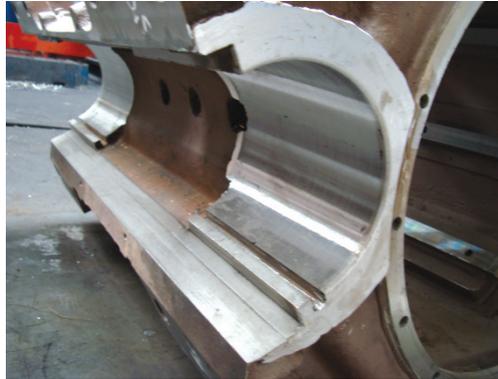
Fig. 12. Half-sleeve of a slide bearing – element of motor body

On the outside of the motor body, there is a half-sleeve of a slide bearing; this contains the shaft of the bogie drive wheels – see Fig. 12. The motor is mounted to the bogie frame in the so-called axle hung nose suspended system. Moreover, it is affixed to the bogie frame via rubber pads with two ears and a special arm. The motor constitutes a partial load of the

wheelset axle, via an axle slide bearing. This impacts the motor operation unfavourably, since vibrations of the drive wheel are transmitted directly to the motor.
