Continuous structural health monitoring of selected geotechnical quantities within Kościuszko Mound in Cracow

Abstract. Kościuszko Mound in Cracow is earthen structure particularly susceptible to deformations, among other things, due to the unfavourable physical and mechanical properties of the ground and a significant tilt of slopes. Since the beginning of its existence to the present day, structural failures were repeatedly occurred, and the biggest took place after 1997, when heavy rains led to the greatest destruction of the entire mound solid ever. Overall renovation, however, did not produced the expected results and did not stop negative atmospheric influences on the monument behaviour. Therefore, in 2012, structural health monitoring was installed on-site, providing remote, continuous and automatic measurements of selected physical quantities, which are important from mound technical condition point of view. System is measuring, among other things, changes in vertical displacements, circumferential and radial deformations, ground pore pressure of water within a mound body and humidity of its surface layers. Correlation of results from geodetic, inclinometer and meteorologi

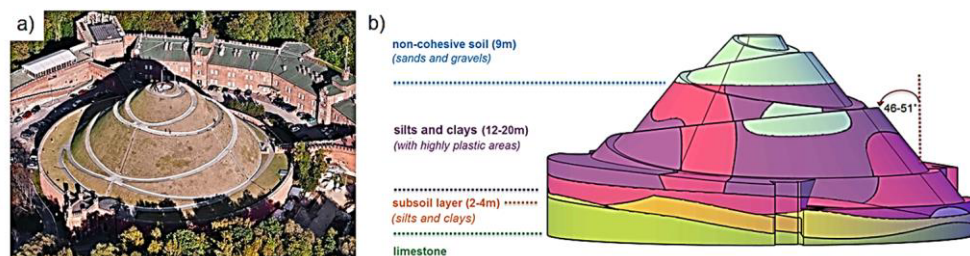
Fig. 1. Kościuszko mound: a) view [5]; b) visualization of ground layers [own elaboration].

The object under the assumption of builders was meant to be a symbol of durability, which cannot be destroyed neither by enemies nor time. Unfortunately, both the construction method and the building material used for this purpose have caused the structure to be susceptible to atmospheric influences. The mound was raised mainly using silt and clays, which are sensitive to water actions. Under the influence of hydrostatic pressure, the particles of soil move and organize, which has resulted in the past and result today in significant deformations of the mound body. Another important thing is steep slope, which exceeds (in some places more than twice) the angle of internal friction of such kind of grounds. This fact makes the Kościuszko Mound in Krakow a unique geotechnical structure worldwide. The shape of the limestone ceiling (inclination to the east) located in the immediate subsoil of the building, and the geometry of the surrounding brick wall (tholobate), which is indeed lower at the eastern side, are also significant for main directions of ground displacements.

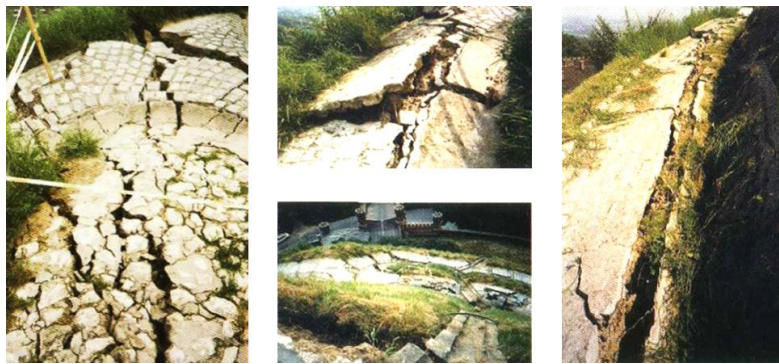
Fig. 2. Damages of Kościuszko Mound after flood in 1997 [1].

In the past, the solid of Kościuszko Mound has been destroyed many times, mainly in the form of landslides, cracks, ruptures and path damages through which rain water could freely enter the structure interior. Prior to 1979, no significant geological research was carried out, as well as engineering works that would improve the technical condition of the facility. Activities which were done were limited to determining the type ground in the superficial layers and describing damages resulting from the external loads. In the later period, until 1997, a number of minor repairs were performed. Among others, ruptures were sealed with clay, irrigation system was built and mechanical slope protection was applied by micropile palisade and ground anchor system. Unfortunately, all repairs proved to be ineffective, primarily because they were designed with incomplete recognition of the geological profile of the mound and did not constitute a comprehensive repair.

Large-scale repairs were carried out only after the 1997 flood, when the technical condition of the mound has been recognized as structural disaster. After its completion, about 50 geodetic benchmarks were installed on the mound peripheries as well as 4 inclinometer tubes. On the basis of vertical and horizontal displacement measurements it was found that for the next 10 years, the mound top settled about 0.50 m and moved in the east about 0.20 m. It means that repairs did not stop the mass movements. Similarly to previous strengthening, designers did not have a full geotechnical documentation of deeper layers of the mound body.

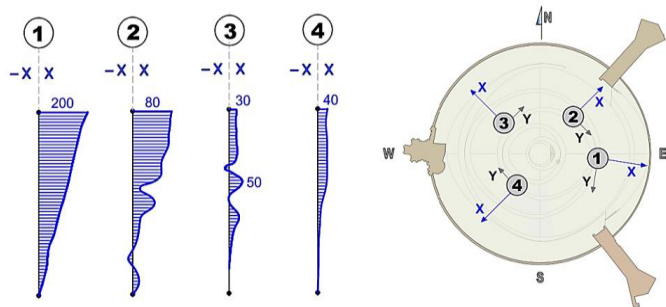
Fig. 3. Selected displacement profiles [mm] from inclinometer measurements between 2012-2014 [own elaboration].

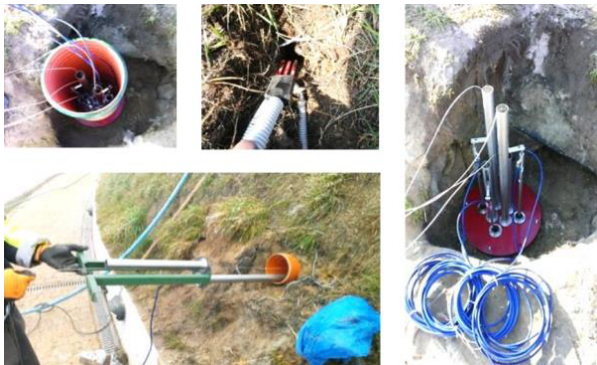
Fig. 4. Installation of SHM within Kościuszko Mound in Cracow [courtesy of SHM System].

One of the basic assumptions of structural health monitoring system design was to recognize the work of ground layers inside the body to perform a full three-dimensional analysis of its structural behavior. [2] It was decided to measure vertical displacements including changes in the thickness of selected soil layers (vertical extensometers), horizontal deformations (circumferential and radial), as well as changes in ground water pressure, soil humidity and temperature. Applied sensors are based on vibrating wire technology, which, thanks to its advantages (accuracy, resistance to external conditions, time stability) is widely used in long-term measurement systems [3, 4, 5, 6].

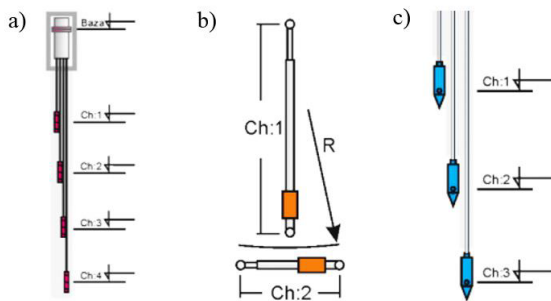
Fig. 6. Measuring sets: a) vertical extensometers, b) horizontal extensometers, c) piezometers [courtesy of SHM System].

Measurements of vertical displacement are performed by means of tendon extensometers (Fig. 6a) in five locations. Details of its operation principle, sample data and results interpretation are presented in Chapter 4. Measurements of horizontal deformation are carried out by extensometers installed circumferentially along the peripheral surface and radially inside the body (Figure 6b). Located in eight places, sensors have measuring bases of 2 000 mm (radial extensometers) and 1 000 mm (peripheral extensometers). As the main active cause of Kościuszko Mound deformation is water infiltration and the associated change in soil moisture, within SHM system at four measuring points and three different depths, vibrating wire piezometers were installed (Figure 6c).

All vibrating wire sensors are equipped with thermistors for parallel temperature measurements. This allows for thermal compensation of measuring data and for evaluation of temperature impact on the global response of geotechnical structure [7, 8].

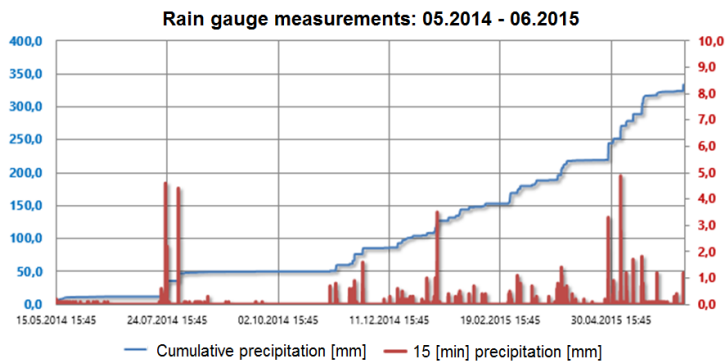
Fig. 7. Exemplary plot of the amount of precipitation [courtesy of SHM System].

The above-described elements of the SHM system should be assigned to structural (technical) monitoring subsystem. In 2014 the installation was supplemented with meteorological monitoring. A weather station consisting of a rain gauge, anemometer, air relative humidity and temperature sensor and pyranometer were installed. Obtained information about atmospheric conditions within the mound (precipitation, sunshine, wind force and direction) can be correlated with data obtaining from the building interior, which will allow to construct dependence between the external environment influences and the behavior of the whole body.

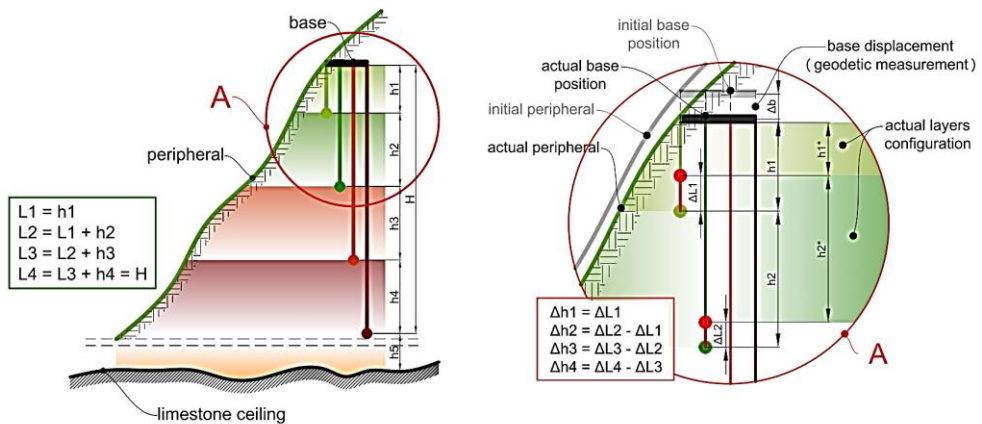
Fig. 8. Construction and operation principle of vertical extensometers [own elaboration].

Extensometric sensors allow for determination of defined segments lengths and they are often used in geotechnical measurements [9]. Within the monitoring system, five extensometers were installed, each consisting of four sensors. One end of a particular displacement sensor is attached to the surface of the mound perimeter (base) and the second, through a stainless steel tendon, is anchored inside the body at various depths - Fig. 7. Changes in the displacement of the base are determined by geodetic measurements, so it is possible to determine absolute changes in thickness of selected ground layers within the analyzed vertical measuring line. The rock ceiling was assumed as a fixed, unmovable reference, so the deformations of five layers are analyzed in a given vertical. The change in length recorded by sensor 1 will be included in the measurement of the length change recorded by sensor 2. Analogously, measurements are made by other sensors. By subtracting the individual displacement values, we obtain changes in the thickness of the ground layers. The sum of the thickness changes of the four layers is equal to the direct value of displacement resulting from measurement carried out by the sensor with the longest tendon (no. 4). If this value is subtracted from the base displacement, we will get information about the displacement of the extensometer anchor.

The sum of the thicknesses h_i^* of all layers (from the rock to surface) in the current configuration will be equal to the sum of the initial thicknesses h_i of the layers minus the base offset Δb .

Knowing the change in length ΔH measured by sensor 4 and base displacement Δb , we can determine the change in the thickness of the lowest ground layer ΔX lying directly above the limestone layer.

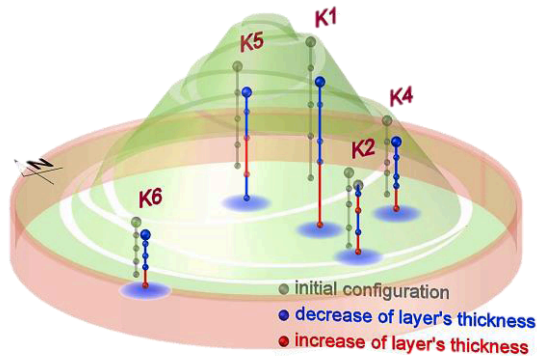
Fig. 9. Visualization of ground layers thicknesses changes between 06.2013 and 09.2014 [own elaboration].

It is worth to notice that the behavior of particular ground layers from which the mound was built is dependent on the depth. It is interesting that the thickness of certain layers is increased (red color and the minus sign in Table 1), which may indicate the presence of bulging soils. Nevertheless, during the entire considered period, there was a systematic decrease in the height of the extensometers bases. A qualitative graphical visualization of changes in the thickness of particular ground layers over a given period of time is shown in Figure 8.

Geodetic measurements showed the largest subsidence of K1 base during analyzed period. It was 26 mm. Base K2 and K6 moved vertically by 7 mm and base K4 and K5 by 13 mm. The largest displacement measured by the K1 extensometer results, among others, from the location closest to the vertical central axis of the mound body. Concentration of the largest ground masses in this area generates the largest subsidence - Fig. 9.

The analyzed section at K5 (northern slope) was the only one with a slight elongation, but it was accompanied by a noticeable decrease in the base position by 13 mm as well as by the longest tendon anchor by 14 mm. The elongation of the section results in the reduction of the thickness of the lowest layer (located directly above the rock). This deformation can be caused by washing away silt and clays from mound solid and moving them into limestone rock crevices.
