Department of Hydraulic Engineering and Hydraulics, Faculty of Environmental Engineering, Warsaw University of Technology

ANALYSIS OF THE TECHNICAL CONDITION OF THE SEWAGE COLLECTOR WITH THE USE OF NUMERICAL SIMULATION

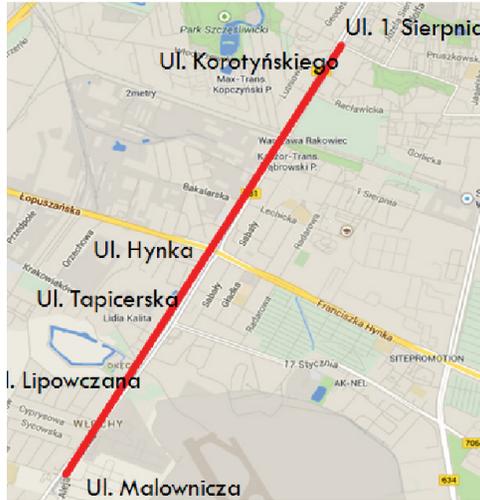
Fig. 1. Construction scheme of the collector (source: own elaboration)

The object of conducted researches and analysis is the bricksewage collector constructed at the end of the 1960s and the beginning of the 1970s, located in Warsaw between Malownicza Street and 1 Sierpnia Street (Fig. 1).

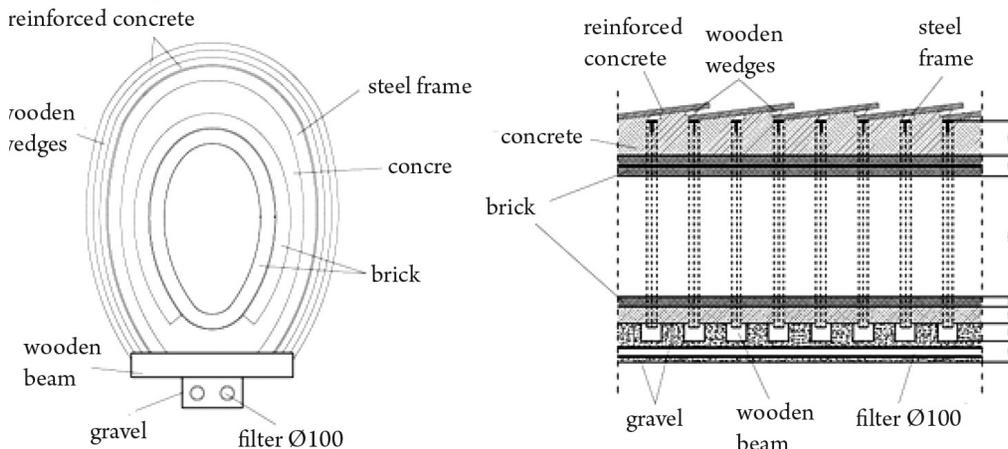
Fig. 2. Construction scheme of the collector (source: own elaboration)

The considered collector with an extended ovoid cross-section and the dimensions of 1400 × 800 mm was constructed with the use of the trenchless tunneling method. The

cladding was constructed of A-type facing, made of prefabricated reinforce concrete boards with the dimensions of $125 \times 11 \times 6$ cm, 6 cm thick wooden wedges and T-beam shaped steel frames with the dimensions of $11,5 \times 13$ cm. The steel frames were supported on the base constructed of wooden beams with the dimensions of $135 \times 20 \times 24$ cm. The walls of the collector were built of two layers of “150” class sewer brick and “80” mark mortar. According to the project assumptions, the space between the brick layer and the reinforced concrete cladding was filled with concrete of $R_w = 140$ at. Corresponding construction schemes of the collector were presented in Fig. 2.

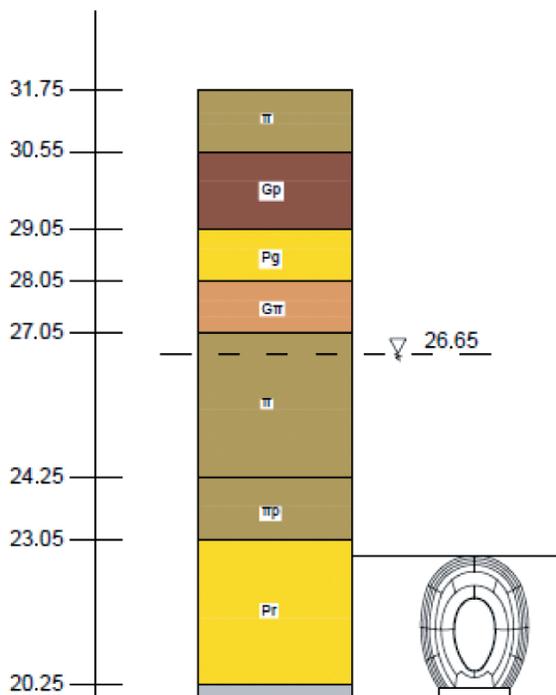
Fig. 3. Geological profile (source: [13])

Geological conditions in the subsoil are created mainly by quaternary structures. Occurrence of sandy clay, loamy sand and silt layer was observed. Gravel layers of a small

thickness were formed deeper in the subsoil. The ground water level was localized at the depth of 26.65 m above the level of the Vistula River (Fig. 3). The ground water shows qualities of sulphate and carbonate aggression towards the concrete.

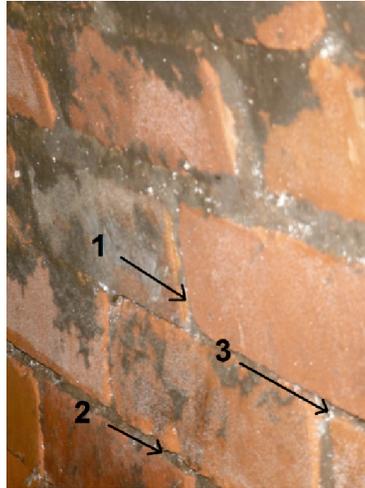
Fig. 4. The wall of the collector. No 1, 2, 3 are places of mortar loss (source: [13])

The considered sewage collector causes many operational problems. Its present technical condition can be defined as unsatisfactory. While conducting field research, numerous damages of collector walls, including 3–15 mm wide cracks, were noticed. In addition, a significant loss of bricks and mortar was observed in some places (Fig. 4).

In these conditions, the optimal solution is using local compaction grouting technology in sites, which are most endangered by groundwater infiltration, along with applying thermosetting lining on the walls of the collector. Instead of thermosetting lining, mortar rich with highly penetrating compounds may be used. The introduction of this solution would provide construction tightness as well as an increase of the strength parameter values of the whole lining and soil surrounding of the collector.

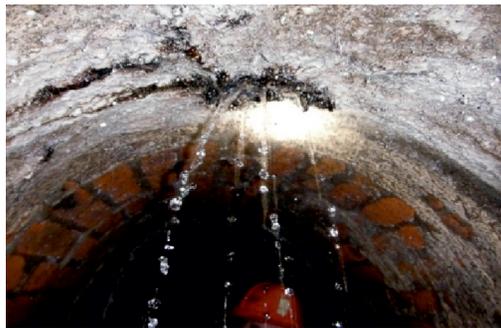
Fig. 5. Leakage into the collector (source: [13])

Significant problems with the collector’s tightness were observed. Numerous accretions indicate that water strongly infiltrates inside the object (Fig. 5). A large number of accretions and a tight structure (Fig. 6) limit the possible sewage flow and cause problems with the capacity of the collector.

Accretion forming is caused by mortar and concrete leaching from the construction, which is a result of chemical aggression. Occurrence of empty spaces within the collector cladding, which cause change in static scheme of the cladding work, should be assumed. Significant

cracks and scratches result in the necessity of constant carrying of groundwater flow load by the already weakened construction. Attempts of impact removal of the accretions resulted in strong outflow of highly pressurized water.

Currently, the main purpose of the collector modernization should be reducing the inflow of infiltrating water as well as tightening of the collector along with sealing its lining.

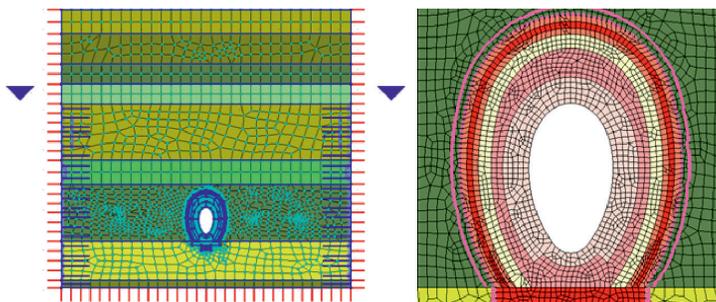
Fig. 7. 2D model generated by Z-Soil (source: own elaboration)

2D simulating was carried out as preliminary calculations in the preparation process of a three-dimensional model of the collector. In the following stages, fields showing individual material areas were created and their parameters were defined (Fig. 7). Material properties of the subsoil were determined on the basis of conducted geological research. In the analysis, typical geotechnical boundary conditions were implemented: horizontal displacements on the outer vertical edges and displacements in both horizontal and vertical direction on the bottom edge of the model were blocked. In addition, the position of the groundwater table was taken into account. In the point of contact of the collector lining and the ground, contact elements of interface type were used (Fig. 7). One elastic-plastic model with Coulomb-Mohr yield criterion was comprehensively used in the calculations.

The specification of material property values used in calculations and presented in the legend of the pictures is shown in Table 1. Due to the lack of the reliable data, the dilatation angle values were omitted.

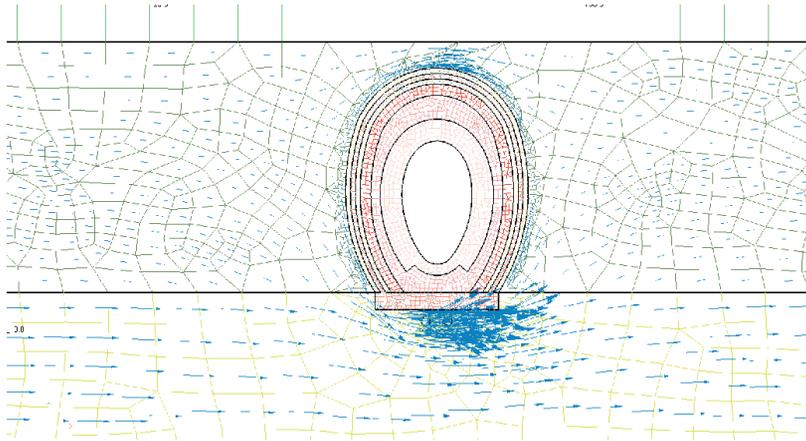
Fig. 8. Vectors of water flow velocity (source: own elaboration)

The calculations were carried out for several different scenarios. In the first one, the process of steady filtration on the assumption of tight collector cladding was analyzed. Afterwards, the influence of local leakages on the course and intensity of the filtration phenomena was simulated. For this purpose, the material parameter values were locally reduced by increasing the value of the hydraulic conductivity coefficient. An elastic-plastic analysis of the construction was carried out in order to determine stress distribution and tensile stresses. To show damages and failures, appropriate material parameters were successively modified with reference to particular areas (E , ϕ , c). Tensile stresses are particularly dangerous to the collector cladding for they can lead to scratches and leakage in the construction. The results of filtration calculations are presented in Fig. 8 as velocity vectors within the analyzed model. The vectors indicate directions of water flow. Lengths of individual vectors are proportional to flow velocity. On the basis of the calculations, it can be noticed that the largest flow concentration occurs directly under the structure (gravel and drains) and in the soil layer above the collector. These are the places of potential suffusion processes, which can result in local deterioration of the material properties of the subsoil.

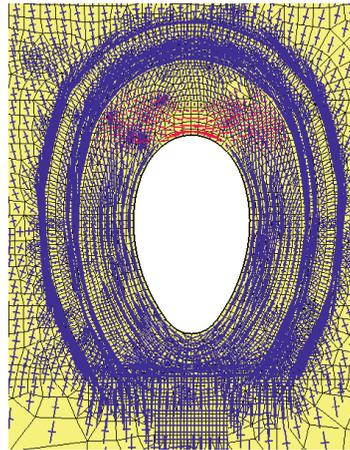
Fig. 9. Tensile stresses in the collector vault (source: own elaboration)

Stress distribution of the collector lining is presented in Fig. 9. Tensile stresses were marked in red. Occurrence of the tensile stresses in that area may cause chink forming in the mortar or its flaking off the bricks. Both these factors are conducive to forming of preferential leak paths. During field researches, leakages in the upper part of the collector were frequently observed.

In each of the analyzed cases, tensile stresses occurred in the upper parts of the collector. The usual indications of their formation are numerous cracks and scratches. These are the places of a particularly intensive groundwater leakage into the object. Results of analysis carried out with the use of the 3D model explain the reasons for ground collapse near Tapicerska Street, which was caused by suffosion processes in silty soils above the collector.

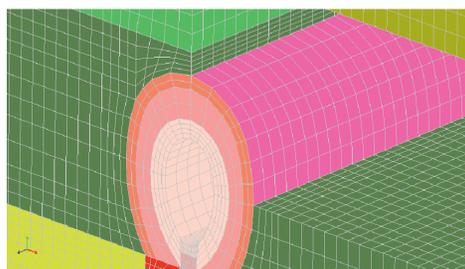
Fig. 10. The contact zone between the collector and the ground (source: own elaboration)

The boundary conditions in the calculations were used in the form of variable ground water levels and traffic loads (tram trackway is located directly above the collector). In the zone between the collector and the ground adjacent to it, the elements of interface type were used once more (Fig. 10). Soil loosening was also assumed in the calculations. For this

purpose, geotechnical parameters (E , φ , c) of the sandy loam, silt and silty clay layer were reduced. This way, potentially occurring suffosion processes associated with detrimental filtration phenomena were simulated.

In the area of soil loosening, increased subsidences of the ground surface were noticed (Fig. 10). This confirms previous observations, taken near Tapicerska Street. This situation puts ground infrastructure safety at risk. What is more, it can also generate additional tensile stresses in the construction of the collector. Directly in the area of soil loosening, displacements of the upper surface of the model were noticed. These processes can be additionally intensified by both progressive suffosion and effects of dynamic factors. Consequently, there is a risk of ground surface collapse, which can result in building disaster.
