Camilla Colla\*

## Verification of sonic tomography outcome through local testing of mechanical properties in historic timber beam

**Cytowanie / Citation:** Colla C. Verification of sonic tomography outcome through local testing of mechanical properties in historic timber beam. *Wiadomości Konserwatorskie – Journal of Heritage Conservation* 2016;47:71-79

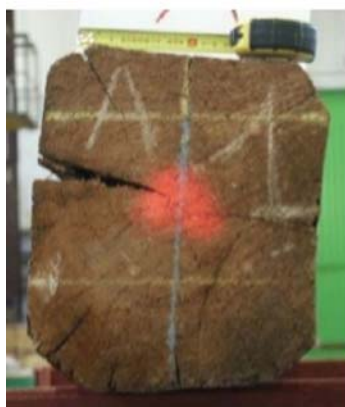
Fig. 1. Beam end view (left), geometric survey of tested cross-section (centre); tomographic stations along the perimeter (right)

Two-dimensional tomography is considered in the following. The object can be perfectly reconstructed through a complete set of its projections. In order to obtain the projections, the object is explored by a dense net of measurement paths. These are variously crossing each other and have different path angle. The waves interact with the material and are measured after passing through it. Variations inside the object, such as variations in density or presence of voids and cracks, are appreciated in the form of modifications of the received signal. In other words, the received signal provides a projection of the object's internal properties (Fig. 2). Transmitting and receiving points have to be placed along the perimeter so that the signal paths are distributed over the investigated section according to uniform density (Fig. 1 right and Fig. 3).

Despite strong irregularities in the material surface, 20 reading stations were marked as regularly spaced as possible along the cross-section perimeter (Fig. 1 right and Fig. 4). All stations progressively acted as signal transmitting points. Seven-ray fans were departing from each source point connecting it to 7 stations acting as receivers (Fig. 3). Hence, the beam section results homogeneously covered by the ideal ray paths. During data acquisition it was not possible to use stations 9 and 10 as transmitting point, located on strongly decayed area, because of the softness of material that inhibited transmission of signals of sufficient energy (Fig. 4 top right).

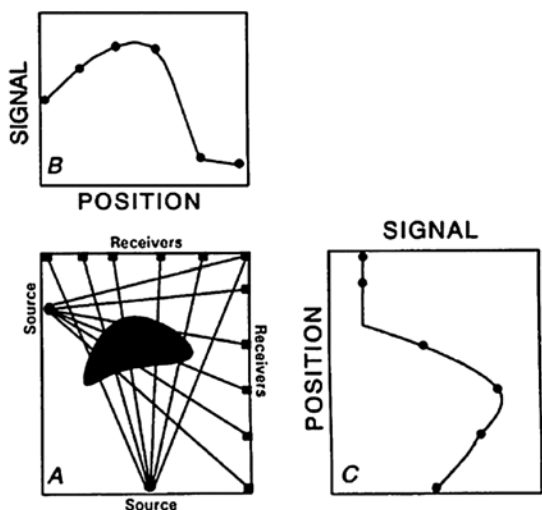
Fig. 2. Projections building in tomography of a rectangular section containing an irregular void [11]

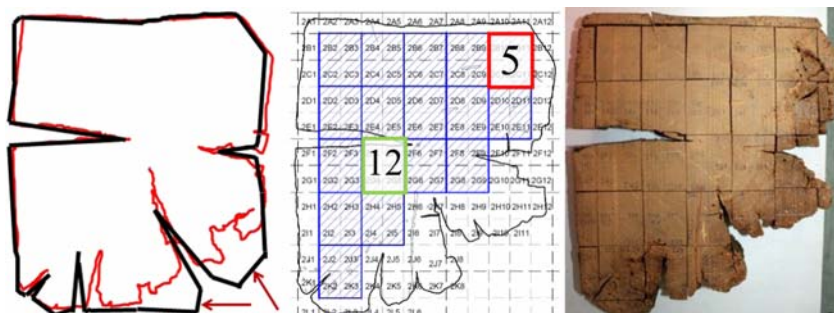
Fig. 8. Comparison between section perimeter from survey at time of tomography data collection (in black) and geometry after cutting of timber (in red); arrows point to material loss between the two phases (left). Grid of specimens for compression tests with position of specimens 5 and 12 (centre). Slice after specimens' cutting (right)

front face of the beam slice keeping into account also the further loss of some millimetres of timber at each cut by circular saw (Fig. 8 right). Before destructive tests, each specimen was measured, weighted and visually inspected for anomalies and defects. The average timber density for the specimens was  $425 \text{ kg/m}^3$ .
