## Numerical survey, analysis and assessment of past interventions on historical timber structures: the roof of Valentino Castle

**Key words:** laser scanning survey, finite element modelling, timber reinforcement, cultural heritage

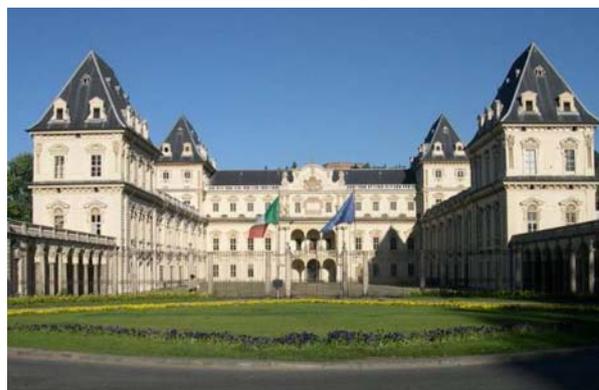
Fig. 1. Valentino Castle in Turin nowadays (photo T.M.)

The Valentino Castle is located in the centre of the Italian city of Turin, facing the Po riverside. The origin of the building dated back in the 17<sup>th</sup> century and its the current structure is due to Princess Christine Marie of France (1606–1663), wife of Victor Amadeus I, who dwelt here from 1630 as she wanted a castle following in style the castles built in that period in France. Therefore the architecture of the castle is inspired by the French principle of the pavilion system, with four towers at each angle, and a wide inner court (figs. 1–2).

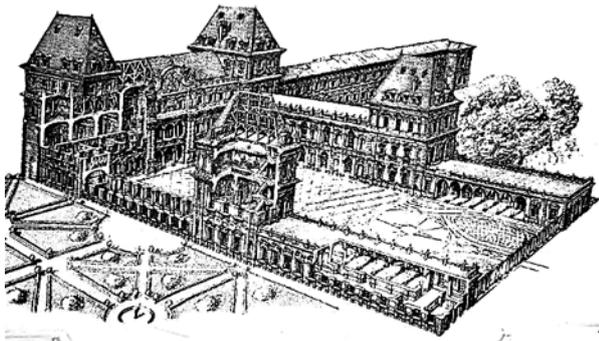
Fig. 2. View of the Valentino Castle (drawing F. Corni, 2012)

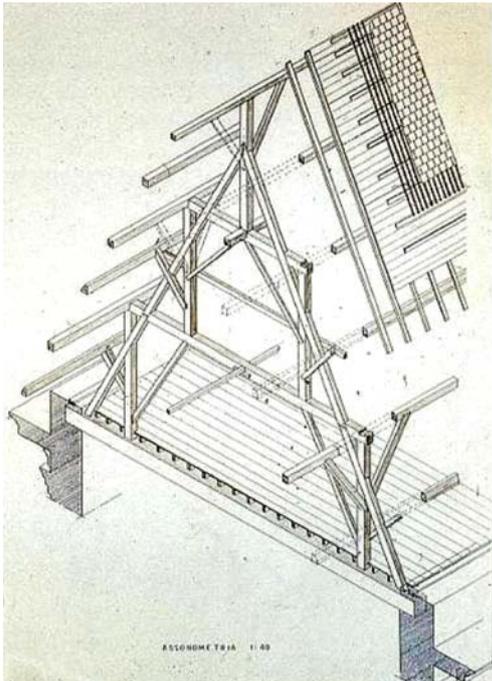
Fig. 3. Scheme of a truss and its components (drawing C.B. 1986)

The timber roof structure of the towers has three-dimensional organization. More precisely, in the transversal direction, it is constituted by four great trusses and two small trussed at the ends. The pitch is

strongly inclined. In the longitudinal direction of the timber structure is composed by the ridge, five series of purlins and by three orders of frames overlaid with stiffening functions (figs. 3–4). This structural complex is firmly secured to the covering planks that support the tiles of black stone [1, 2].

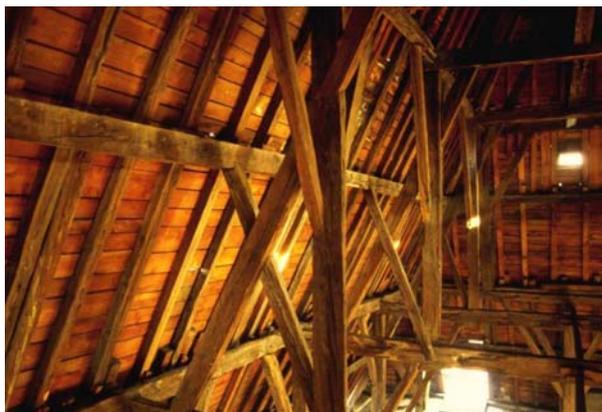
Fig. 4. Inner view of a tower (photo C.B. 1986)

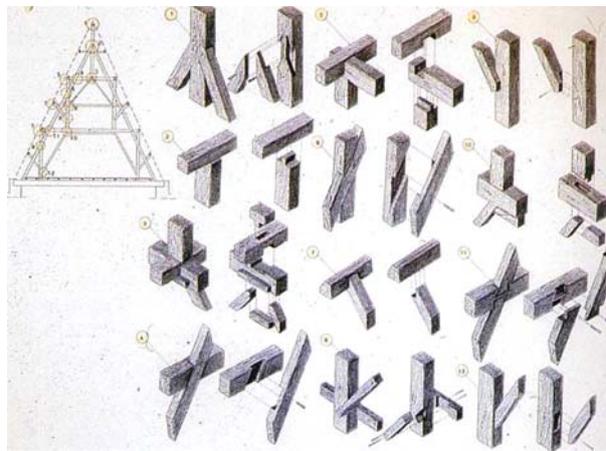
Fig. 5. Abacus of timber joints (drawing C.B. 1986)

The geometric survey was carried out carefully in order to understand the structure, the types of connections and each assembly step. There was a particular focus on some assembly marks dating back at the time of the building site which allowed the identification of the original components from those replaced later (figs. 5, 6, 7).

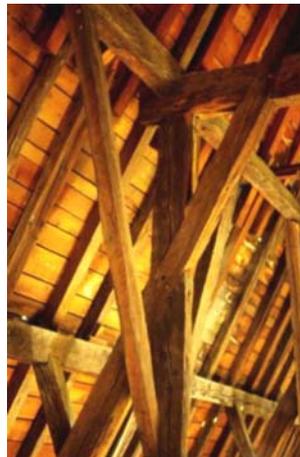
Fig. 6. Timber joints

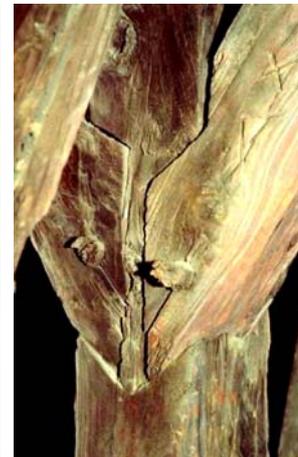
Fig. 7. Assembly marks (photo C.B.)

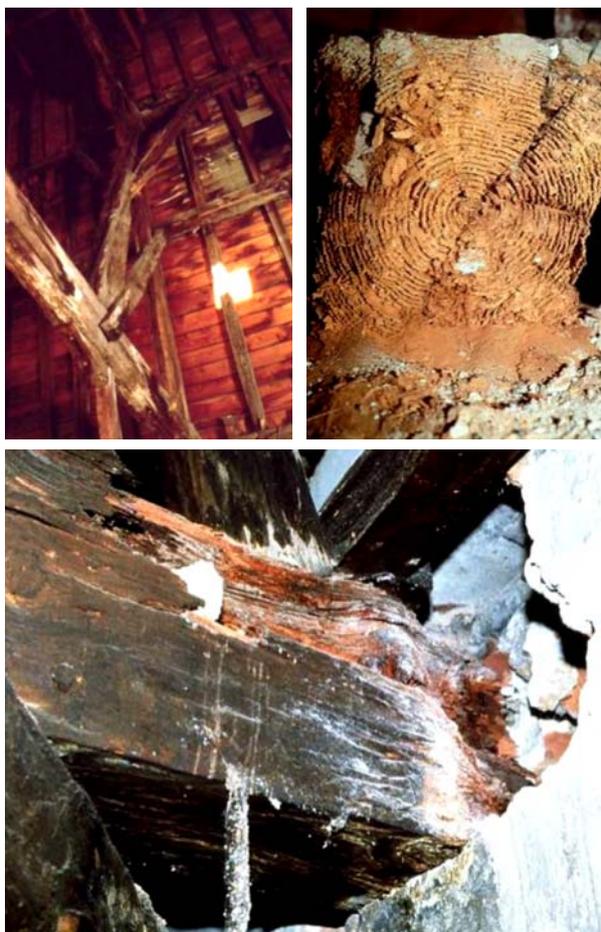
Figs. 8–10. Biotic decay due to due fungi and insects (photo C.B. 1986)

Moreover diffuse infiltrations of rainwater speeded up the attacks in some specific locations in the structure and in particular in the beams' head area. In the wood of some components restrained in the external

wall, a high level of humidity was detected as well as a diffuse state of decay (figs. 8, 9, 10).

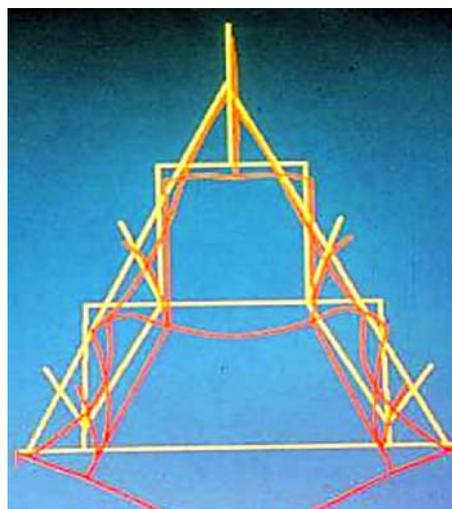
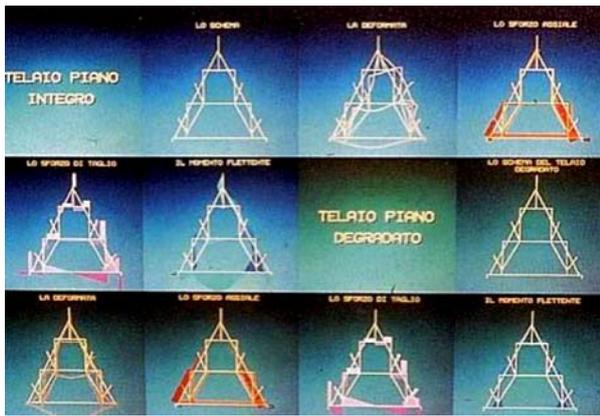
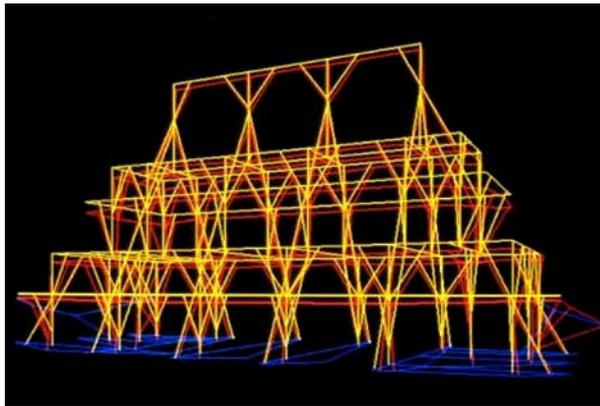
Figs. 11. Structural analysis: bi-dimensional model, deformations and stresses, tri-dimensional model (1986)

Figs. 12–13. Structural analysis: bi-dimensional model, deformations and stresses, tri-dimensional model (1986)

In the case of the spatial model 500 elements and 1040 joints were taken into account with a total amount of 1818 equations. That investigation showed that the structural components were not verified for the loads considered. Later the behaviour of the roof planking as a "shell" was assumed, allowing the structural verification (fig. 11, 12, 13).

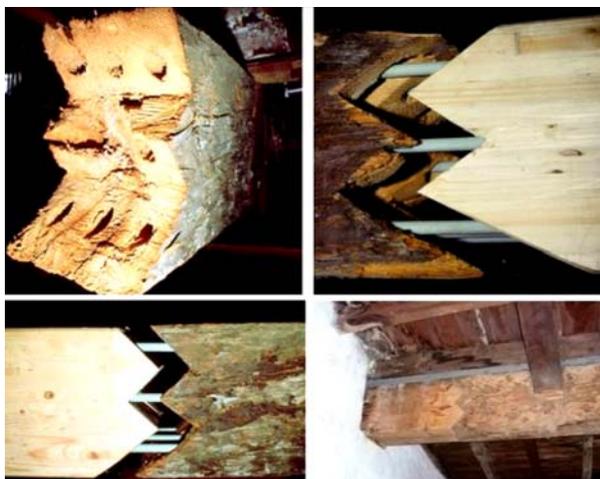
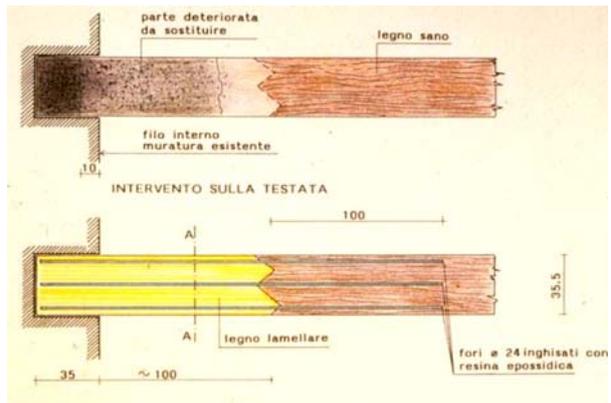
Figs. 14. Reinforcement intervention on tie beams' head-pieces using reinforced glue-laminated timber. Realization (1986)

Figs. 15. Reinforcement intervention on tie beams' head-pieces using reinforced glue-laminated timber. Realization (1986)

A phase of reconstruction of each damaged area of the tie-beam heads was provided using glue-laminated timber reinforced by fiber-glass rods. A good level of ventilation was guaranteed through the insertion of neoprene layer in between the wall and the glulam to get to a good durability of the intervention (figs. 14–15).

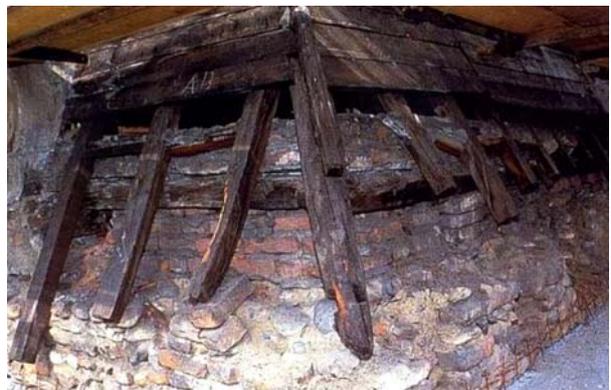
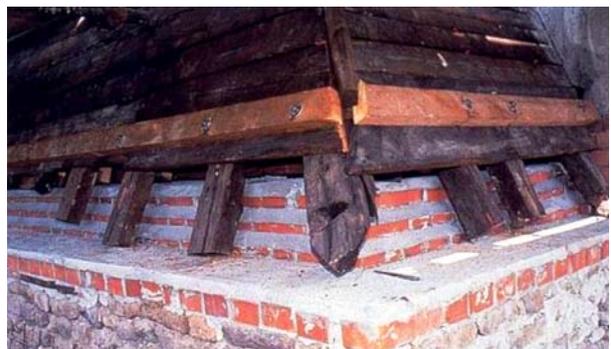
Figs. 16–17. Area of the masonry wall supporting the timber carpentry before (Fig. 16) and after (Fig. 17) the intervention (1986)

Another phase of intervention involved the reinforcement of the area of support of the timber joists and planking at the top of the masonry walls (figs. 16–17).

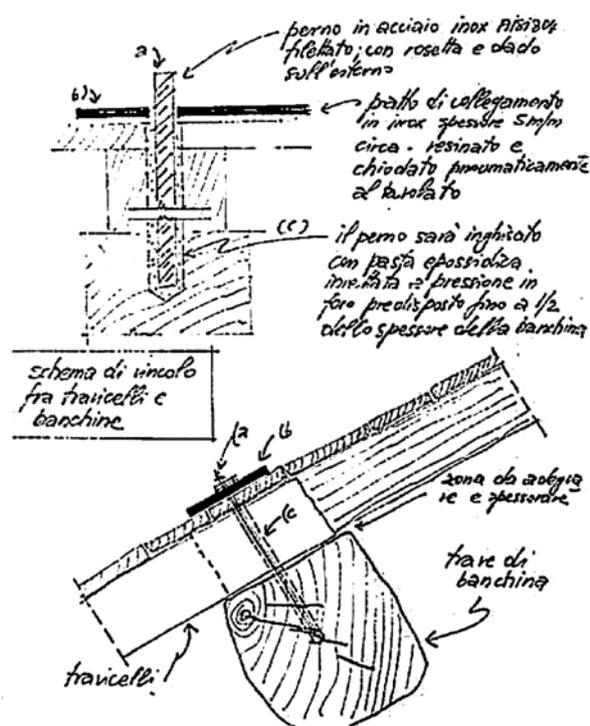
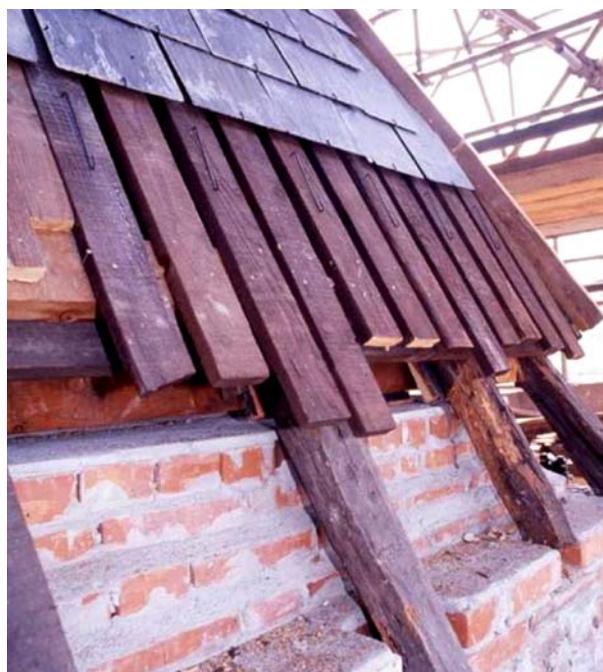
Figs. 18–19. Connection between rafters and girds via steel pins to get the continuity of roof pitch

This intervention was conducted to connect the covering planks and to reinforce the “shell” behaviour (figs. 18–19).

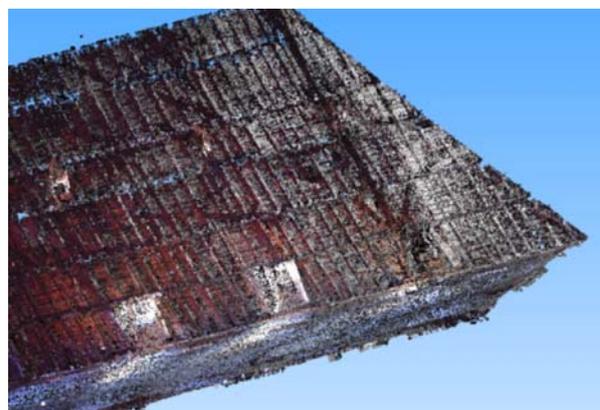
Fig. 20. TLS point clouds adjusted in the same coordinate system

have been executed on ground level of the attic; the scan positions have been chosen in order to optimize the complete data recording of the complex structure, placing them one for each space between trusses (figs. 20–21).

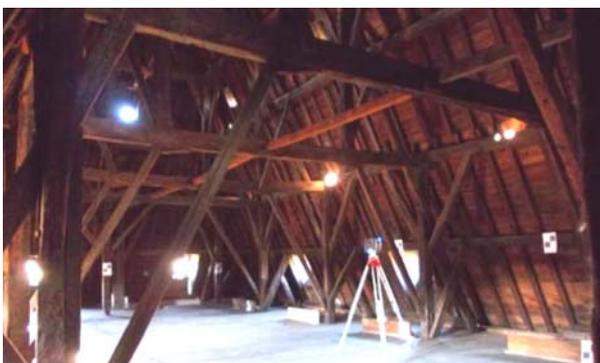
Fig. 21. The Scanner Focus<sup>3D</sup> acquiring phase

- all measurements have been processed in a unique, local coordinate system using a reference network of two topographical vertexes; these points have been the reference for measuring all the Control Points (CP) coordinates, through the positioning of targets.
- the LIDAR survey has been realized with the terrestrial Laser Scanner Focus<sup>3D</sup> – CAM 2. Six scans

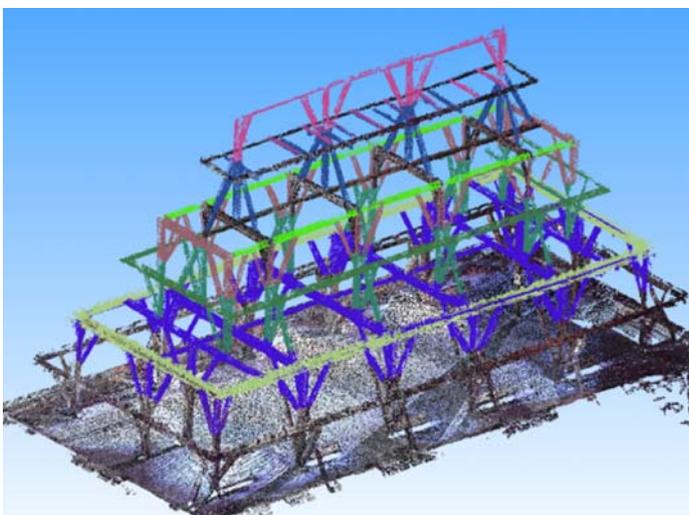
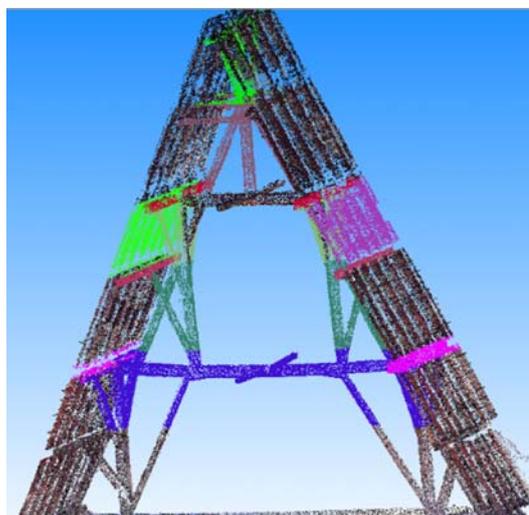
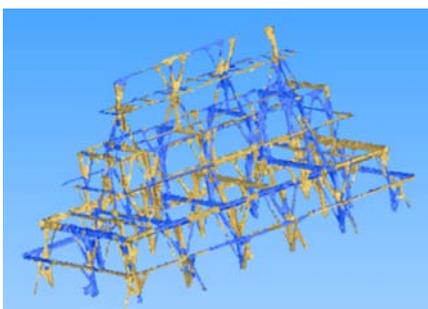
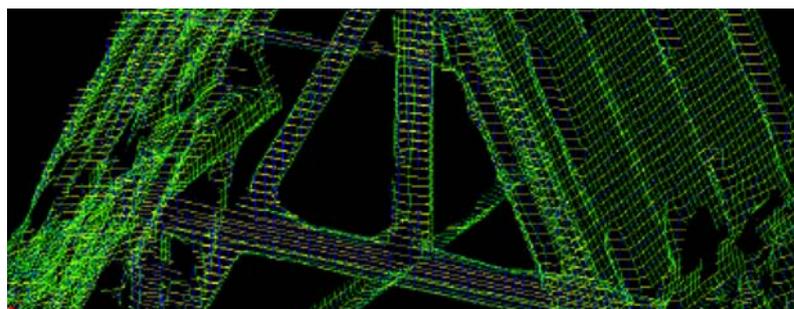
Figs. 22–25. (above) Whole roof structure segmentation, and the selection of a portion to be submitted to further analyses. (below) The complete mesh surface of roof structure and a zoom on extracted section profiles

Many editing procedures of the models, included the profiles extraction, is highly automated. As a consequence the dimensions of elements sections are easily achievable, while the beam axis scheme has been generated almost manually (figs. 22–25) [10].

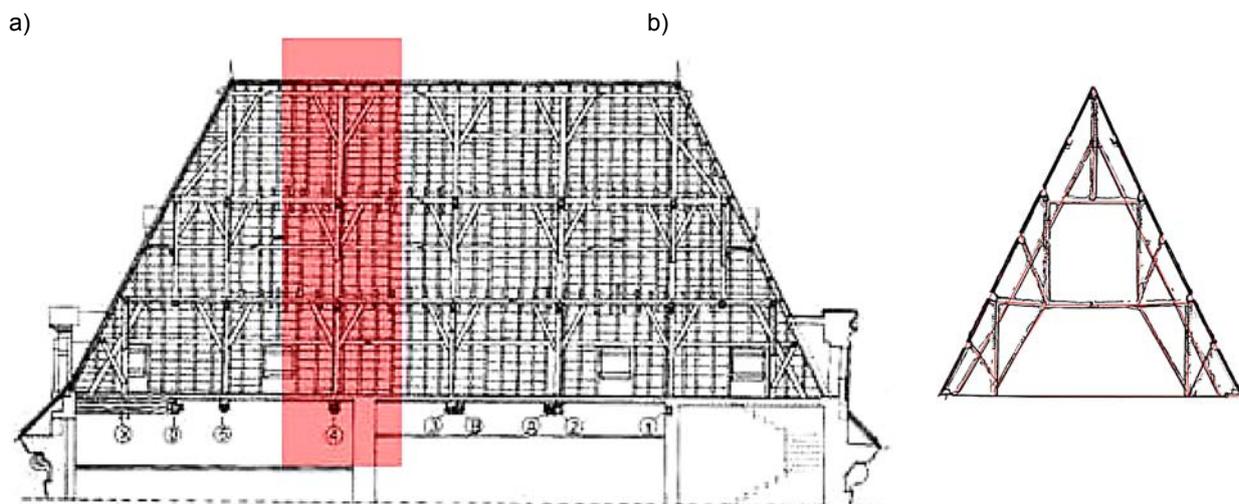
Fig. 26. Section of the roof structure and (in red) truss under consideration (a), beam axis line geometry (in red) obtained from the laser acquire points cloud (b)

Figure 26a shows the truss that was chosen for the analysis, while in figure 26b it is possible to appreciate the relation between the points of the cloud and the idealized beam axis of each element.

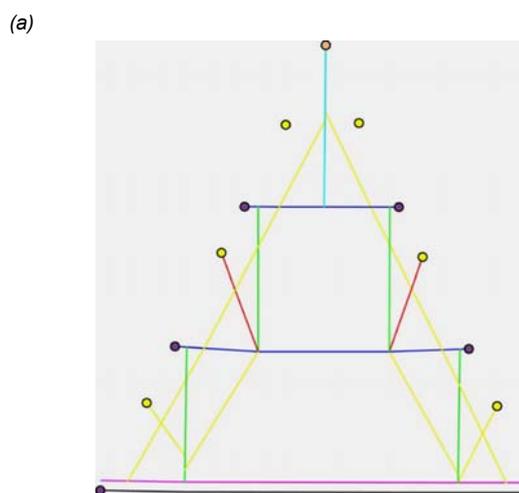
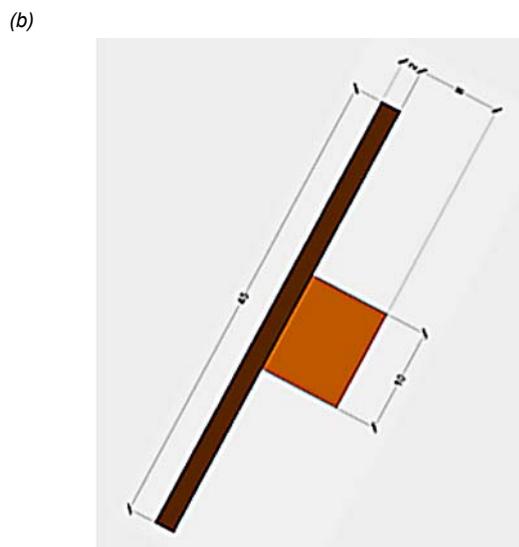
Fig. 27. Scheme of uniform section elements (reported in table 1) (a), Section of the ribbed planking (b)

Figure 27a represents the scheme of the different structural element sections. In figure 27b, the scheme of the ribbed planking is shown. In the present calculation, the ribbed planking has been accounted for by means of an equivalent flat shell of the same stiffness, with equivalent thickness equal to 7 cm. Table 1 lists the sections adopted in the model for the different structural elements (the same section is assigned to structural elements with the same color).

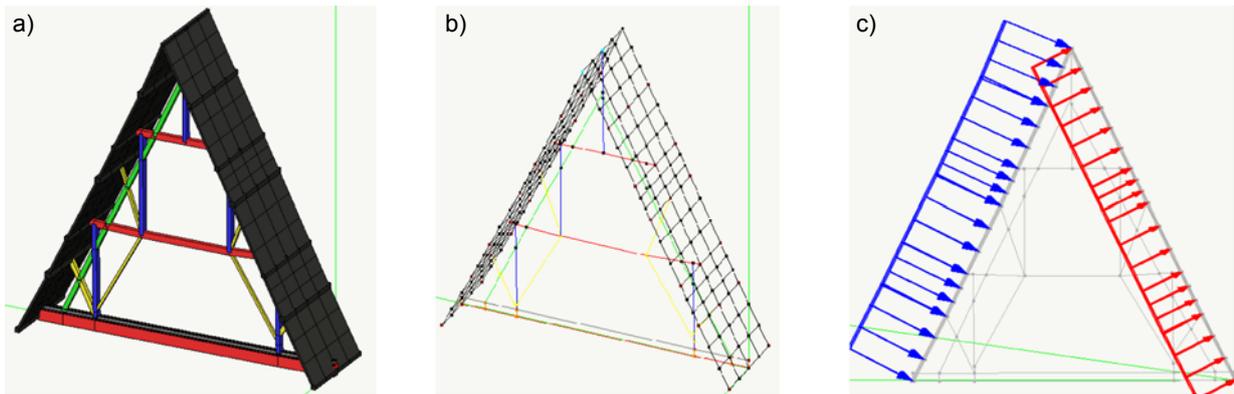
Fig. 28. Solid model of the structural subsystem (a), wireframe structure (b), wind load (c)

In this structural model the effect of the stiffening of the planking structure is directly accounted for, by means of an equivalent flat shell. The truss structure is assumed as periodical, with a constant span between each frame. This is simulated providing the appropriate periodic boundary condition to the shells. Figure 28a shows the solid model of the structural subsystem, while figure 28b shows the wireframe structure. Figure 28c shows one of the load combinations for the wind action.

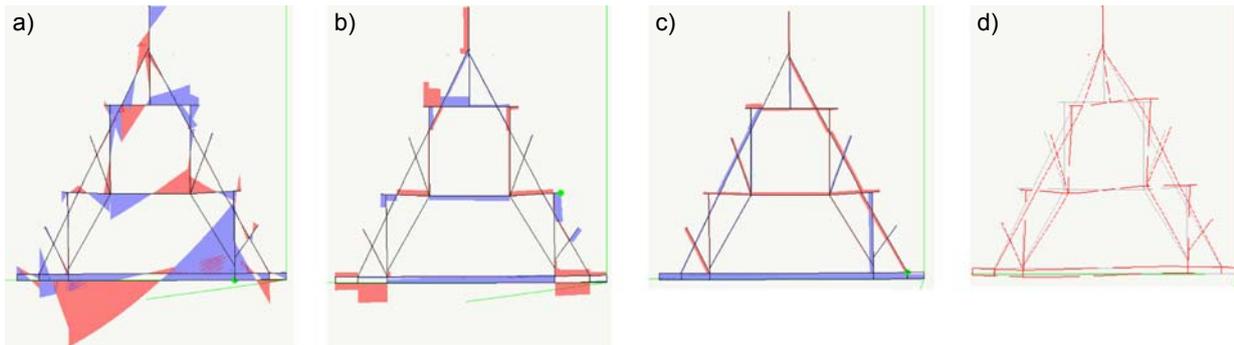
Fig. 29. Bending moment (a), shear force (b), axial force (c), and elastic deformed shape (d)

The envelope of the beam axial or shear forces and bending moment, together with the elastic deformed shape, are shown in figure 29.

The structure reacts to the action of wind without excessive deformation and without particular stress concentration in any structural element.

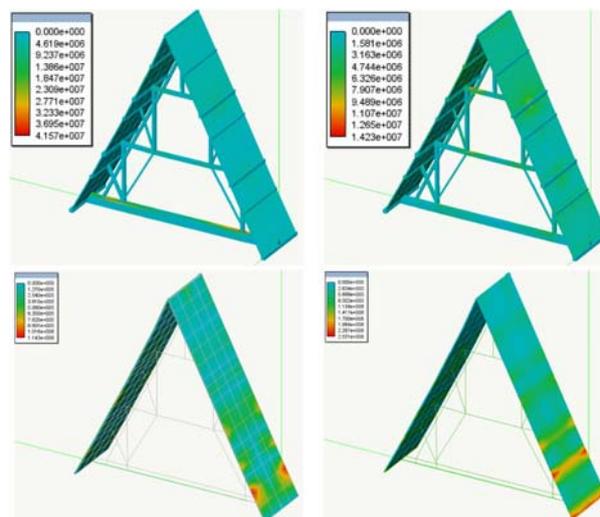
Fig. 30. Principal stress contours in the whole structure: tension (a) and compression (b); Principal stress contours in the planking: tension (c) and compression (d)

In order to better appreciate the levels of stress in the structure, the principal tensile and compression stress contour plot can be drawn. If the contour plot is limited to the planking elements (fig. 30c, d), it emerges that the planking in the lower position of the roof is the most beared.

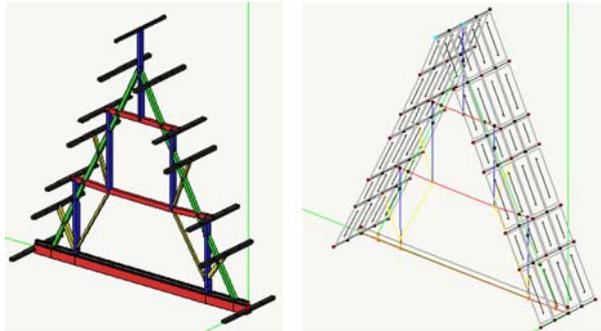
Fig. 31. Load bearing frame truss (a), specialized fictitious non-bearing load elements (b)

truss frame is expected to carry the load (fig. 31a), and the wind and non-structural dead load can be applied to the structure by means of specialized fictitious non-bearing load elements (fig. 31b).

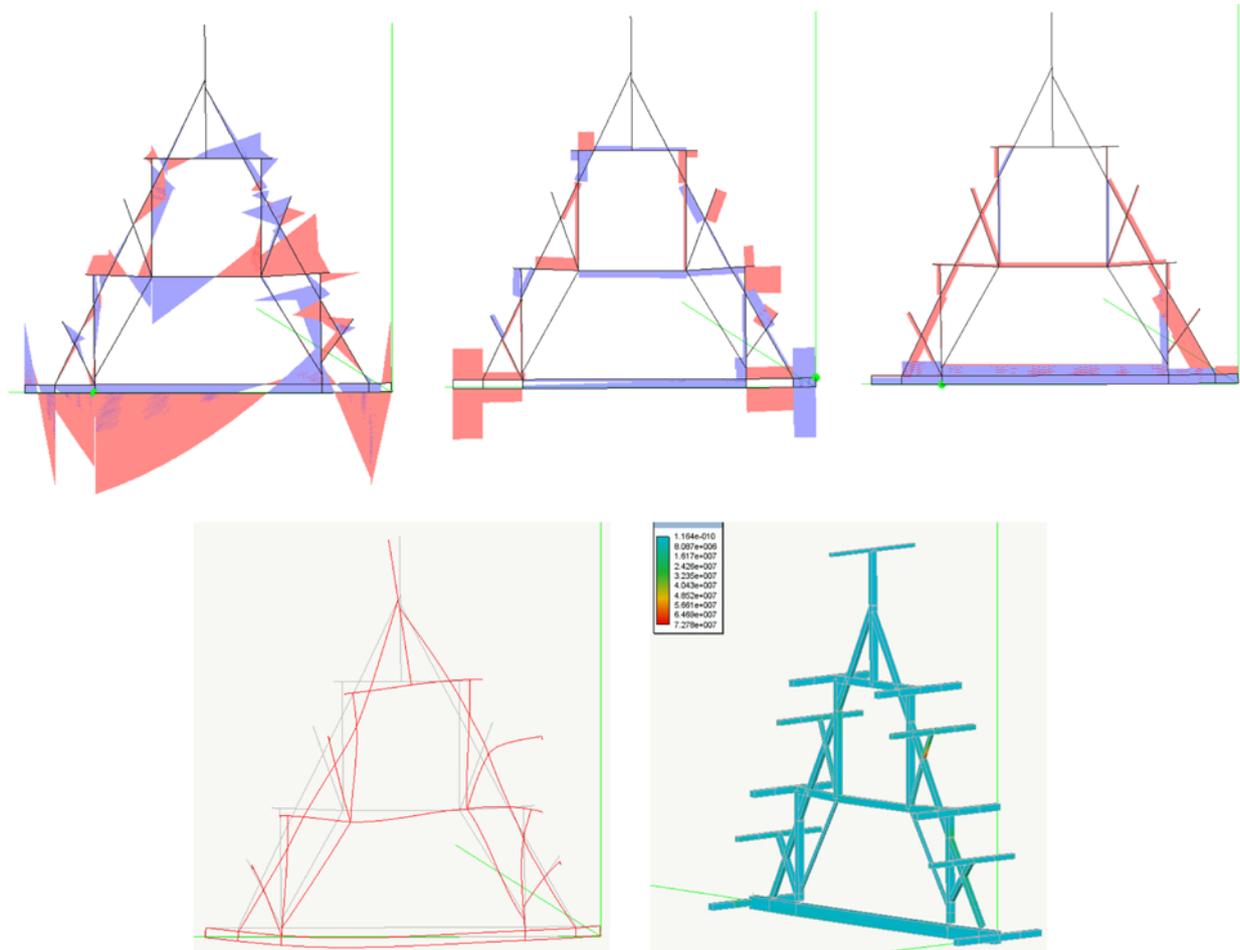
Fig. 32. Bending moment (a), shear force (b), Axial force (c), elastic deformed shape (d), principal compression contours (e)

The results of the linear analysis are reported in figure 32. It is evident that, if the constraining of the planking is disregarded, overestimated bending moment and consequent deformations are obtained in several structural elements (especially in the median-upper part of the roof, where the previous analysis provided low-intermediate levels of stress). As a consequence, the calculated levels of stress are not admissible for timber.

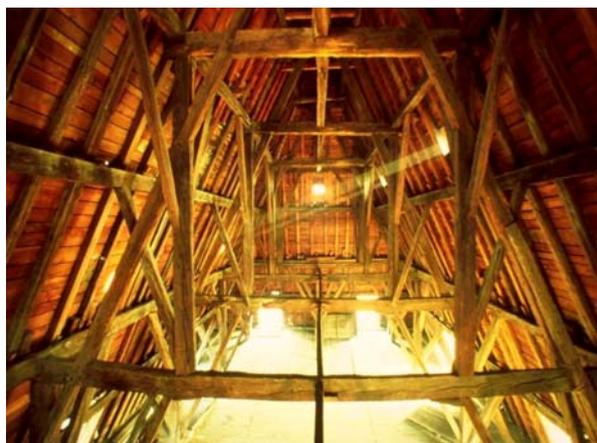
Fig. 33. The timber roof structure of the north-east tower nowadays (photo C.B.)

The positive assessment of the new accurate structural analysis improves and optimizes the results obtained at the time of the intervention carried out 30 years ago. This confirms the durability of an intervention performed with minimally invasive techniques due to the tri-dimensional behaviour of the structure. Furthermore, the present research allows to start a localised monitoring of this important timber roof structures dating back to four centuries ago (fig. 33).
