KAROLINA BIAŁOBŁOCKA*

HISTORICAL COLOUR SCHEMES OF ARCHITECTURE: SELECTED METHODS OF PRESENTATION

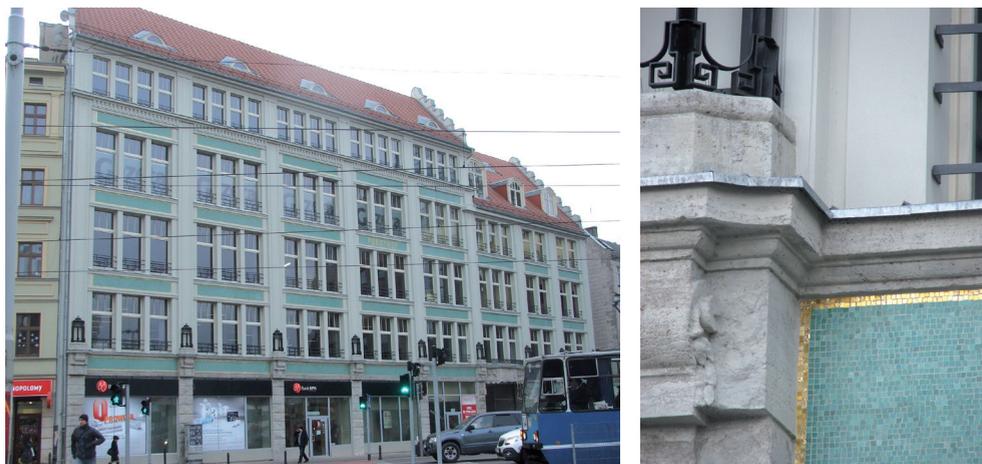
Ill. 1. Wrocław, ulica Świętego Antoniego, ‘Pokoyhof’ – the former department store from 1910 after recent refurbishment to the original colour scheme

Such a restoration as that described above took place at the former Pokoyhof department store at 2-4 ulica Świętego Antoniego in Wrocław. The building was erected in 1910 and since then, the only significant damage to have occurred was the destruction of the stone details of the entrance area – these were destroyed during the Night of Broken Glass in 1938. The examination of the exterior walls and courtyard was conducted in 2010⁵. It was revealed that originally, the ground floor of the façade was covered with travertine. Above the ground floor, the light grey plaster imitated stone with regard to both colour and texture. A grey hue was achieved by adding an organic black pigment, probably charcoal, to lime. The examination revealed that panels below windows were decorated with glazed green and gold mosaics made of 2 cm × 2 cm squares [2]. The discovered original colour scheme was resorted during recent refurbishment (Ill. 1).

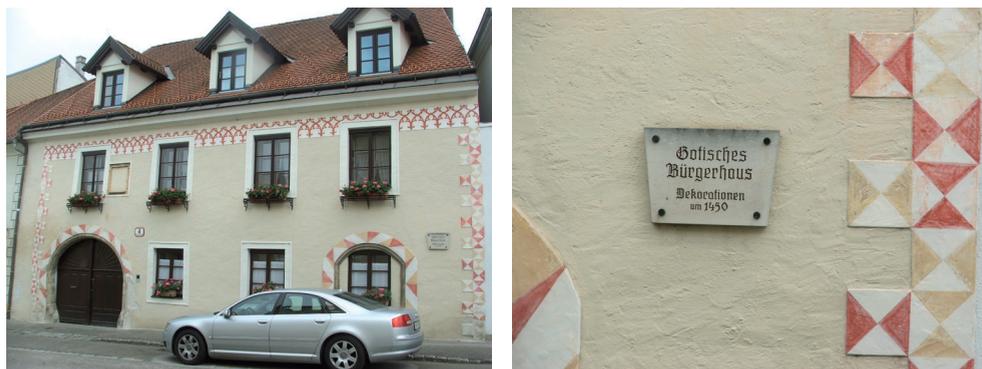
Ill. 2. The dwelling of medieval origin in the Market Square in Eggenburg, Lower Austria.
Photo by the author

A dwelling at the Market Square in Eggenburg, Lower Austria, is an example of a rebuilt building with the restored original colour scheme. The dwelling of medieval origins has probably been refurbished several times since the Middle Ages so the character of the late Gothic residence vanished. With time, the doors, windows, and window surrounds have been replaced with a newer design, the roof windows were also added. As a result, only the restored colour scheme, dating back to 1450, reminds us about the building’s medieval origins (Ill. 2).

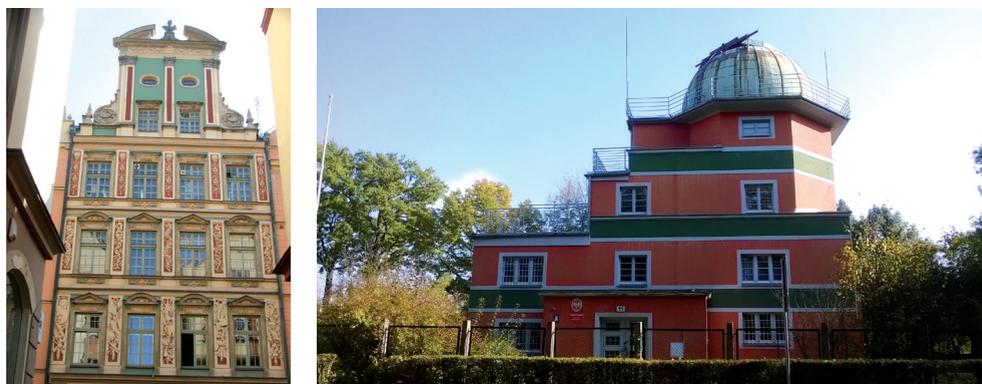
Ill. 3. Examples of colour schemes based partially on historic data and partially on other factors such as personal preferences of key individuals – the Baroque dwelling at 12 ulica Kuźnicza, Wrocław (left) and the modernist observatory at 11 ulica Kopernika, Wrocław (right). Photos by the author

A combination such as that described above is currently visible on a dwelling at 12 ulica Kuźnicza, and on the observatory at 11 ulica Kopernika, both in Wrocław. According to the results of paint research, a monochromatic colour scheme was applied to the exterior at 12 ulica Kuźnicza in the first and second chronological phases, these were green and red, respectively⁸. The wall surfaces and the stucco works were originally painted light green, close to 9385/9369 in the KEIM colour chart. It was not possible to establish the original colour of stone components due to the poor condition of paint remains [2]. As previously mentioned, red was established as a colour of the second chronological phase. A two-coloured scheme of green and red that combined results from both phases was designed during the refurbishment and finally applied to the façade. In this way, a new composition was created which was unproven by paint research (Ill. 3).

A similar effect to that applied at 12 ulica Kuźnicza was achieved on the elevations of the observatory at 11 ulica Kopernika. The observatory was erected in the first half of the 20th century and its colour scheme, as presented on the original design, represents a colourful trend in Modernist Movement architecture⁹. Red and blue horizontal stripes were juxtaposed with white in between them. Blue was also intended to be on the observatory dome; however, blue was replaced with green on the elevations and on the copper dome during recent refurbishment (Ill. 3).

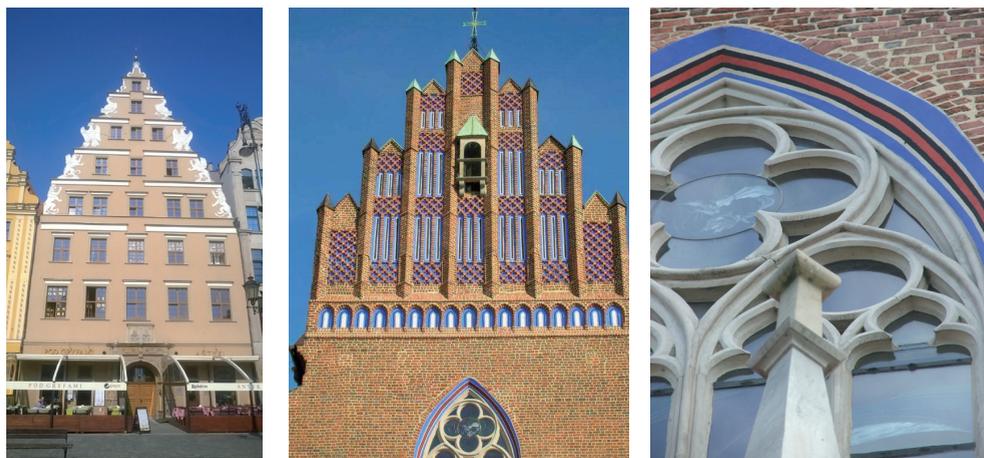
Ill. 4. Examples of presentations of later repainting – the Mannerism façade of a dwelling at 2 Rynek, Wrocław and the 19th-century colour scheme (left); the medieval Corpus Christi Church at 26 ulica Świdnicka, Wrocław and later polychrome, probably from 1927 (middle and right).

Due to a lack of original substrates or poor methodology of paint research, it can happen that examinations only allow the identification of colours from later chronological phases which are not stylistically connected with the form of a given building or its original ornamentation. As a result, it may happen that repainting from later chronological phases is restored. For example, this happened at the dwelling at 2 Rynek in Wrocław. The façade of medieval origin was rebuilt in the late Renaissance and it is a rare example of the Mannerism style in Wrocław. Primary sources indicate that the façade has been repainted several times since then. In the 17th century, the walls were repainted and in the 18th century, they were whitewashed and repainted with, probably, black, green and ochre colours – this is assumed on the basis that such pigments were mentioned on a receipt [2]. During renovation in 1935, it was estimated that the façade originally was two-coloured in blue and yellow [8]. Examinations were conducted in 2011; however, due to very few remains, they did not yield complete results¹⁰. The conservator who conducted paint research discovered remains of pigmented plaster with charcoal, and traces of light blue and dark ochre paints; however, it was not possible to connect these findings with certain chronological phases. The first colour scheme which was possible to identify and put an approximate date to was the beige colour scheme from the 19th century. This colour scheme was applied to the Mannerism building during the last refurbishment (Ill. 4).

A similar situation to that presented above applies to remains of old polychrome that were detected on the medieval façade of Corpus Christi church at 26 ulica Świdnicka in Wrocław¹¹. However, the conservator who examined the building estimated that all the discovered plaster comes from later refurbishments. Light creamy, lime-sand plaster with paint on top was detected on the arch of the front lancet window. There were traces of black, blue and red stripes emphasising the form of the stone arch. Traces of blue were also detected on the upper part of the gable. The conservator suggested that these polychromes were introduced in 1927. During recent refurbishment, the Neo-Gothic polychromes were restored on the medieval church (Ill. 4).

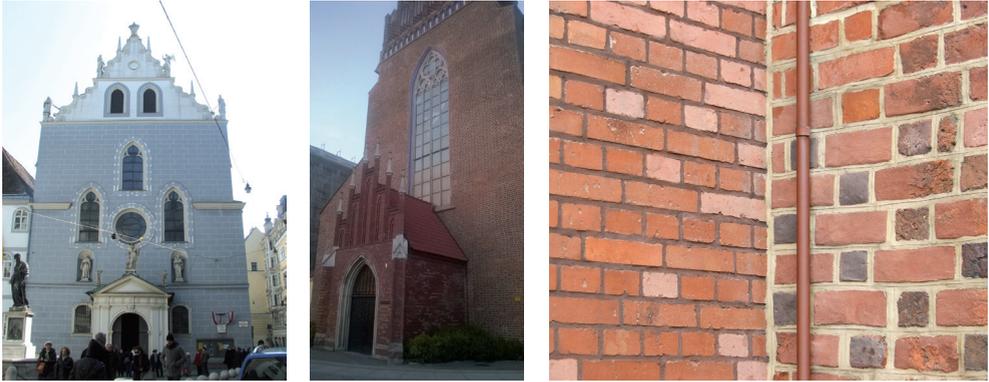
Ill. 5. Examples of presentation of colour schemes form different periods – the Franciscan church, Old Town, Vienna (left); Corpus Christi Church, 26 ulica Świdnicka, Wrocław (middle and right). Photos by the author

Buildings are usually rebuilt and expanded in the architectural styles and painted colours popular at the time of refurbishment. It can happen that conservationists decide to simultaneously expose two or even more discovered colour compositions, all of them be the original colour schemes of particular extensions of the building. We can see such solutions on churches with porches that were added sometime after the initial construction such as the Franciscans church in Vienna City Centre and Corpus Christi church in Wrocław. The Viennese church has a Renaissance façade covered with blue-grey imitation of stone, whereas the Baroque portico is painted ochre and white. Similarly, the medieval brick façade of Wrocław church was differentiated from the 19th-century brick porch by the colours of the mortar joints. The conservator who examined the Wrocław church estimated that the medieval joints of the first chronological phase were light cream, and of the second chronological phase, were yellow or ochre¹². Added in 1875, the Neo-Gothic porch was decorated with cherry-red pigmented mortar joints. The colours of joints were reproduced to the original colours, in accordance with the style in which both the main building and the adjacent porch were originally erected (Ill. 5).

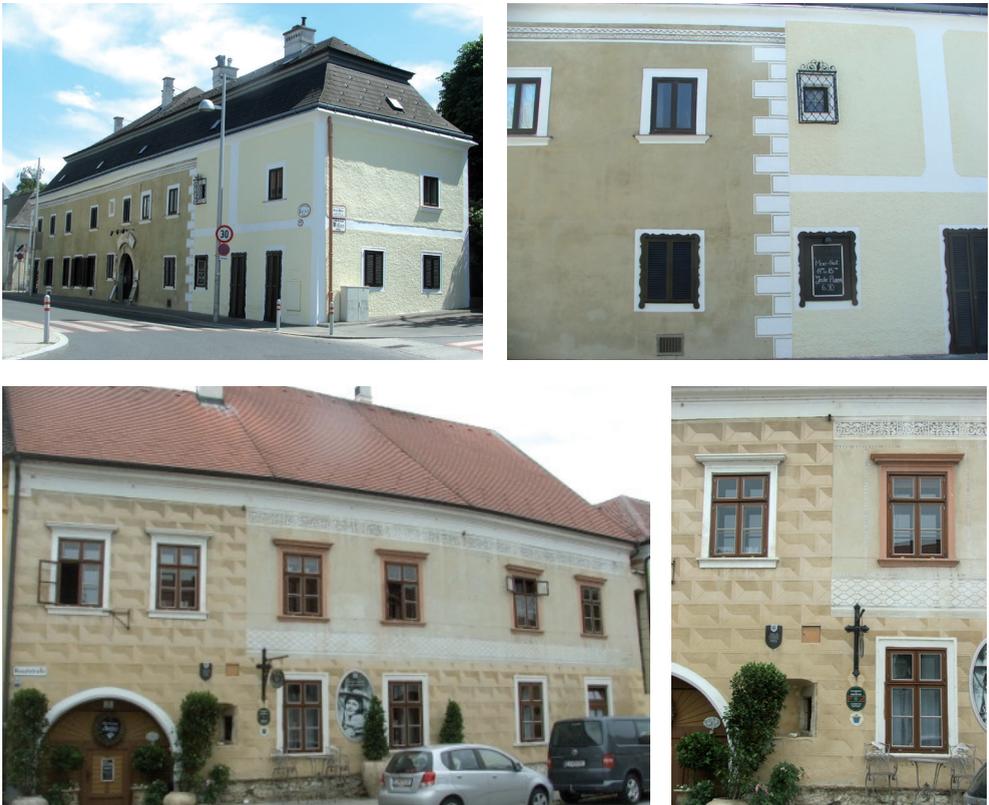
Ill. 6. The dwellings in south Vienna (above) and in Rust am See, Lower Austria (below). By introducing two different colour schemes to a flat surface at the same time, the building is divided into smaller parts. Photos by the author

in south Vienna. A 16th century colour scheme is restored on the east end of the building: grey plaster covers the surface of the wall and white is applied to the architectural details; whereas the west end of the building is painted ochre and white, imitating architectural details (Ill. 6). A similar presentation method with two different colour schemes on one flat elevation is visible on a dwelling in Rust am See; however, while standing at a distance from the building, we can notice a difference in the height of each end of the roof that somehow explains the change of colour scheme. The ground floor and part of the first floor above the entrance door is covered with an ochre block imitating stone. The remain part of the first floor is a light grey-yellow, additionally decorated with grey and white friezes. Brown is applied to all of the window frames. In both cases, the colour of the roof and the cornice somehow unify the whole building (Ill. 6).

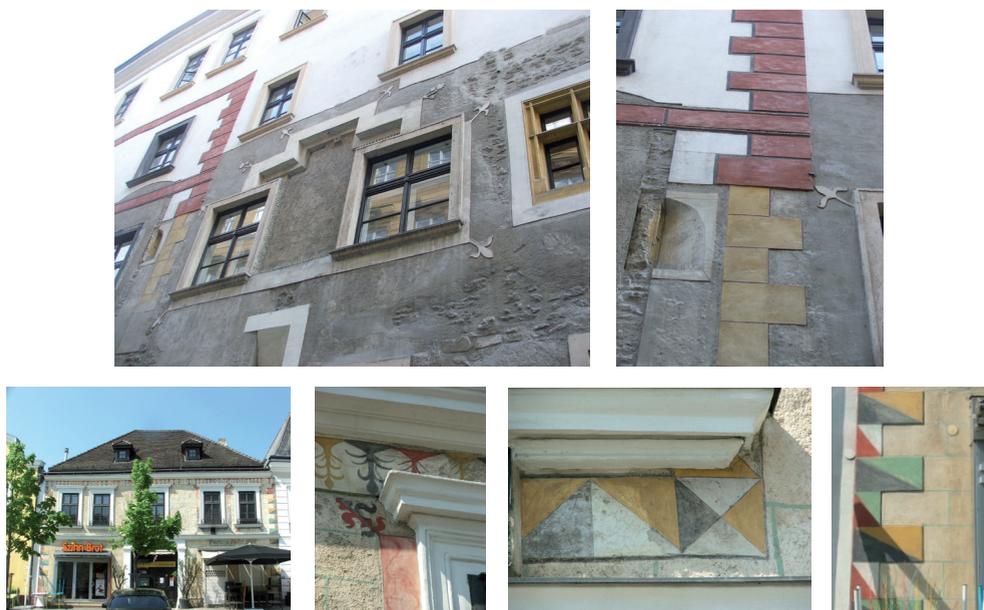
Ill. 7. The details of elevations of dwellings in central Vienna (the upper row) and Perchtoldsdorf, Lower Austria (the lower row) – the colour compositions are an effect of juxtaposing various remains of polychrome from different phases and styles. Photos by the author

Colour schemes that are composed of various elements from different chronological phases – pieces that were applied in different centuries and were attributed to different styles – may in fact create a new composition that is more or less clear to passers-by. This way, all the valuable remains are saved, preserved and exposed, but the completely new composition may in fact be slightly chaotic. Such a solution was spotted on the back wall of a dwelling in the Old Town in Vienna – the entire wall is covered with various elements from the Middle Ages and the Renaissance. Similarly, the façade of a dwelling in Perchtoldsdorf, Lower Austria was decorated with items from different phases: black and red window surrounds; black, yellow and white window surrounds; white window surrounds; a multi-coloured corner rustication, a multi-coloured cornice; a yellow and green wall surface – yellow imitating stone blocks and green imitating mortar joints (Ill. 7).

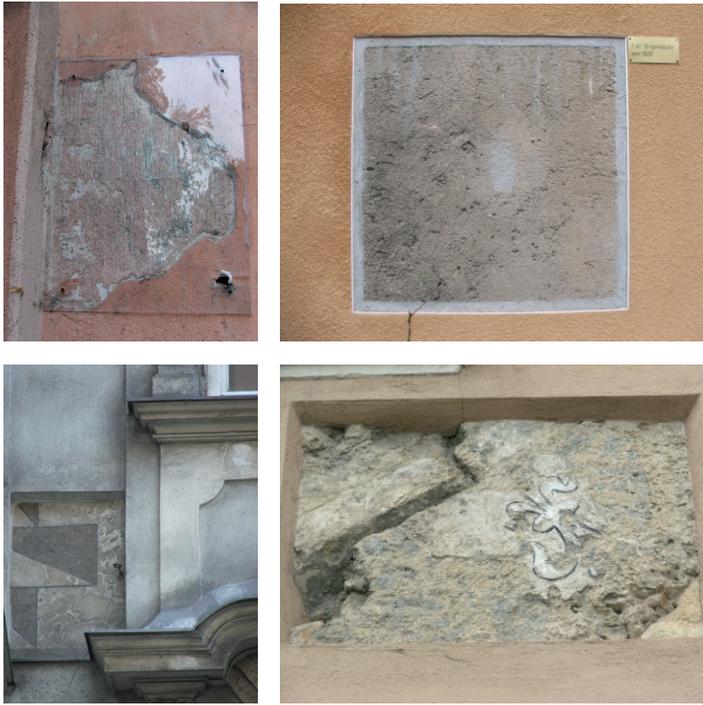
Ill. 8. Samples of original substrates presented as evidence in Wroclaw, Berlin, Vienna and Wiener Neustadt. Photos by the author

Small pieces of the original substrates, plaster or paint, are sometimes exposed on a very small surface, and since those samples are not part of the applied colour schemes, they are usually exposed in a less visible area, such as the back elevation or a corner of a façade (Ill. 8). However, it may happen that original polychrome survived only in a much more exposed place, such as the centre of the front elevation. Here, depending on the method of presentation of the survived remains, such presentation may make an impression as being rather accidental, especially in case the exposed sample does not follow the structure of a whole façade (Ill. 9). Such samples are only partial, yet, this way we are able to at least see on a very tiny area what the original colour may have looked like.

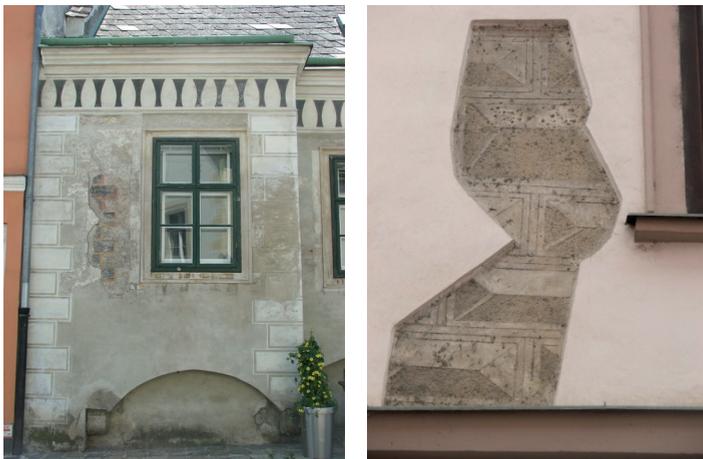
Ill. 9. Traces of historical polychrome on dwelling in Heiligenstadt, Vienna and remains of Renaissance sgraffito in the Old Town in Prague. Photos by the author

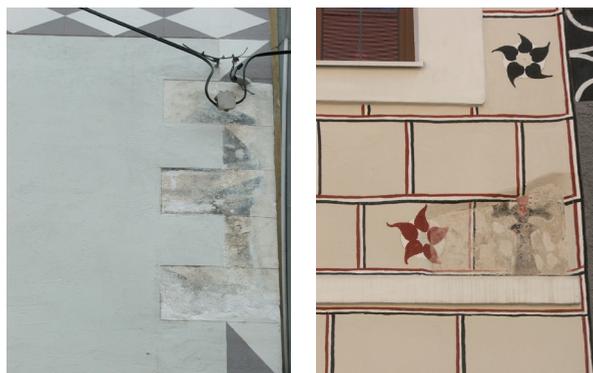
Ill. 10. Original remains incorporated into restored colour schemes: dwellings in Wiener Neustadt (left) and in Görlitz (right). Photos by the author

Therefore, a restoration of the original colour scheme may consist of a sample of original coating. In this way, original and restored polychromes are usually differentiated by saturation and/or lightness of the same hue (Ill. 10).

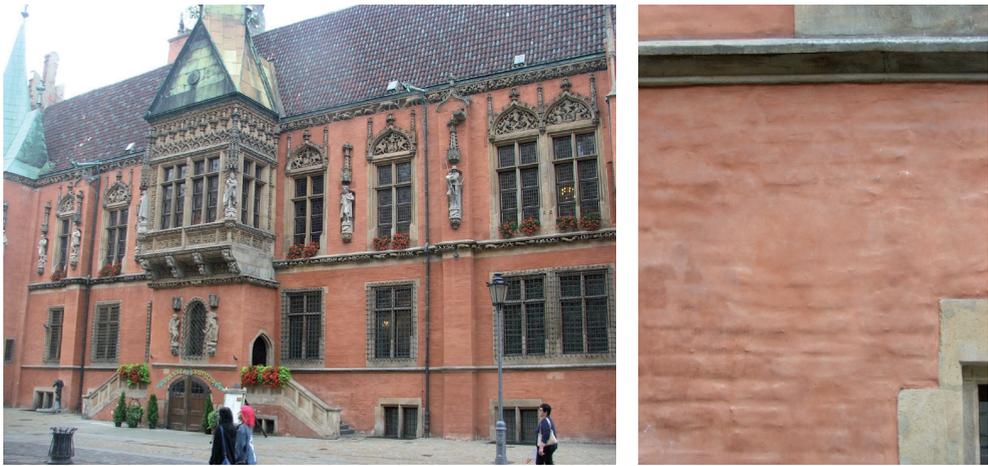
Ill. 11. The partial reconstruction of medieval polychrome on the Town Hall in Wrocław – the south elevation covered with wave-like whitewash and painted transparent iron red.
Photos by the author

Examinations of the exterior of Wrocław Town Hall allowed the partial estimation of colour usage in the third and fourth chronological phase, dated to the late Middle Ages¹³. Although it was not possible to trace the original medieval wall painting, it was estimated that at that time, the wall surfaces were painted a red hue, close to iron red. During the last refurbishment of the south elevation in 2009, paint was applied the way the background layer could be see-through into a rough, wave-like surface, imitating a medieval polychrome as much as possible in every aspect (Ill. 11).
