MANFRED WEHDORN*

RESTORATION OF THE LIECHTENSTEIN PALACE

Abstract

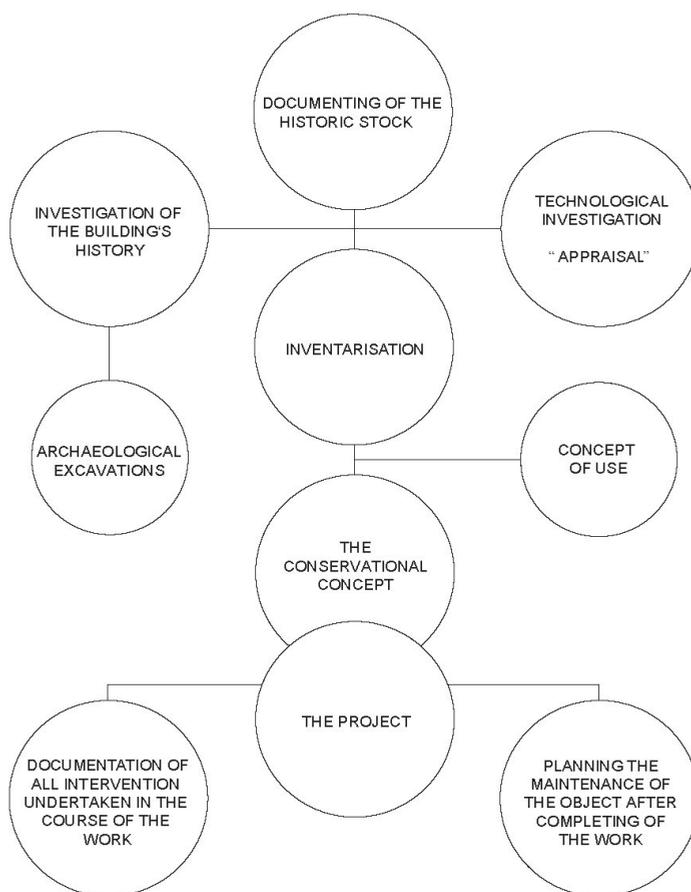
III. 1. Schematic scene of a conservation project

The basic principle underlying the work was the consideration and realization of the monument’s value in accordance with the Management Guidelines for Cultural Heritage Sites. The development and management of a conservation project cannot be compared to other construction projects; as shown by the relevant schematic (Ill. 1).

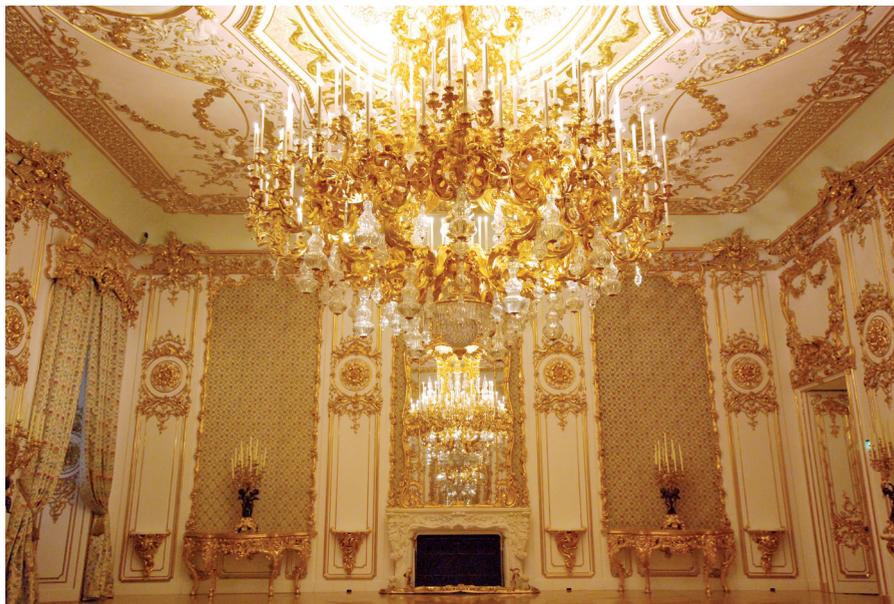
III. 2. Quadratsaal chandelier
II. 2. Kandelabr w Sali Kwadratowej

A particular challenge was posed by the lighting and in particular by the reacquisition of the original chandeliers and wall lights, which were all sold due to lack of funds in the 1960s. It is thanks to systemic research that all of these light fittings were discovered in the possession of a Viennese antiques dealer, who had never associated even the chandeliers with the City Palace. The items were bought back, so that today, with the exception of one room, all the state rooms are fitted with the original Biedermeier chandeliers and girandoles. The painstaking care required to recreate the light fittings can hardly be imagined, as they had – understandably – been dismantled and stored in boxes, some were very shabby and glass components had been broken.

The central chandelier has a diameter of approx. 3.40 m, a height of approx. 4 m and holds 288 candles; the room also contains four corner candelabras and wall lights, so that the room was originally lit by a total of 560 candles. It is immediately obvious that a reconstruction using traditional light sources is not possible, if only because of the heat that would be given off by such a large number of lights in the one room.

Even in the pre-planning stage – so more than five years ago – it was therefore decided that the state rooms at least should be fitted with LED lights, and this at a time when, although nobody was in any doubt as to the future of LED lighting, the necessary light sources were not yet available on the market. A significant factor in this brave decision was the knowledge

that LED light sources have an average life of 50,000 hours, making on-going maintenance considerably cheaper. As a result, lighting planners and companies first developed the required LED candle model in the course of the restoration work, creating an optical and light pattern which could be compared to that of candles in the Biedermeier era in terms of both the brightness and the colour of light. – Today around 1,200 LED candles cast the right light on the state rooms⁵.

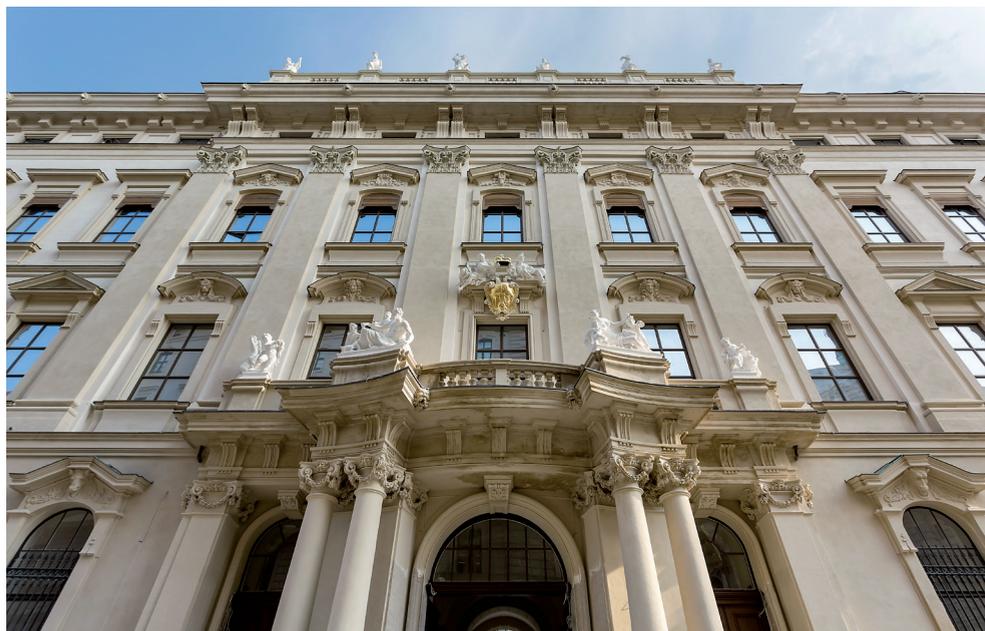
III. 3. Façade of Liechtenstein Palace after restoration
II. 3. Fasada Pałacu Liechtensteinów po restauracji
