MAŁGORZATA MILECKA, EWELINA WIDELSKA\*

## NEW OPPORTUNITIES OF FINANCING REVITALISATION OF HISTORICAL GARDEN COMPOSITIONS IN THE LIGHT OF THEIR CONSERVATION

\* PhD. DSc. Małgorzata Milecka, MSc. Eng. Ewelina Widelska, Department of Landscape Design and Conservation, Faculty of Horticulture and Landscape Architecture, University of Life Sciences in Lublin.

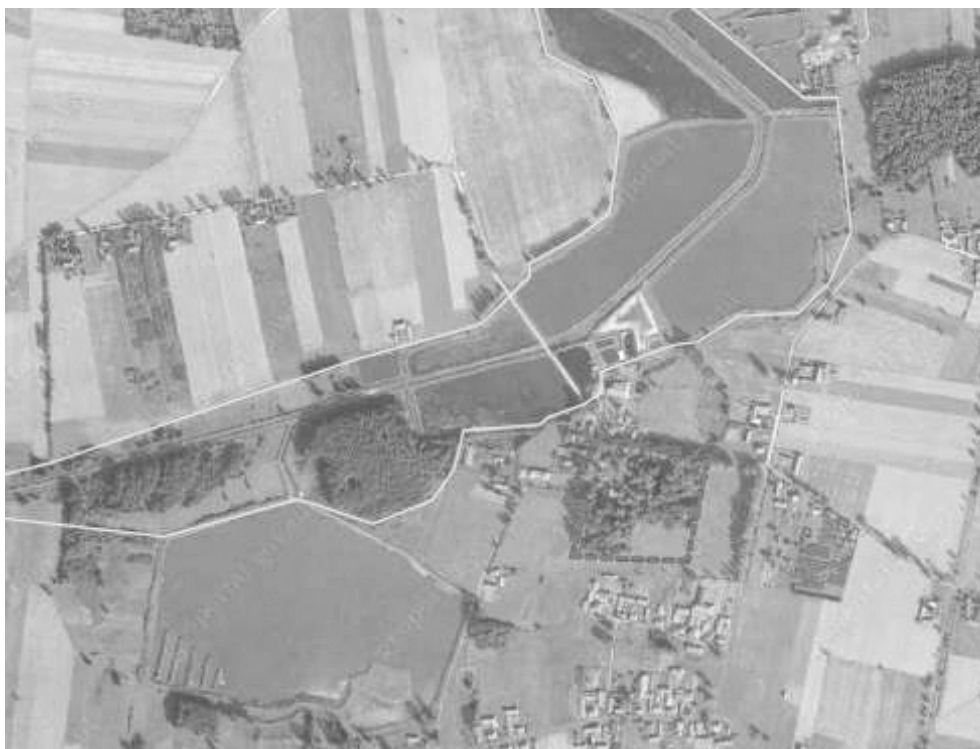
III. 1. Aerial view of Chociw with marked park area and the habitat corridor of the Krzemionka River (authors' own study on the basis of an aerial view from Geoportal – <http://maps.geoportal.gov.pl/webclient>)

The municipality of Czerniewice is a typical farming region with a small participation of service and industry establishments. The existence of historical architecture and natural environment, unspoilt by industry, provide this farming municipality with new paths of development based on service business, agro tourism and recreation. An essential part of its landscape structure is the Krzemionka River, supplying the region's ecosystem and being its main habitat corridor. Next to the valley, in Chociw, there is an old park whose structure has developed over the years. The park, its rich stand and undergrowth, which have not been cultivated for many years, form another vital element that adds to the biodiversity of this farming area. It is this asset, which is the basis of further environmental and landscape analyses, which became the main tenet for the park's revalorisation project.

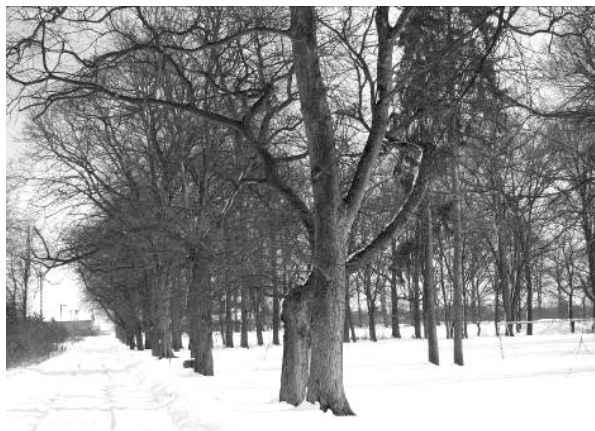
III. 2. A row of old trees along the representative road to the manor (photo by M. Milecka 2013)

The park has not been fenced. Its front boundary is lined with what remains of the old planting. Until 2013 a representative road lined with some preserved poplars complemented with young spruces led to the manor house, but now it has been replaced by a line of linden trees. The northern part of the park is practically deprived of bigger groups of trees, with the density of stand growing towards the southern part, i.e. towards the manor (lines of elm trees and still noticeable relics of hedgerows).

The remains of the lines of trees on the boundaries of the park suggest that the area of the park used to be different. The stand is rich in very old, outstanding specimens of trees, some of them 120 years old. What is left of the old composition are the fragments of the representative road leading to the manor and the tree rows, as well as some remains of the old paths. Less durable plants, i.e. groups of bushes, decorative parterres and the undergrowth were destroyed. At the time of the research, in 2013, almost entire area of the park was covered in undergrowth which developed in the course of natural succession. However, an element of small garden architecture did not survive.

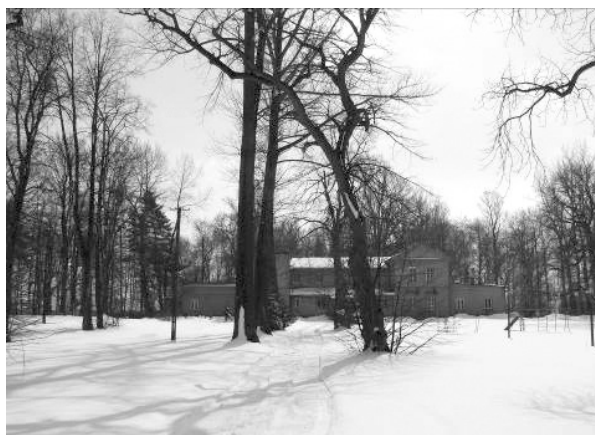
III. 3. Relics of the representative road (photo by M. Milecka 2013)

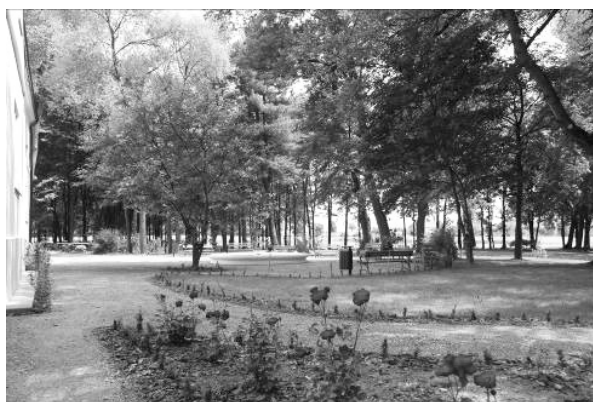
III. 4. View of the main garden area situated in its southern part – after revalorisation (photo by M. Milecka)

The part of works related to the greenery and planting proved to be a complete misunderstanding. Placed in incompetent hands, not only did they not bring the desired effect, but caused further destruction, as was the case with the park's undergrowth which needed only proper maintenance and in turn, without any previous consultation and contrary to the performance and acceptance specifications, was utterly devastated. In its place (especially in the shade of the old-growth trees) grass was sown, which brought a truly pitiful effect. Nevertheless, on the day of the completion of the works the park looked very well, especially for those who had seen the park a year before. Yet, for the authors of the project the outcome was not at all satisfactory, particularly as regards new greenery which was supposed to be the essence of the park.

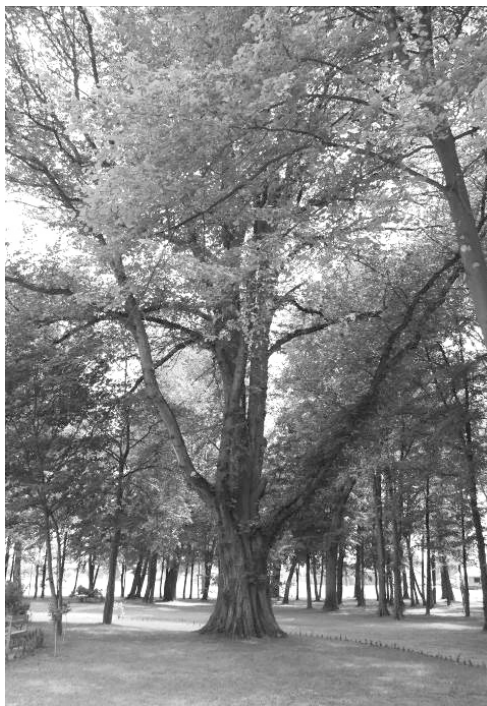
Ill. 5. Impressive natural monuments in the Chociw Park (photo by M. Milecka)

In the Chociw park there are 27 trees registered as natural monuments (Directive No. 4/96 of the 4<sup>th</sup> November 1996 regarding natural monuments issued by the Piotrków Provincial Governor – Dz. Urz. Woj. Piotrkowskiego No. 21, of the 8<sup>th</sup> November 1996).

1. 15 pedunculate oaks *Quercus robur*
2. 6 small-leaved Linden *Tilia cordata*,
3. 2 Weymouth pines *Pinus strobus*,
4. 2 white poplars *Populus alba*,
5. 1 horse-chestnut *Aesculus hippocastanum*,
6. 1 Norway maple *Acer platanoides*.
