## ANALYSIS OF MECHANICAL EFFECTS OF LOW- AND HIGH-FREQUENCY TEMPERATURE CHANGES IN A MASSIVE CONCRETE DAM

The numerical simulation of time evolution of thermal and mechanical fields in a selected section of a massive concrete dam was undertaken by means of the Finite Element Method (FEM) using 3D modelling. Low- (i.e. with time period – year) and high frequency (i.e. with time period – day) cycles of environment temperature variation were considered. The results of the computation confirmed the hypothesis of the vulnerability of the structure to thermal influences and explained the mechanism of the structural defects observed.

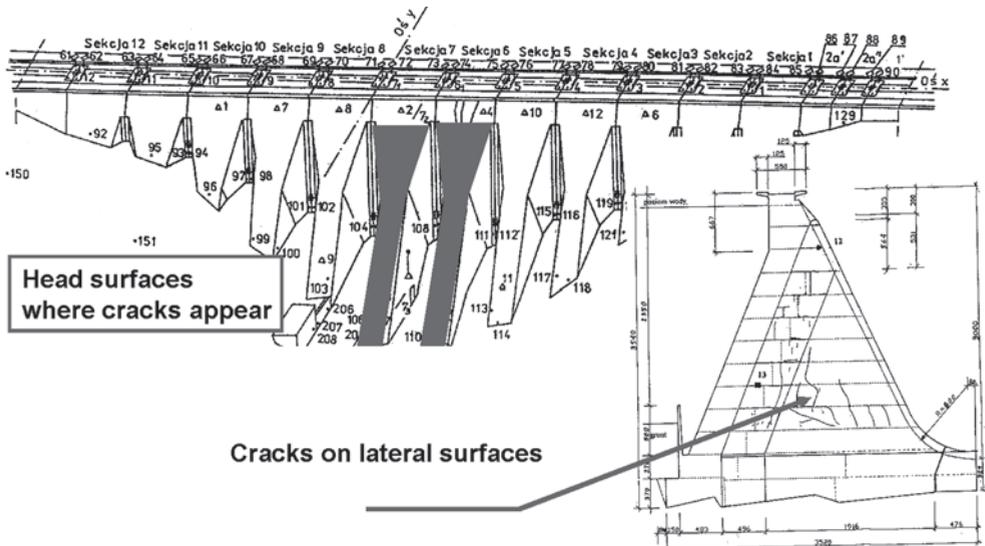
In the year 1998 [3], i.e. after 34 years of exploitation, cracks and fissures in the buttress and transition zones of the highest sections of the dam (nr 6 and 7), as shown in Fig. 1, were noted during a technical inspection. In the year 2013 surface cracking of the concrete was also detected on the head surfaces of the buttress. An explanation for the observed phenomena has become vital for the safety assessment of the dam and design of the rehabilitation procedure. The crack pattern indicates that the possible reason for cracking is the influence of the thermal stress field.

Fig. 1. a) View of the dam from the downstream site b) View of the right wall of the buttress of the 6-th section of the dam with cracks, after [3].

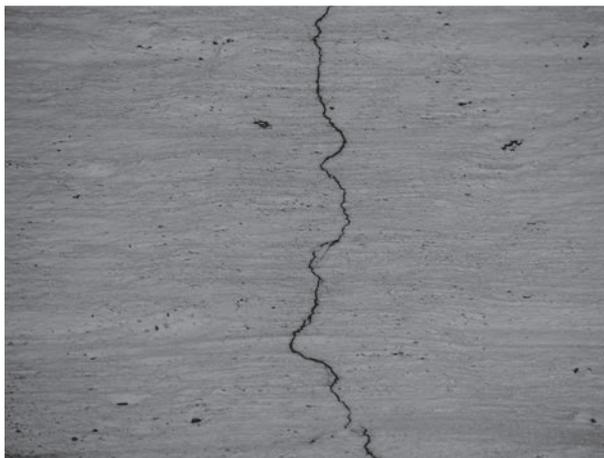
Typical cracks appearing on the head surface of the buttress are shown in Fig. 2.

Fig. 2. Crack on the head surface

In attempting to explain the origin of the multiple cracking of the concrete appearing on the head surface of the buttress, which cannot be result of the yearly temperature cycle, an analysis of daily (high-frequency) environmental temperature variation was undertaken. This is set in the 3D/2D domain which is representative of the whole region close to the head surface. This is shown in Fig. 6. An analysis of high-frequency temperature changes for full model of the section requires also a much denser FE discretisation (estimated size of element in near-surface zone ~10 cm) and time stepping  $dt = 0.1$  day (10 steps per day). These would result in an unacceptably long computation time (few days). Therefore an approximate procedure has been chosen.

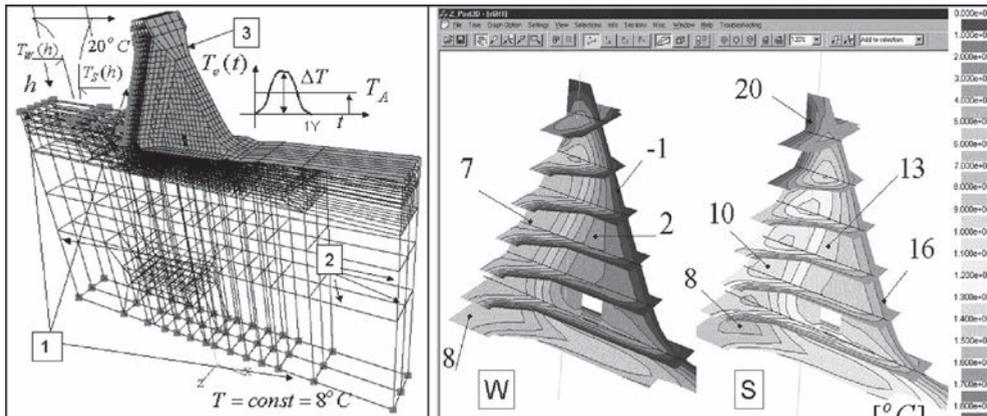
In the analysis, all 3 types of boundary conditions (BC) were used (Fig.3a):

Fig. 3 shows the FE model (rough mesh is shown) with BC used in the 3D analysis of heat problem and the resulting temperature distribution in [°C] in winter [W] and in summer [S].

Fig. 3. a) Heat transfer BC. b) Temperature distribution in winter [W] and summer [S]

The temperature field shown in Fig. 3b and Fig. 4 was obtained during the first computational analysis of the dam, conducted by the first author of this paper in 2002 and reported in [5, 6]. In the present analysis, the FE mesh was densified, see Fig. 5, giving however practically the same output.

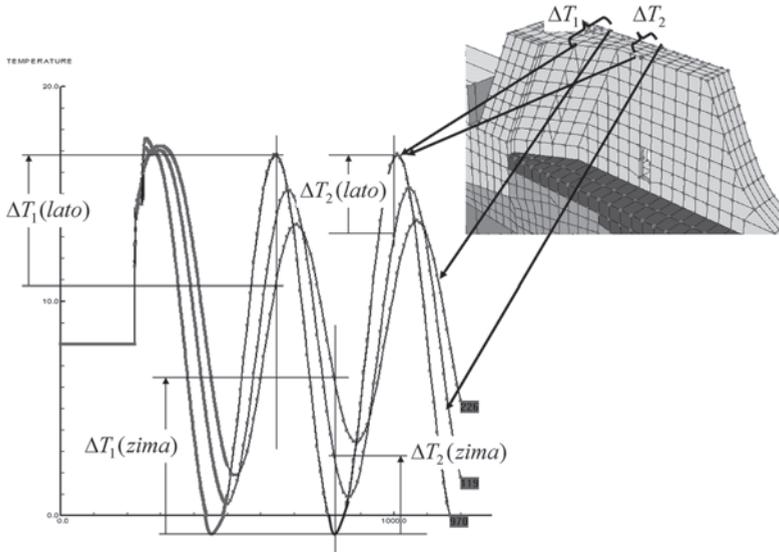
In Fig. 4 the histograms of the temperature in points laying on the surface and in the midst of the buttress are shown. A temperature difference of up to  $\Delta T_1 = 7^\circ\text{C}$  appears between the interior and the side surface of the pillar due to the high thermal inertia of the system, related to large dimension of the structure ( $L_{\min} = 5.0$  m). Moreover, the gradients of these strains in the transversal directions are not constant. This explains the main source of thermal stresses and, in consequence, cracking on the lateral surfaces. As a result of subsequent mechanical analysis, the principal stress distributions are shown in Fig. 5 (compression-blue, tension-red). Due to the symmetry, only half of the pillar is considered.

Fig. 4. Histograms of the temperature at selected points

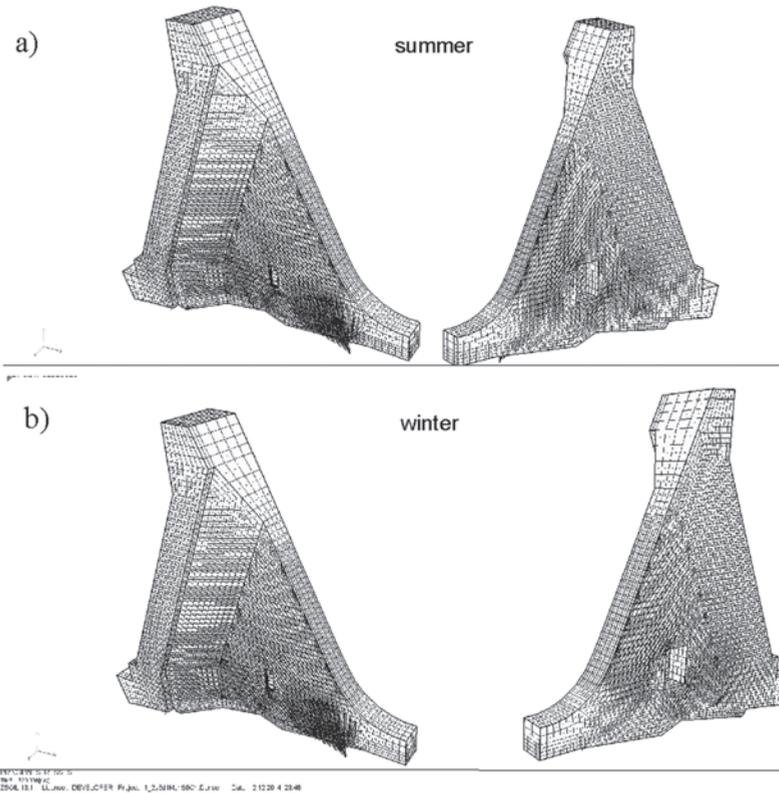
Note, however, that the above low-frequency thermo-mechanical analysis does not indicate any reason for cracking in the head surfaces of the buttress. In this zone, both in summer and in winter, only compressive stresses appear, reaching the value  $\sigma_n \cong 1$  MPa, in the direction tangent to the slopes of the pillar.

Fig. 5 Principal stresses a) in a summer b) in a winter

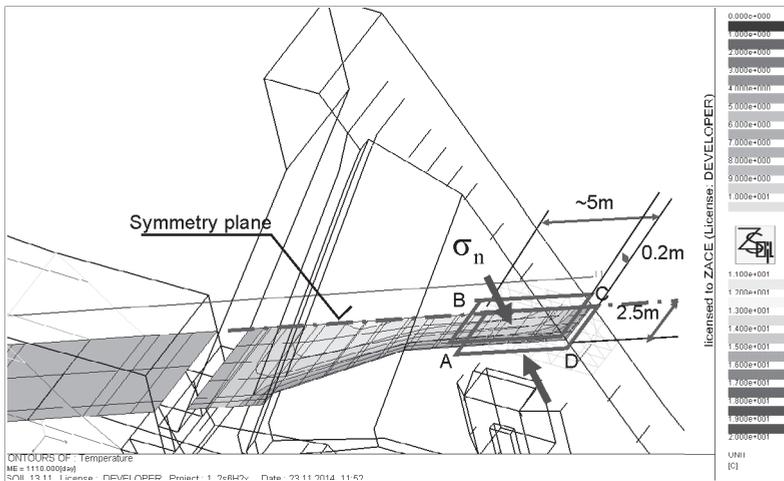
Fig. 6. Localization of the domain for high-frequency thermal and mechanical analysis

- along the segment AB – 1-st type of BC, by adopting nodal temperatures as a function of time obtained from the low-frequency solution;
- along the segment BC, on the symmetry plane, 2-nd type of BC (adiabatic,  $q_T = 0$ );
- along the segments CD and AD, 3-rd type of BC (convection). The function of ambient temperature  $T_{eHF}(t)$  describes diurnal variability throughout the year, with yearly averaged temperature  $T_A = 8^\circ\text{C}$  and  $\Delta T = 18^\circ\text{C}$  being the amplitude of daily averages. A term describing the diurnal fluctuation has been added.

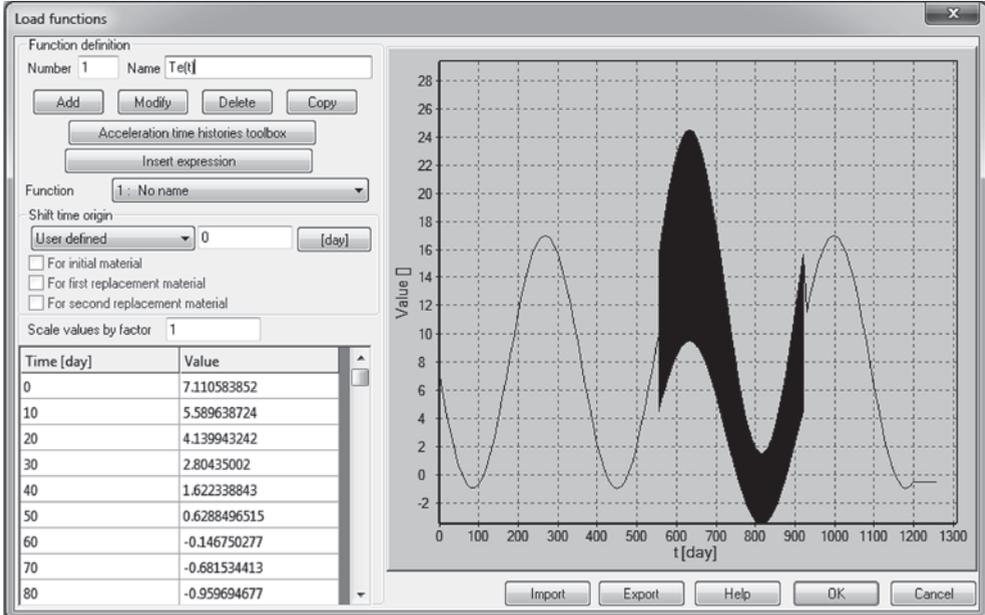
cycle was adopted in the form of a sine wave. The ZSoil screen with the function  $T_{eHF}(t)$  is shown in Fig. 7 with high-frequency variability lasting for one year, from the  $t_1 = 555d$  till  $t_2 = 920d$ .

Fig. 7. Ambient temperature function, with high-frequency part  $T_{eHF}(t)$

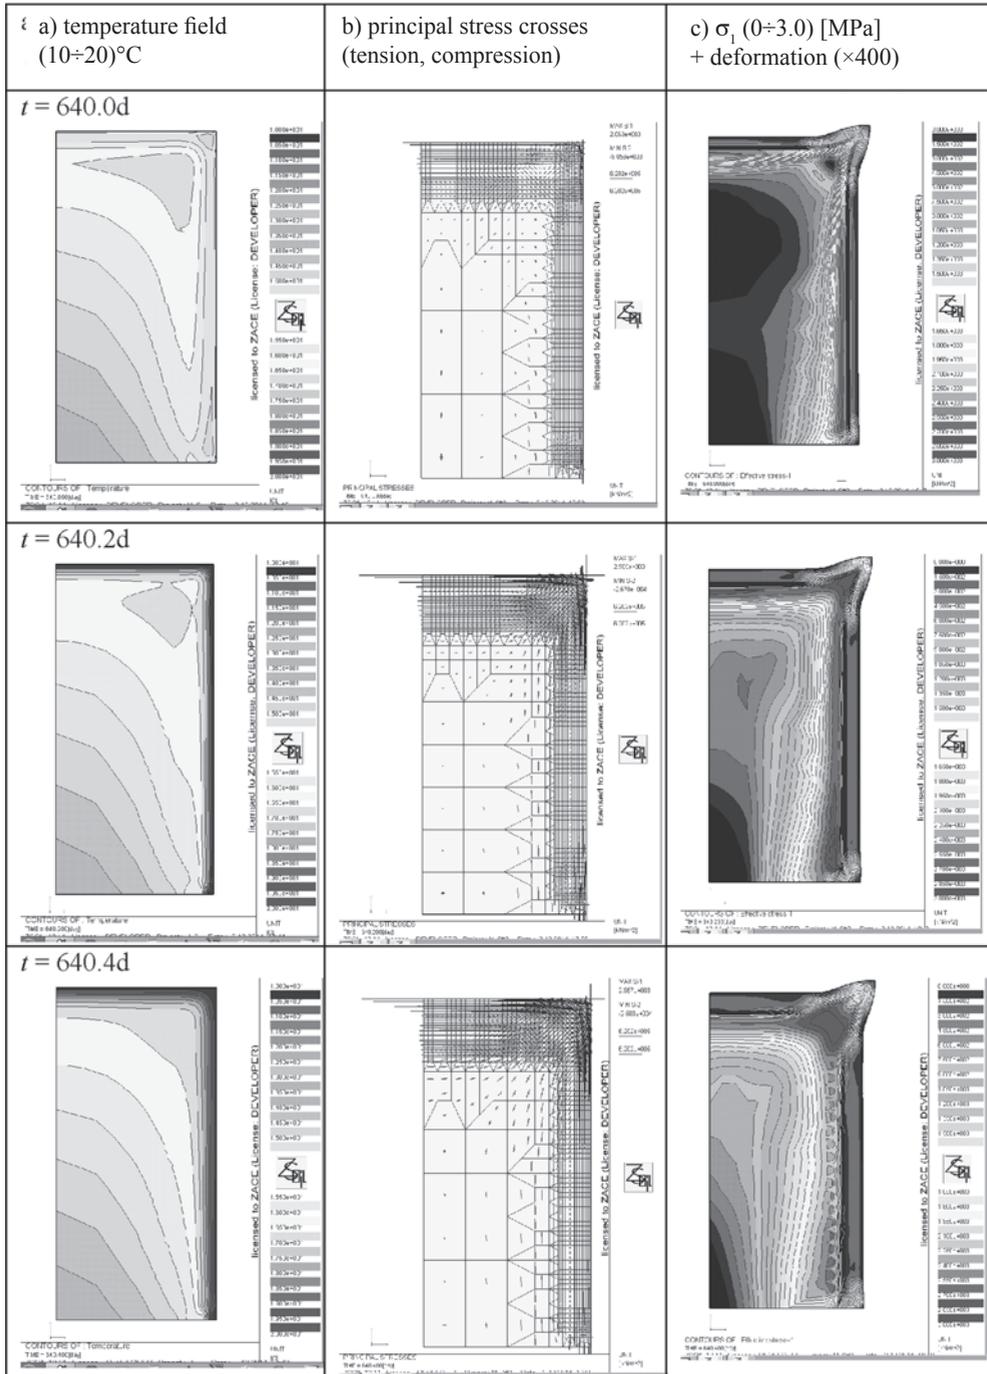
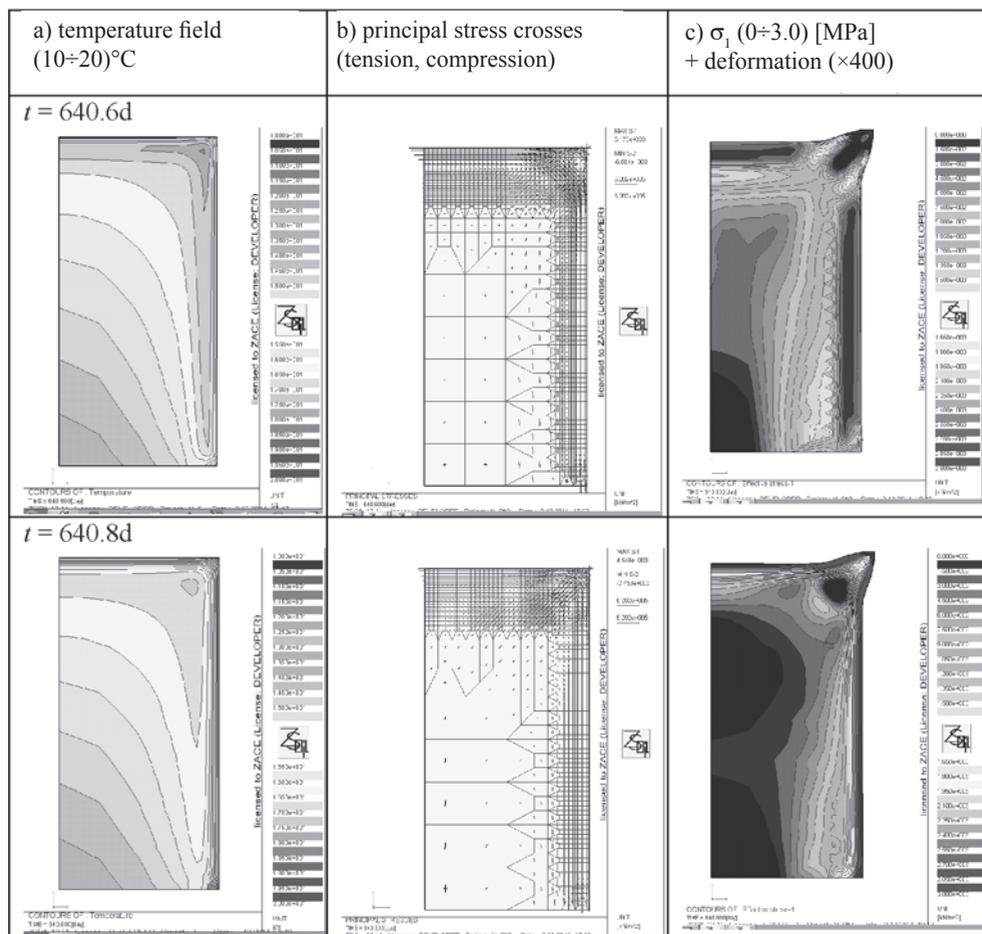
The following results from thermal and subsequent mechanical analysis for high-frequency temperature variation are shown in Fig. 8: map of the temperature field, principal stress crosses, map of maximum tensile stresses. They are given in 5 selected time instances ( $t + 0.0d$ ,  $t + 0.2d$ ,  $t + 0.4d$ ,  $t + 0.6d$ ,  $t + 0.8d$ ), during one selected day ( $t = 640d$ ) in summer. For that day the maximum of diurnal temperature fluctuation has been reached ( $\Delta T_{ds} = 15^\circ\text{C}$ ).

These results explain the essence of the observed phenomena in the following way: the maximum daily temperature zone shifts from the outer surface into the depths of the massif, temperature gradients reach the value  $\sim 4^\circ\text{C}/0.5\text{ m}$  near the surface. The accompanying thermal strains increments  $\Delta \epsilon_{ii}^o(x, y, z) = \alpha \Delta T(x, y, z)$  have a spatial distribution which do not conform to the compatibility equations (are not-kinematically allowed). As the final deformation must satisfy the compatibility equation, the difference between this and the deformation related to imposed thermal strains is the source of a thermal stress field.

In the present case, these stresses reach values close or equal to the tensile strength of the concrete ( $f_t = 3.00\text{ MPa}$ ). These may be one cause of the cracks at the surface zone. The extent of these cracks is about 0.5m in the depth of the massif.

Fig. 8. High-frequency temperature fields and thermal stresses in one daily cycle
