MICHAŁ ZIELINA, ANNA MŁYŃSKA, TADEUSZ ŻABA\*

## EXPERIMENTAL RESEARCH ON DETERIORATION OF DRINKING WATER QUALITY AFTER CEMENT MORTAR PIPE LINING

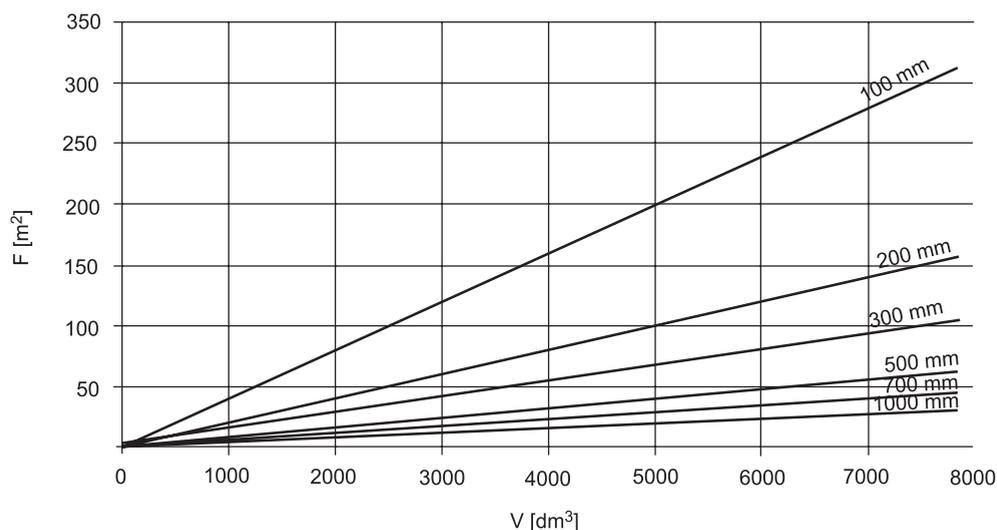
Fig. 1. The dependence of the water volume on the coating surface for a few different pipeline diameters

Pipe diameter is another parameter that is significant for determining the concentration of chemical elements in the water after contact with the cement mortar coating in the pipeline. The volume of the circular pipe section rises proportionally to the square of the inner pipeline diameter, while the inner wall surface of the pipe section rises only proportionally to the diameter. Therefore, the larger the pipe diameter, the smaller the volume of water per cement mortar unit surface area (Fig. 1), consequently the larger the pipe diameter, the smaller the influence of the cement mortar on the water quality [10].

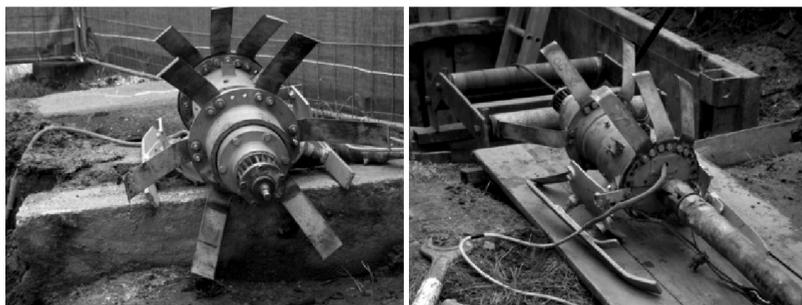
Fig. 2. Rotary head for cement mortar lining water pipes (author's photo)

The renovated water main section is located along one of the main streets in Cracow. The 500 mm diameter pipeline is made of steel and is 725 metres long. In a place where the pipeline passes under the road, a 110.5 metres-long section was renovated by cured-in-place pipe method in which a resin-saturated felt tube made of polyester and nylon fibers was pulled into the corroded pipe. The rest of the 614.5 metres of water main was renovated by cement mortar lining. The process of renovation was preceded by hydrodynamic cleaning with the aim of removal of accumulated pollution and corrosion products. Cleaning equipment powered by a water pump produced a pressure of discharge water of almost 100 MPa. The cement mortar lining process was conducted by centrifugal spreading of cement mortar on the inner surface of the pipe using a rotary head (Fig. 2). The cement coating thickness was equal to approximately 10 mm. The expected thickness of cement lining was achieved by providing a constant flow of cement mortar from the rotary head and its constant rotation speed and suitable rate of movement of the spraying equipment along the water pipe.

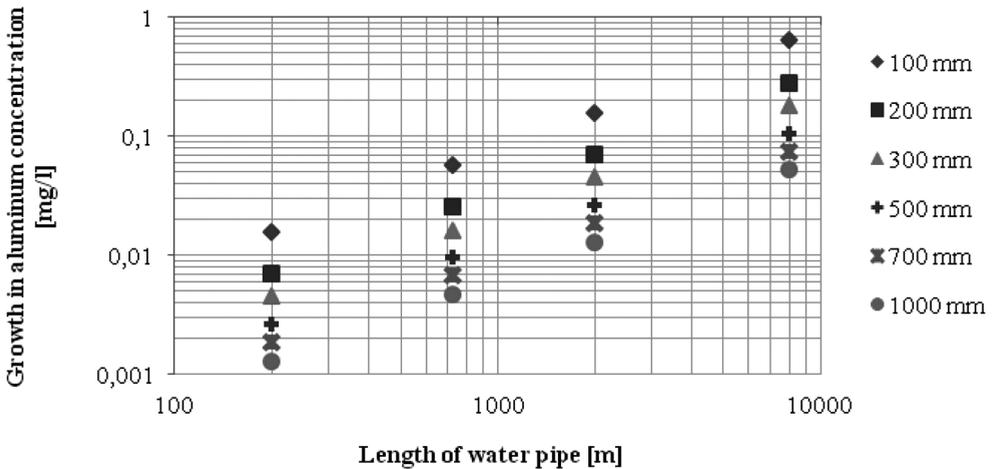
Fig. 3. Growth in aluminum concentration depending on the length and diameter of a freshly renovated cement mortar lined pipe for 0.5 m/s velocity

different possible flow velocities, pipe lengths and diameters. The results of the calculations are presented in Figures 3 and 4. The calculations took into account preceded flushing, 6 days water retention, pressure test and 6 hours of flush. Figure 3 presents the results of the calculation for water drinking flow velocity equal to 0.5 m/s and Figure 4 presents the results for 1.0 m/s velocity.

Growth in aluminum concentration increases proportionally to the length of the cement mortar lined pipe and decreases proportionally to the pipe diameter. So, the smaller the diameter and the longer the renovated pipe, the greater the risk of pollutant leaching from the cement mortar into the water. The higher velocity of water in the pipeline, the shorter contact time with the cement coating. The shorter contact time with the cement coating, the smaller growth of aluminum concentration. So, the higher water velocity, the smaller growth of aluminum concentration. In Figures 3 and 4, two velocities, 0.5 m/s and 1.0 m/s, were taken into account. Assuming an inversely proportional dependence between water velocity and growth in aluminum concentration, a two times smaller growth in aluminum concentration for 1.0 m/s velocity is expected than for 0.5 m/s.

Since the maximum limitation of aluminum concentration in drinking water based on [11, 12] is equal to 0.2 mg/l, the growth in concentration equalling 0.1 mg/l appears to be dangerous and should not be allowed. For 0.5 m/s velocity, such high growth of aluminum is expected to appear if a 200 mm diameter pipe is a minimum 3 km long, or if a 500 mm diameter pipe is more than 8 km long. Of course, allowable growth in aluminum concentration depends on the aluminum concentration in the water produced by the treatment plant and the flushing time period.

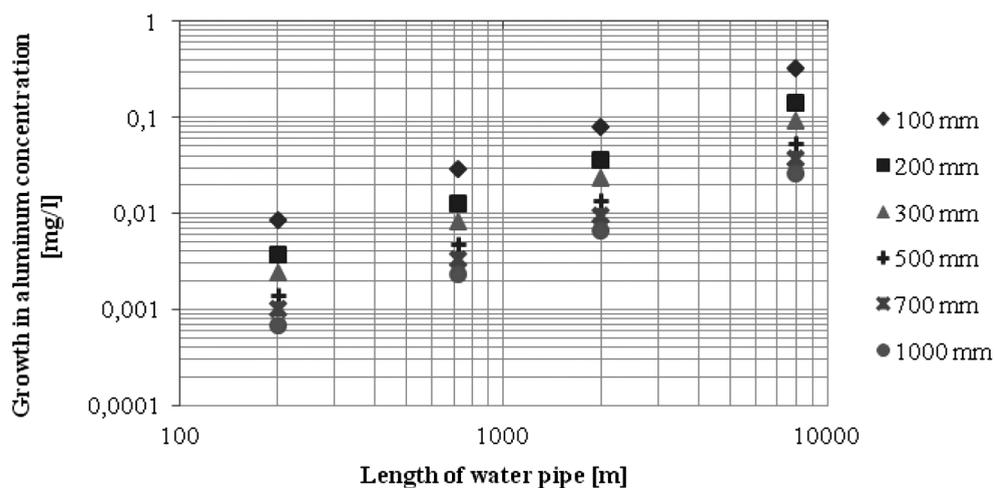
Fig. 4. Growth in aluminum concentration depending on the length and diameter of a freshly renovated cement mortar lined pipe for 1.0 m/s velocity
