BOGDAN DZIEDZIC\*

## VENTILATED PLINTHS OF MODERN AND MODERNIZED HISTORIC BUILDINGS

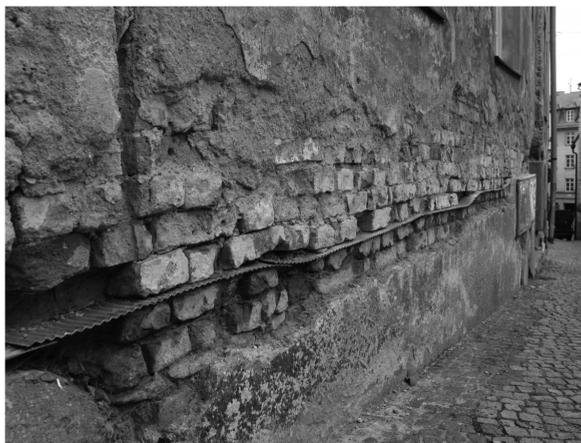
Ill. 1. Corrugated sheet drain membrane, Olomouc, the Czech Republic

drainage wells. These wells allow the land around the building to dry and to uncover the walls at the basement level in the ground with stable humidity, which then allows for the estimation of the structure of the walls below ground level. When no repair work without the knowledge of building physics had been carried out previously, there is no need to remove unwanted masses and materials, which did not fulfill their task of protection against water pressure. At the moment when the drain wells provide moisture stability in the ground and allow full control of the water which flows into them giving the opportunity to pre-dry the walls of the basement, the application of the methods of capillary action shutoff can proceed. One of the simplest and most effective methods is the segmental undercutting of foundation walls from the inside and from the outside in order to introduce sheet or plastic membrane (Ill. 1). Such methods are quite expensive as they require the use of the already mentioned wells, but they ensure full satisfactory protection against capillary action as one of the very few.

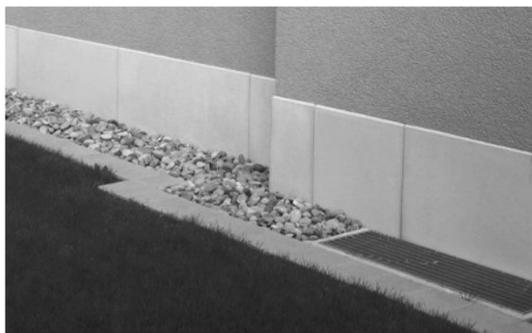
Ill. 2. Sandstone plinth in a new building with a rim of pebbles, Zurich, Switzerland

A professionally made perimeter drain along with a backfill of thick rinsed stones up to the level where the plinth begins, should be an important supportive element complementary to correctly performed horizontal and vertical insulation (Ill. 2).

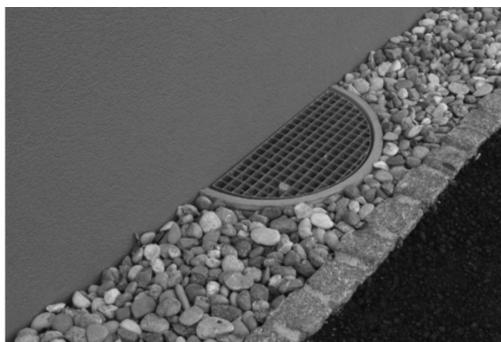
III. 3. Plinth of a new building with the rim of pebbles, Zurich, Switzerland

A well-made drainage enables to drain water from the close proximity to the foundations away to the well and the proper backfill of coarse pebbles allows for stable ventilation and reduction of water pressure on the vertical waterproofing layer. The thick pebbles allow for the ventilation of underground space around the waterproofing layer acting as a layer of perimeter ventilation around the basement walls (Ill. 3 and 4).

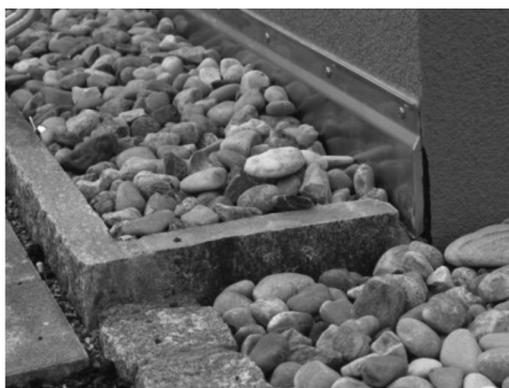
III. 4. Plinth of a new building with the ventilation rim of pebbles, Zurich, Switzerland

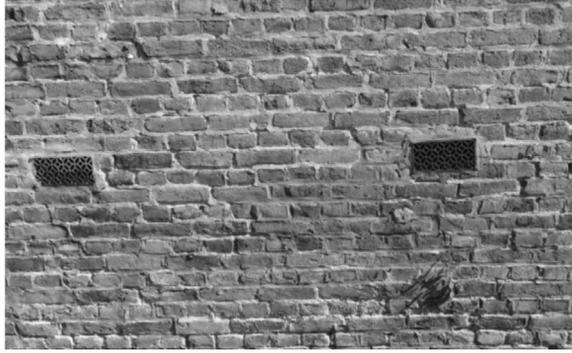
Ill. 5. Modernized plinth of an old tenement house  
(salt glazed decorative airbrick), Amiens, France

In view of the properly executed modernization of the building, in particular the part of the basement, plinth ventilation should be remembered. The said peripheral ventilation layer must be equipped with exhaust openings in the plinth construction (III. 5 and 6).

The study has also shown that properly constructed water insulation, with no outlet of moist air, can have an equally destructive effect on raising the level of moisture zones of walls and plinths. Thus, in the latest building projects (III. 8, 9 and 10) and modernization works of historic buildings (III. 5 and 6), ventilation systems under the plates and plinth elements are introduced. These systems permit some exchange of air, allowing for the free flow of air with high moisture. This shortens the process of evaporation as the moisture

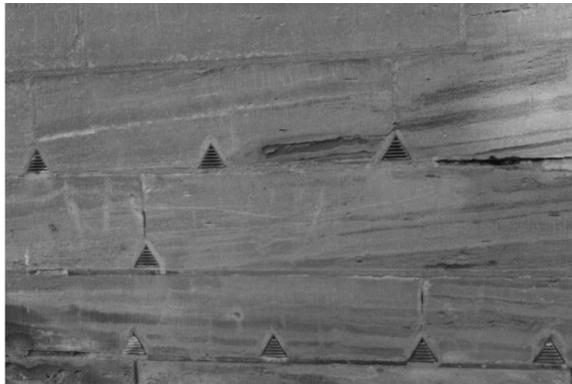
Ill. 6. Ventilated sandstone plinth of the modernized  
gothic cathedral in Bayeux, France

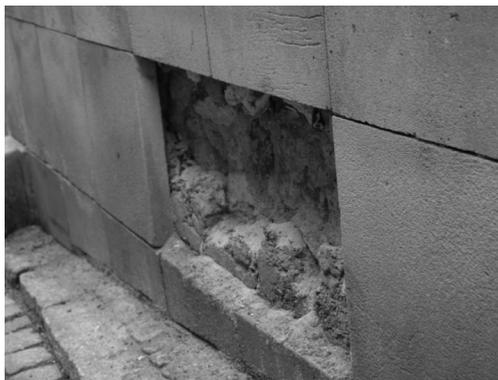
III. 7. Sandstone plinth. Eroded slab due to water vapour condensation, Olomouc, The Czech Republic

It often happens that a properly executed vertical and horizontal insulation assisted by the dimpled membrane does not guarantee the prevention of plinth corrosion. Moist air from underground layers gets into the higher parts of the plinth. Caverns beneath sandstone slabs (Ill. 7), of which old buildings plinths were usually made, fill up with moisture from the water vapour condensation in a year and lead to a change in the dew point of the wall.

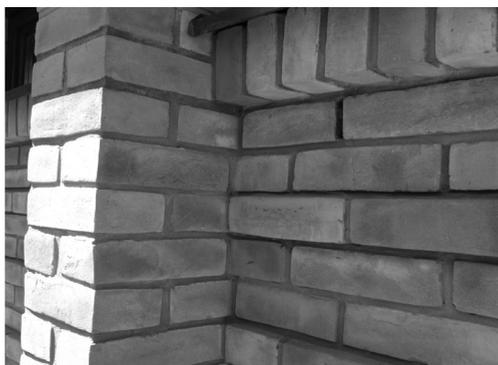
III. 8. New ventilated brick plinth in a monastery, Cracow-Mogila

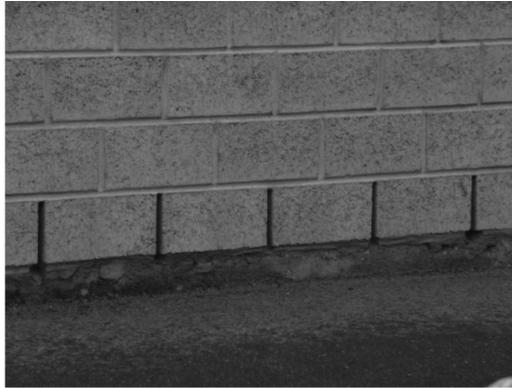
III. 9. Plinth of a new building with vent, Martini, Switzerland

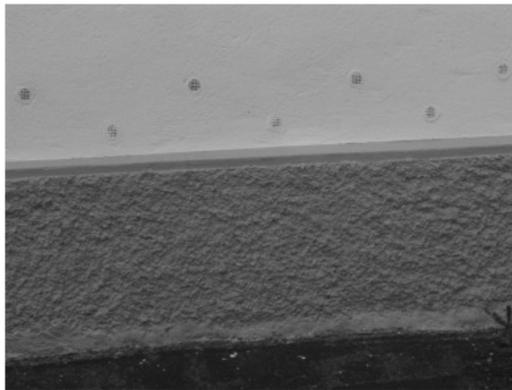
III. 10. Plinth of a new building with ventilation elements, Zurich, Switzerland
