SLOPE TEST LOAD MONITORING IN PURPOSE ASSES SAFETY OF THE CRANE MOUNTING

MONITORING PRÓBNEGO OBCIĄŻENIA SKARPY DLA OCENY BEZPIECZENSTWA ŻURAWIA MONTAŻOWEGO

Keywords: location of the crane assembly, load test of the slope, geodetic monitoring

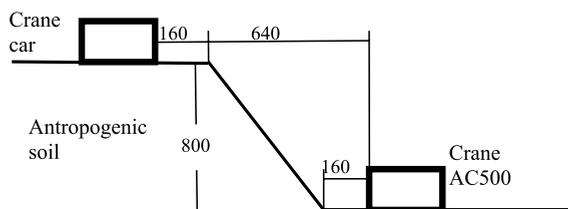
Fig. 1. The crane location scheme

Erecting the new headquarters of the National Polish Radio Symphony Orchestra was conducted in difficult conditions from an organizational point of view due to the limited surface and complex high-rise construction site conditions. Collision-free positioning of the crane, to provide the necessary range for the installation of the roof was only possible from one side of the building, in an area where there was a deep trench. In the excavation that had already been carried out, construction work a smaller crane was also located. Thus, positioning of the AC500 crane assembly had to take place on a high slope. The question arises as to whether such an arrangement is safe and what action is required to check the security risk of the works, to predict the behavior of the slope, to take action to prevent the appearance of the effects of risk. Figure 1 shows a schematic arrangement of the crane bracket.

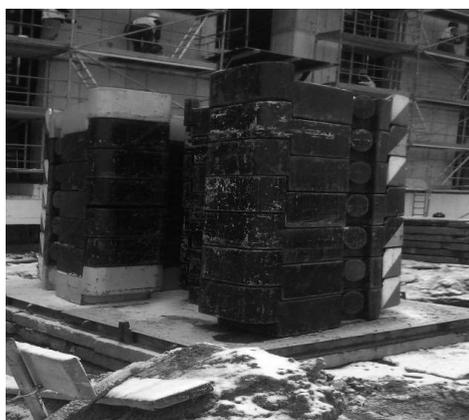
Fig. 2. A test load of the slope with ballast

After laying the ballast in the form of blocks with a total weight of 150 tonnes (Fig. 2) and is made of concrete slabs control measurement readings benchmarks. Schematic layout of measuring benchmarks are shown in Figure 3 In order to allow for the assessment of the impact of the time factor on the size of the displacement of the slope was instructed to withstand the loading ballast for not less than three days. Geodetic control readings were performed in a total time of 96 hours – starting from the pose of full ballast loading. Installation of the DEMAG AC500 hydraulic crane was only possible after no evidence of any instability of the slope was found; proven in the in-situ construction, ie after the ballast load the test substrate.

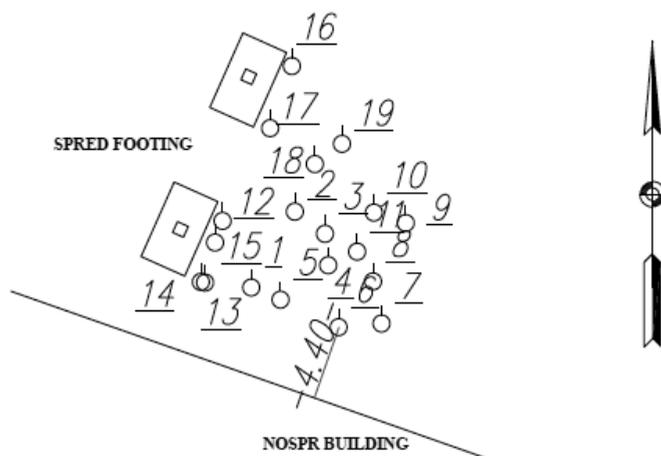
Fig. 3. Distribution of benchmarks on the monitored slope
