DESIGN ERRORS RESULTING FROM THE ADOPTION OF AN INCORRECT MODEL OF A STRUCTURE

The paper presents the design errors resulting from the adoption of an incorrect model of a structure as an example of real tanks. In addition, based on our own numerical analysis of a football stadium, the paper shows the differences between results obtained from the three-dimensional model – and other, more simplified schemes.

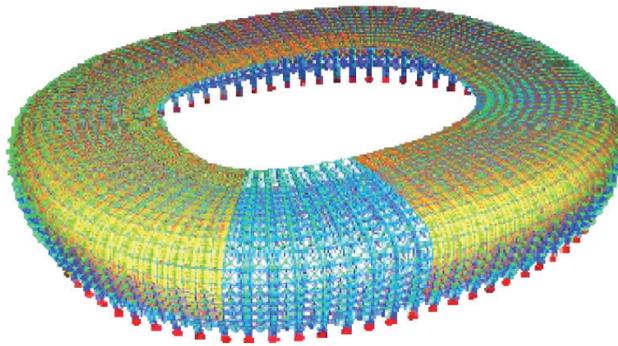
Fig. 1. Model of the structure of the stadium in Gdańsk – SOFiSTiK (5)

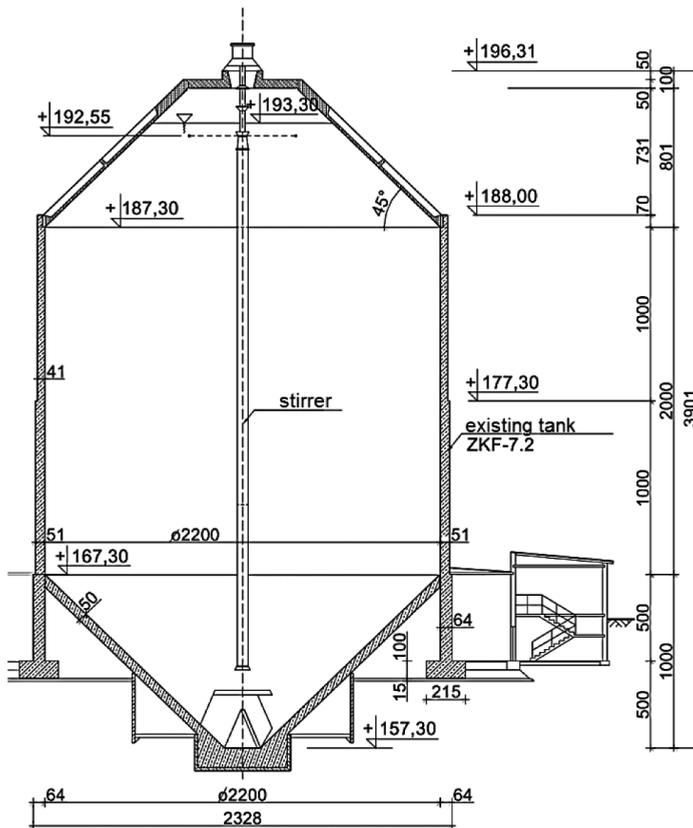
The structure and size of the tank is shown in Fig. 2. The roofing is in the form of a truncated cone, which consists of 44 prefabricated, reinforced concrete hollow-core rib plates, connected to each other with spandrel beams. The continuity of the circumferential reinforcement is provided by welded rods connection in the spandrels, while the L-shaped $\text{Ø}6$ reinforcement every 20 cm, connects the spandrel beam with the prefabricated element ribs (Fig. 3). At the top of the cone, there is a cross-reinforced concrete monolithic slab with a 50 cm thickness and a diameter of 6 m. The roofing is connected with the cylindrical shell by means of a circumferential ring.

Fig. 2. Cross-sectional view of the tank (2)

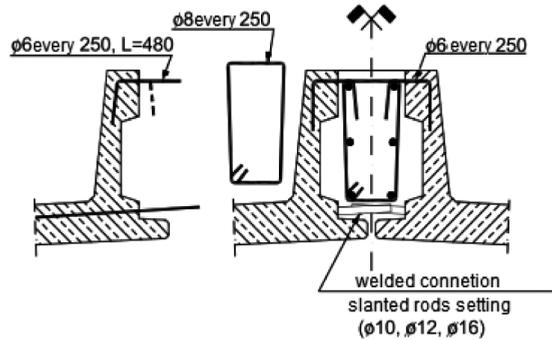
Fig. 3. Detail of the prefabricated elements connection (2)

In this direction, the reinforcement was determined for a scheme of a unidirectional slab supported on ribs and loaded with wastewater pressure at a variable level. The circumferential connections, as shown in Fig. 3, were the weakest link of the roofing structure. The effect was that they were damaged already in the initial phase of use, with a minimum overload (3% of the working load).

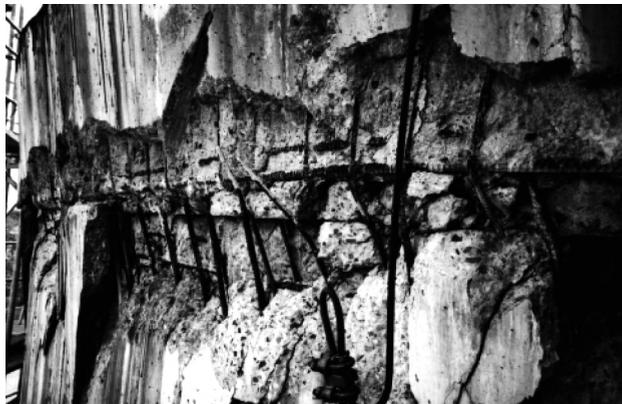
As a result of biogas explosion, the tank suffered much damage and was out of operation. The damage observed included disruption of the connection between the prefabricated element ribs and the concrete topping. Moreover, the connection between the roofing and the cylindrical shell at the height of the ring was torn. Also, the ring was locally torn and displaced outwards along the plane of the connection with cylindrical shell (Fig. 4), the top plate was cracked along the perimeter and the cylindrical shell was cracked vertically beneath the ring.

Fig. 4. Morphology of damages on the top of the tank (2)

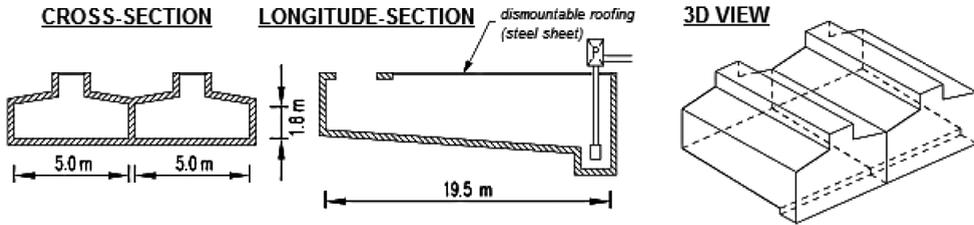
Another example of a structure whose failure was caused by errors at the design stage is an underground double-chamber phosphorus storage tank, insulated with a 10-cm Styrofoam layer. Its geometry is shown in Fig. 5.

Fig. 5. Geometry of the analysed tank (3)

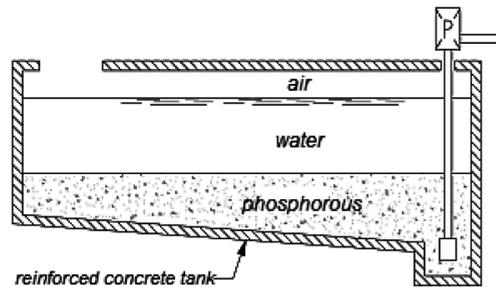
The phosphorus storage technology requires a water seal, with a water temperature of approx. 90° . The diagram of such a water seal has been shown in Fig. 6. Disregarding the thermal load was a fundamental error in the design documentation. In addition, certain technological loads were not taken into account, subsoil was not examined, and an incorrect structural model was adopted, which did not represent the actual spatial work of the tank.

Fig. 6. Water seal diagram (3)

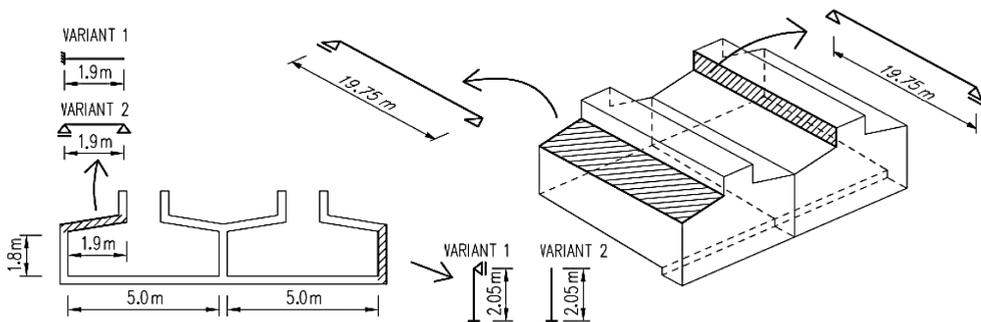
The individual walls of the structure were treated as separate, bent beams, with no axial forces. The adopted model is shown below.

Fig. 7. Static diagrams included in the tank design (3)

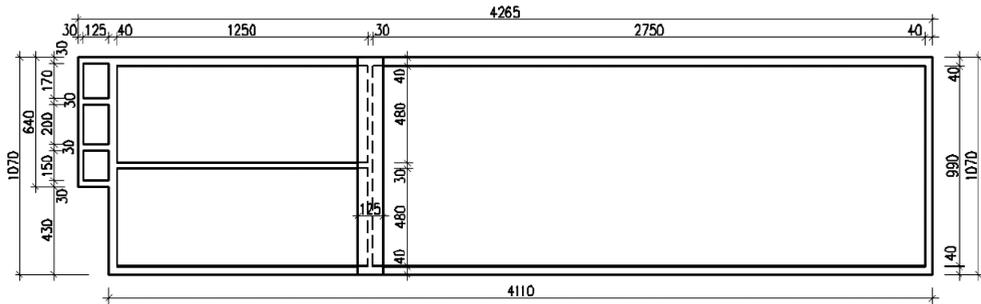
The reinforced concrete sewage tank consists of three chambers: one main and two smaller ones, the dimensions of which are presented in the diagram of tank structure (Fig. 8). The tank height is 4.15 m (calculated from the top surface of the bottom slab). The thickness of the foundation slab is 40 cm, and the thickness of the external walls is 30 cm. Tank walls were reinforced with $\text{Ø}14$ mm mesh every 30 cm in the parallel and meridional directions, which in combination with the foundation slab, was condensed ($\text{Ø}14$ mm every 15 cm).

Fig. 8. Tank diagram – tank projection from the top (4)

The main reason for the tank to fail was the adoption of simplified static diagrams, the omission of the axial forces occurring in the walls, and the omission of temperature effects. The cumulative effect of the errors was that the actual work of the tank structure was not modelled.

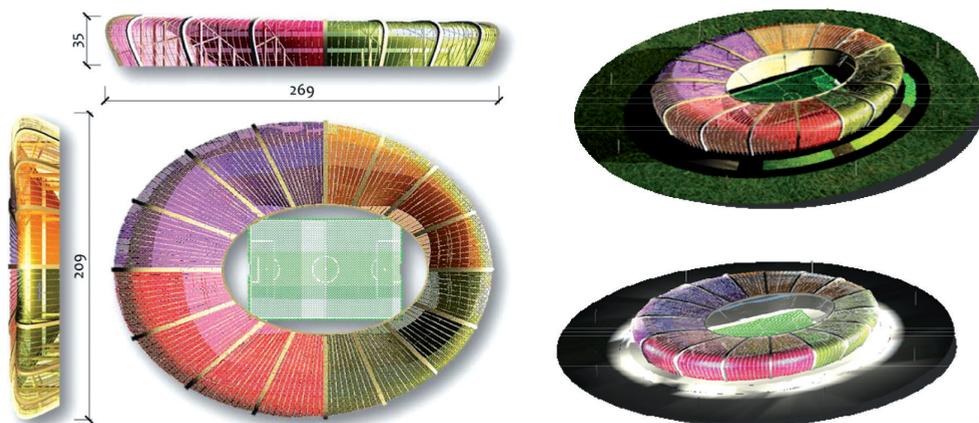
Fig. 9. Size of football stadium and its visualisation (done by the authors)

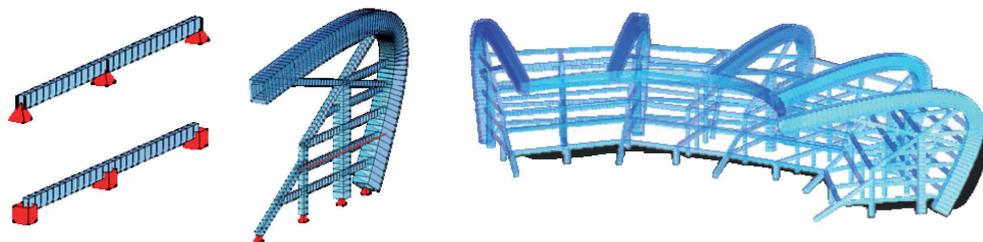
Below an example of a two-span beam as a binding joist of the third floor of the stadium is given.

Fig. 10. Models of the beam support: hinged, fixed, monolithic in 2D frame, monolithic in 3D skeleton arrangement

The 2D frame model changed the nature of the supports at the beam-ends due to different levels of stiffness of the elements connected in the node. The first support behaves in a similar way to the hinge; the second one is similar to the fixed support. However, the respective moment is over 30% greater than the fixing moment of the one-dimensional analysis. Such a result, without taking into account the impact of deformation, would not be possible. In the 3D model, the moments changed not only quantitatively, but also qualitatively – stretching of lower fibres occurred in the first node. The omission of this fact in the calculation is, of course, unacceptable. In addition, over the centre support the value of the bending moment increased by over 35% compared with the 2D analysis and up to 70% compared with the 1D analysis with the supports.

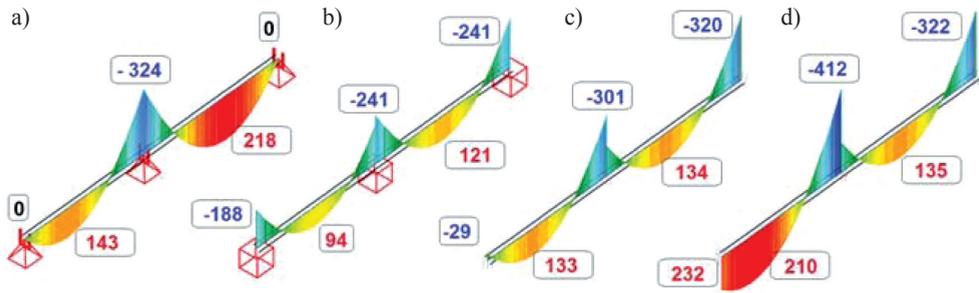
Fig. 11. Bending moments (kNm) for different support conditions: (a) hinged (b) fixed (c) monolithic in the 2D frame (d) monolithic in the 3D skeleton arrangement

This brief analysis leads to a simple conclusion – classic simplifications for complex engineering systems may lead to a qualitatively incorrect assessment of the structural response.

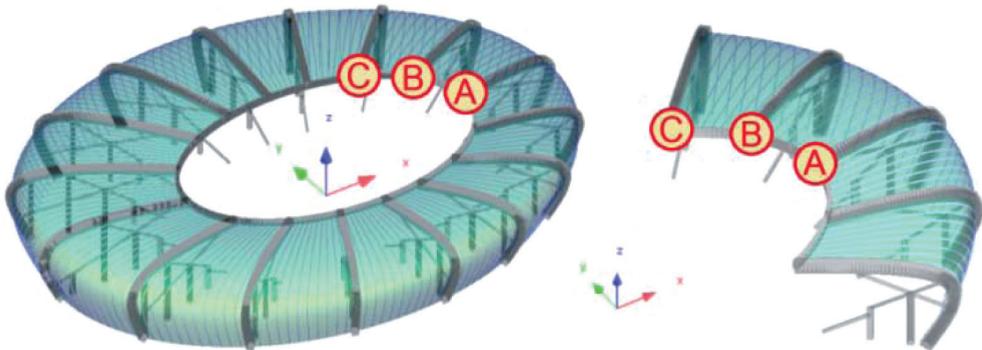
Fig. 12. Three-dimensional model of the total shell and of a part of it

Of course, it is possible to cut out a single 2D frame from the structure, or even an entire section of the structure (as in the figure above) and calculate the displacements using the program. However, such an approach wrongly assumes that girders are operating as cantilevers. In fact, the structure under dead load and other loads, works as a shell ribbed in two directions. The deflections are affected by the stiffness of the roofing structure in the longitudinal direction (perpendicular to the girders axis). To render this phenomenon as close as possible to the actual response of the structure, a three-dimensional model needs to

be used. In our case, even a simplified model (peripheral stiffness ensured only by the shell) showed that the actual deflections are reduced by about 20% from those obtained with the support model.

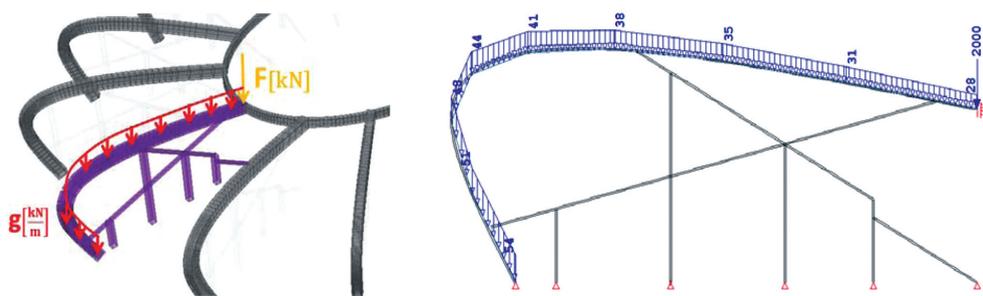
To perform a 2D analysis, the engineer must have greater experience and intuition because it is essential to adopt certain assumptions. When discussing the frame, the question of the connection of the girder with the compressed circumferential ring arises. From among many possibilities, partial fixing was adopted, which allows a vertical displacement, but at the same time induces bending moments. Loading with a shell (the steel truss) was assumed to be as evenly distributed over the girder length, and the weight of the ring was modelled by a concentrated force. In case of the 3D model, simplifying assumptions described above were not made.

Fig. 13. Static 2D frame diagram

Numerical analysis results showed over-dimensioning of the structure's elements in 2D analysis, i.e. the values obtained for the cross-sectional forces of the presented example are on average 20% higher in the 2D than in the 3D model. This is due to the fact that the three-dimensional object has a spatial stiffness, which is not available when 2D frames are chosen for modelling.

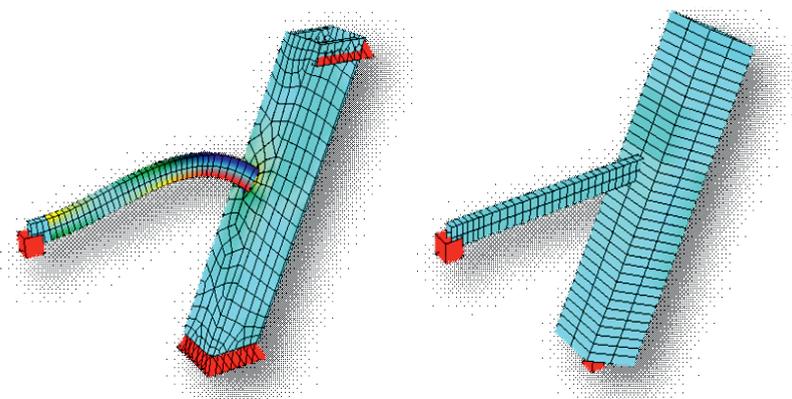
The analysis of the shell model showed that in the connection area, there is a stress state in the girder which cannot be determined on the rod model.

Fig. 15. On the left: the shell model of the girder; on the right: the rod model of the girder
