Elisa Poletti<sup>1</sup>, Graça Vasconcelos<sup>2</sup>

## Seismic behaviour of traditional half-timbered walls: cyclic tests and strengthening solutions

**Keywords:** Half-timber, Cyclic test, Traditional reinforcement, Dissipation of energy, Ductility

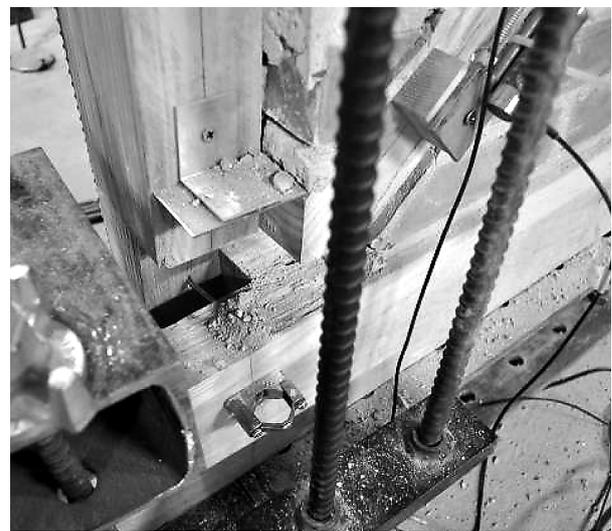
a) UIW3

Fig. 8. Uplifting of posts and opening of connections

For the lower vertical load, the walls do not present significant damage, while it is present for the walls tested under the higher load. In fact, while the walls subjected to the lower level fail due to the opening of the bottom connections, with the vertical posts uplifting at the bottom (Fig. 8a), the higher loaded walls fail due to shear in the central connection (Fig. 8b) with wood crushing. The bottom connections tend to open and uplift in this case too, but they don't control the general wall failure.
