Laser modeling and Structural assessment of a XVIIth century wooden dome

Keywords: Cultural heritage, Wood dome, Structural assessment, Digital photogrammetry, Laser surveying, Orthophotography

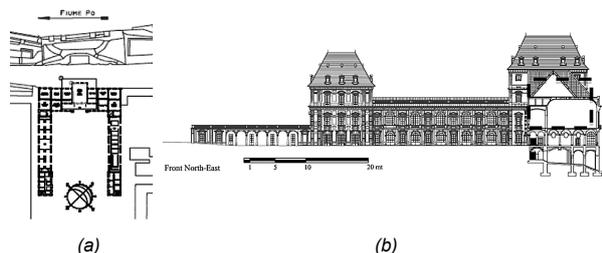
Fig. 1. Plan (a) and longitudinal section (b) of the Castle

ported by wooden tables connected to an elaborated wooden frame [2]. A scheme of the plan and longitudinal section of the Castle is shown in Fig. 1.

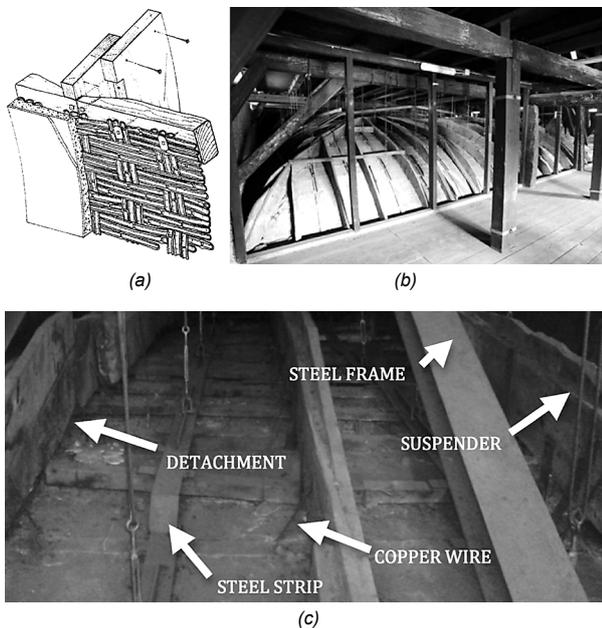
The principal structure is the above wood rib frame (Fig. 2a) that rules the curved shape of the dome. Each rib is obtained joining together two or more shaped planks with steel nails. The wood planks are 3-6 cm thick, 20-40 cm wide, and usually 2-3 m long. The rib spacing is around 0.7 m. The ribs are connected with steel nails to the underlying orthogonal wood joists. Joist section is 5 cm wide and 2 cm height. The joist spacing is around 25 cm. The continuous reed mat is hanging on the joists, and realizes the surface for the subsequent layers of plaster and stucco for the frescoes.

Fig. 2. Scheme of "camorcanna" layers [4] (a), extrados of the Hall of Honor (b) of the Valentino Castle

More recently, in occasion of the celebrations of the first Century of the Italian Republic, the roof structure was renewed and a steel frame structure was placed above the dome, and connected, with vertical suspender cables, to iron strips that were screwed to the little wood carpentry. An overview of the extrados of the dome, with the steel frame structure and the suspenders is shown in Fig. 2b, while some details are shown in Fig. 2c.

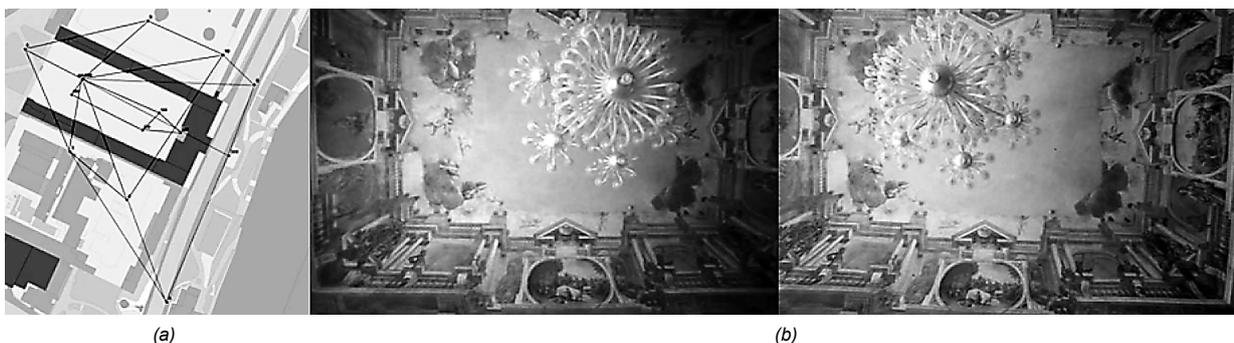
Fig. 3. The first order GPS network fixed for the Valentino castle survey (a), Stereoscopic photographs showing the encumbrance of the chandelier (b)

The presence of the chandelier required the acquisition of redundant data. Therefore, 8 photograms, set in two stripes with a high overlapping percentage (80%), have been collected

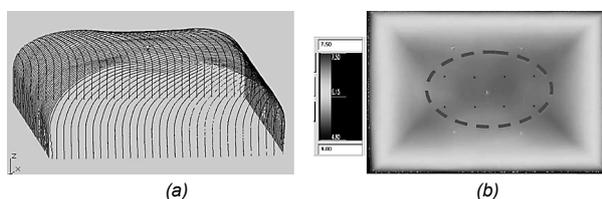
and spotting the anomalies (horizontal and vertical planes, containing straight lines or generatrix polycentric arcs). After a model shape optimization, several sets of the vaults profiles have been extracted using the commercial tool 3D Reshaper by Technodigit (Fig. 4a).

The digital elevation model (DEM – Fig. 4b), in which radiometric code of each pixel represent the distance from a plane, in this case horizontal, have been obtained by a cloud decimation until 5% of raw data (from 20 to 100 million points). This surface representation reveals a probable loss of the original geometrical shape: we can estimate a subsiding area near to the central portion of the vault (red dots oval in Fig. 4b). The loggia vault, located close to the main lounge, presents some more precise geometries; the second DEM, derived from another laser model similar to the one we are discussing [7], shows different clarity of intersection bends; we need to consider that such structure has been under restoration during 1980s. The Dem is also used for the correct photogrammetrical projection of images on a plane, in order to obtain orthophotos or textured models [8].

Fig. 4. A laser profile model for visual control of subsidence (a); The Hall of Honor DEM: the red oval identify the subsidence zone, caps shaped, while the light points are fire detectors and the blue points are the computed locations of photograms projection centers (b)

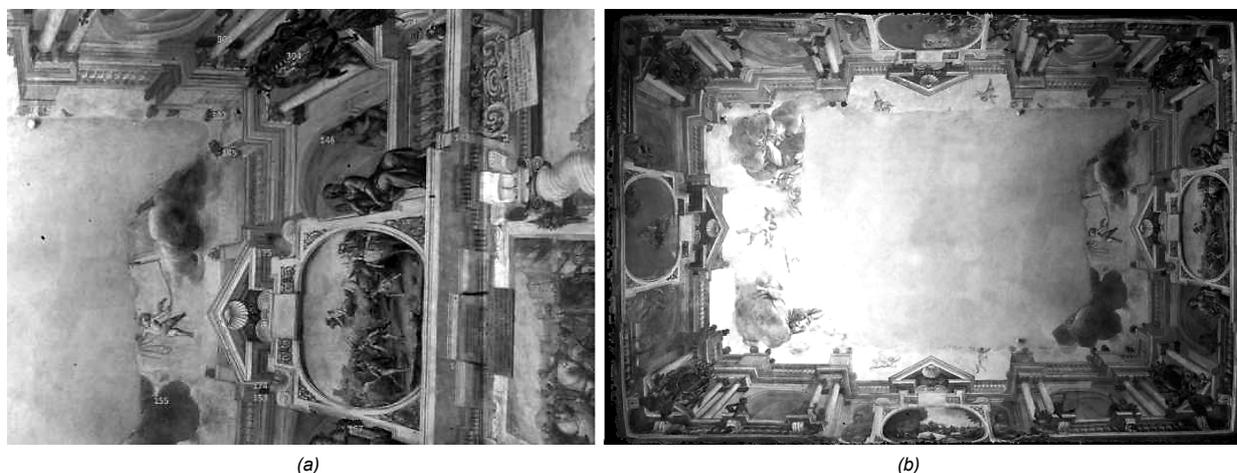
The photogrammetrical survey has been planned in order to generate an orthophoto of the dome [8]. The non metric camera (Canon EOS 1Ds mark II, sensor CMOS 24×36 mm 4992×3328 pixels) with the calibrated objective (focal length 20.42 mm) has acquired photograms from the floor; since the max shot distance is about 9 m, the embracement is about 16.2×10.8 m, i.e. close to the Hall size.

Fig. 5 Control points for the computing of photogrammetric solution are natural points on the frescos (a); final orthophoto of the dome, obtained by a mosaic of projected photograms (b)

with the pixel size equal to 3 mm (Ground Sampling Distance – GSD). The orientation solution, performed by a single block processing (bundle block method) has provided very good results, with round minus square on measured points equal to few millimeters.

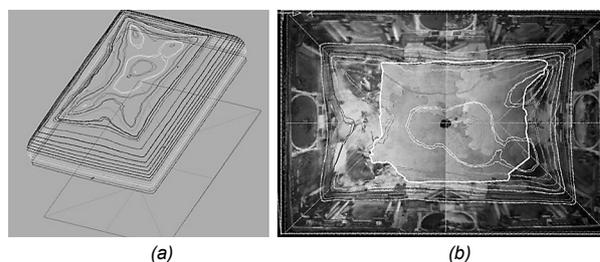
The analysis of section profiles, set in the horizontal or vertical planes and compared with the hypothetical original bending arcs, has enabled the chance to ascertain several localized deformation of the vault, in the order of few centimeters. The surface contours of the vault, computed with a equidistance of 5 cm, presents an high level of geometrical aberration (Fig. 6a), that must be considered in the structural assessment of the vault.

The location of height anomalies obtained from the laser model, and the shape of the frescos abruption outlined in the orthophoto, are in good agreement when results are reported to the same reference system (Fig. 6b).

Fig. 6. Superimposition of the referenced orthophoto with the section profiles (a); final orthophoto of the dome, obtained by a mosaic of projected photograms (b)

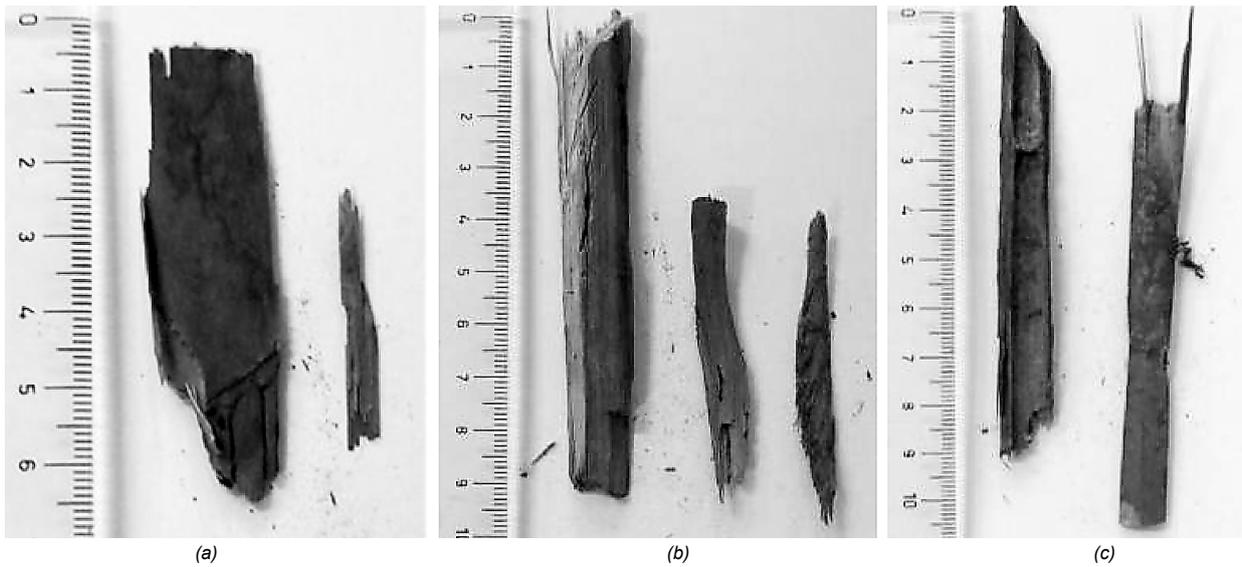
Fig. 7. Sampling of the wooden structure for identification: from the joist (a); from the rib (b); from the reed mat (c)

use, as well as building techniques and craftsmanship from existing structures provides knowledge that can be applied to present-day construction. A quality assessment begins with the assessment of the members and components that make up the structure as a whole. Samples for the identification of species concerning the main structural elements of the vault are shown in Fig. 7.

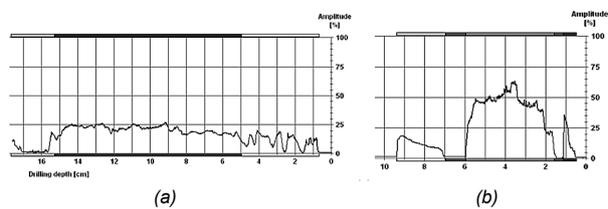
The resistographic drilling sampling was performed on some of the ribs of the vault, drilling in the two directions perpendicular to the rib longitudinal axis, respectively along the rib height and along the rib thickness (Fig. 9). When drilling is performed along the thickness (Fig. 9b) of a rib composed by three planks, the two discontinuities are clearly recognizable.

Fig. 9 Resistographic drilling diagrams: along the rib height (a); along the rib thickness (b)

The amplitude in the resistograph diagrams reveals a wood quality ranging from good to very good. It is worth noting that such values are hardly ever encountered when testing nowadays poplar samples. In fact, historical poplar, grown without intense cultivation program, and in a quite colder environment with respect to nowadays, is a much tougher material.

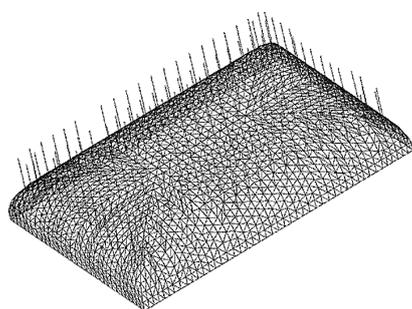
A preliminary Finite Element model has been set up in order to understand the structural behaviour of the vault. The model accounts for the exact geometry of the vault, according to the laser survey and the corresponding initial geometry extrapolation. In addition, all the main structural components are considered: the shell and the rib frame, as well as the iron strips and the suspenders. The shell represents the behaviour of the plaster, of the reed mat and of the wood joists in a single equivalent layer. The linear analysis has been carried out with the finite element program DIANA [9]. The overall mesh of the model is shown in Fig. 10a, while the table in Fig. 10b reports the basic mechanical assumption.

E [Pa]	ν	ρ [kg/m ³]	type
Suspenders	2.1E+11	0.3	7850	truss
Ribs	8E+9	0.2	510	beam
Strips	2.1E+11	0.3	7850	beam
Vault	13E+9	0.3	1500	shell

Fig. 10. Mesh of the model (a); mechanical parameters of the model (b)

The model is subjected to the only action of dead load due to gravity. At the present stage, the nonlinear behaviour of the materials has not been considered yet. Therefore, the model can provide only preliminary information about the structural behaviour of the dome.

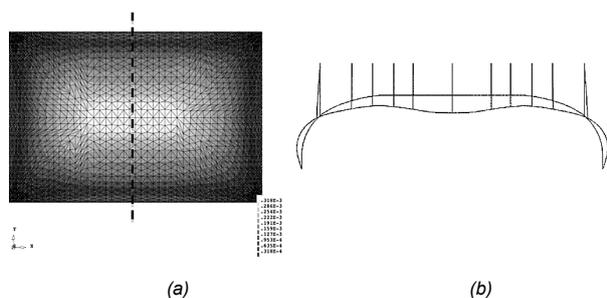
Nevertheless, the obtained deformed shape, shown in Fig. 11, is in agreement with the anomalies measured by the laser-scanning survey. In particular, the annular region around the big chandelier appears to be the most prone to displacements. On the other side, the suspenders, which are located in the outer region of the vault, are not elongated at all. This corresponds well with the evidence of the survey, which reveals that many of them have actually lost their tension.

Fig. 11. Contour plot of vertical displacements (a); transverse section with vertical displacements (b)

This information is combined with some non-destructive analyses and with the structural survey of the extrados of the vault. The preliminary finite element model is confirmed as far as the deformed shape is concerned, and also the loosen suspenders can be localized.

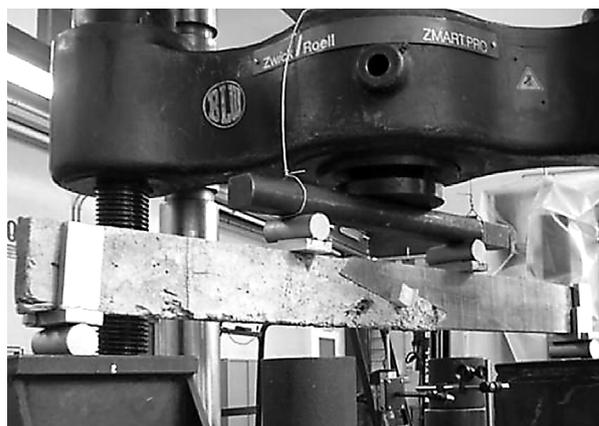
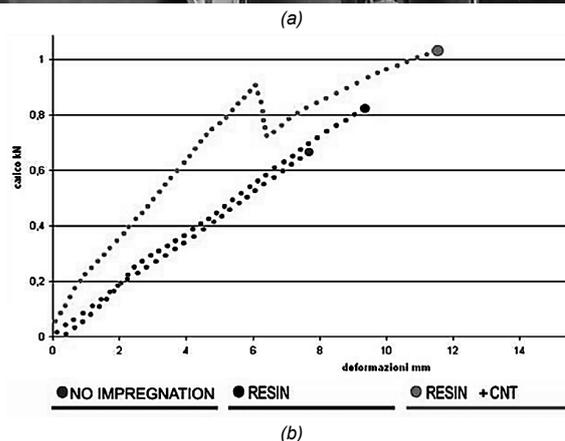
Fig. 12. Bending tests and scheme for the mechanical resistance on timber "Jupiter" joints (a); load displacement diagram: positive effect of the reinforcement (b)

The extraordinary maintenance of the vault has to be carried out adopting very low invasive, but very innovative techniques. This is the subject of the project M.A.N. for the consolidation and reinforcement of historical wood structures with nanoreinforced composites. Such techniques have been already tested on historical samples, characterized by the classical "Jupiter" joint connection [10]. The first results obtained from the laboratory tests are quite promising, as can be seen by Fig. 12b; therefore the technique will be applied in the described case study.
