## MINING INFLUENCE IN THE AREA OF THE PSZCZYNKA RIVER AND THE METHOD OF RIVERBED RESTORATION

#### Abstract

This paper investigates the influence of extraction on the surface in the area of the Pszczyńska river. The mining-enhanced terrain subsidence hitherto observed has also resulted in the subsidence of the riverbed and its embankment. Some geotechnical solutions are proposed, including the reconstruction and repair of damage to the existing infrastructure. Such measures should facilitate a proper flow of water in the riverbed which is similar to a natural flow.

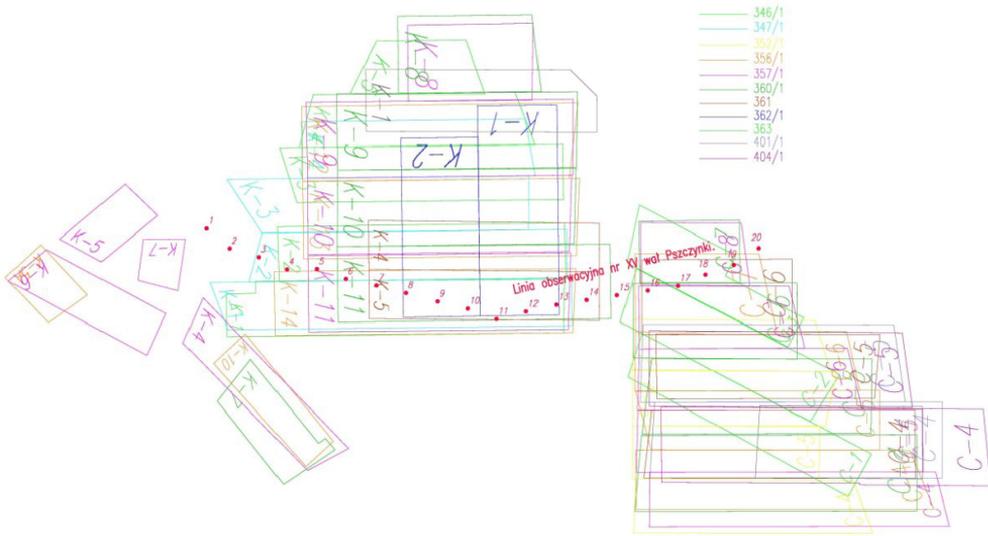
Fig. 1 presents the distribution and shape of particular walls and the positioning of the measurement line where the measurements were performed from 2005.

Fig. 1. Excavation in the area of the Pszczynka river and the positioning of the observation line

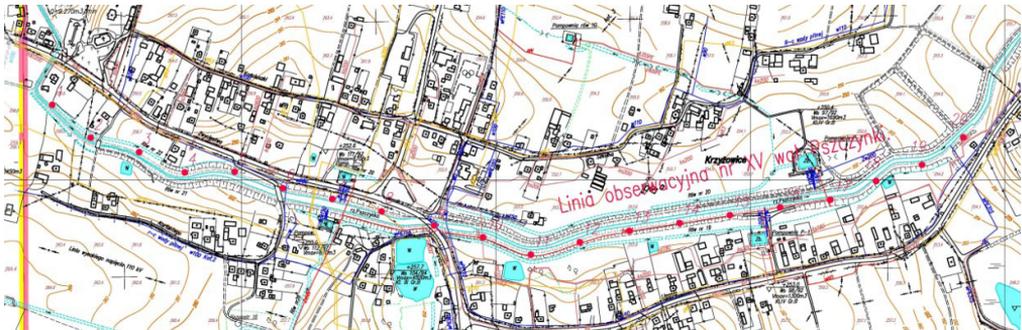
The process of subsidence trough formation, enhanced by mining exploitation in the discussed area, is documented by the results of geodesic measurements from the period June 2005 to June 2018, taken on the observation line running along the riverbed. The 2,000-metre long line consists of 20 geodesic points fixed at every 100 meters on both sides of the river,

Fig. 2. Map of the analysed area and positioning of the measurement line

relatively close to the riverbed. A map showing the distribution of the measurement points in the area of the bed of the Pszczynka river is presented in Fig. 2.

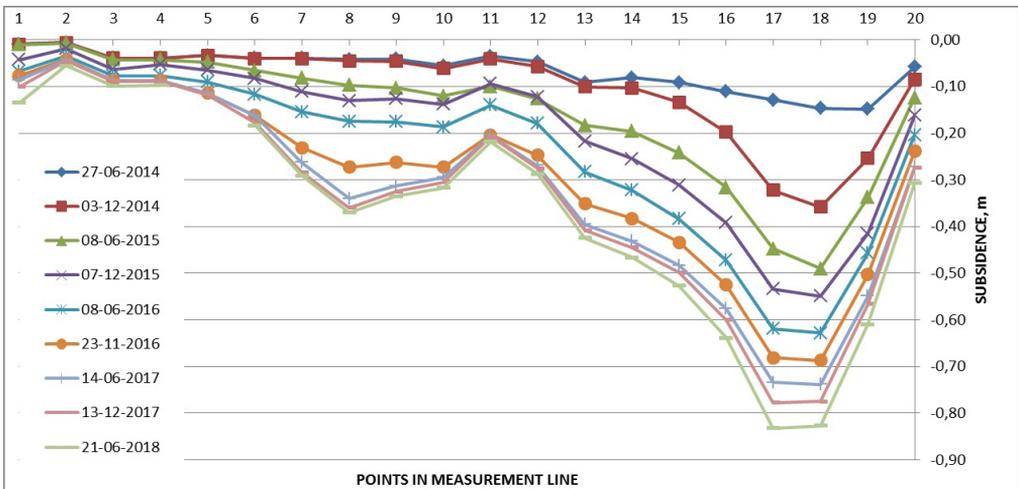
Altitude monitoring made it possible to interpret the process of deformation. During the period of thirteen years of measurements, the maximal surface subsidence created two subsidence troughs with maximum values of 1.79 m at point No. 8 of the measurement line and 1.79 m at point No. 18 of the line. Undoubtedly, the walls excavated directly below the measurement line exerted a crucial impact on the volume and rate of subsidence. The values of subsidence at the end points of the observation line in the western direction indicate a clearly decreased character (subsidence of only 0.23 m in point No. 1). The subsidence also decreases eastbound (0.73 m at point No. 20). In the middle of the measurement line (point No. 11), the subsidence reached the value of 0.28 m. The increase of subsidence is presented in Fig. 3.

Fig. 3. Subsidence of points on the measurement line in the area of the Pszczyńska river in the period June 2005–June 2018

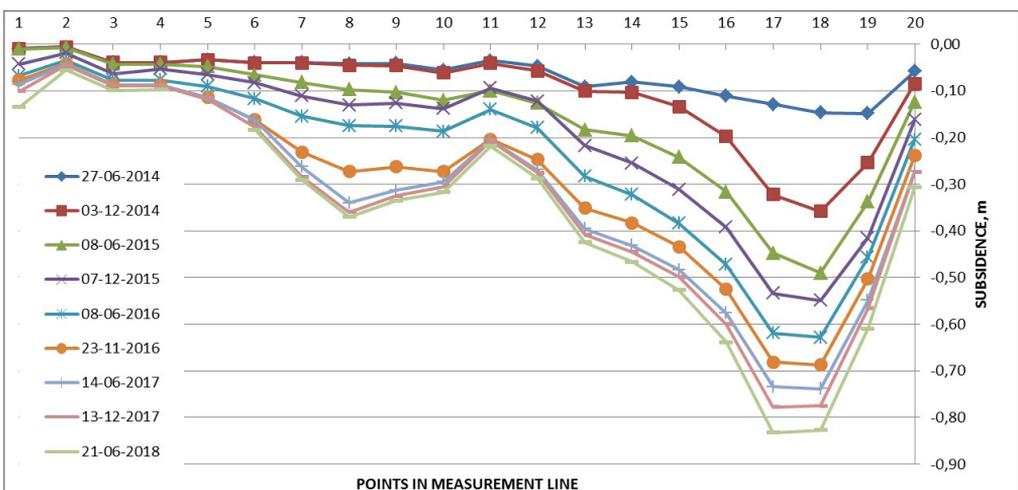
In the next stage of the study, a period of low exploitation intensity (November 2013–June 2018) was examined, when five longwalls in three seams (362/2, 401/1 and 404/1) were extracted. Surface subsidence reached values approaching 0.83 m at points Nos. 17 and 18, which is presented in Fig. 4. From the west, mining exploitation was also executed in walls C-4 and C-5 in seam 401/1, and in walls C-4 and C-5 in seam 404/1, which is illustrated by the subsidence at points Nos. 15–20 on the measurement line. The line remained within the exploitation area, thus it is impossible to record the entire subsidence trough. The measurement line indicates the reduction of subsidence mainly from the west side (exploitation of one wall K-1 in seam 362/1).

Fig. 4. Subsidence of points on the measurement line in the area of the Pszczyńska river in the period November 2013–June 2018

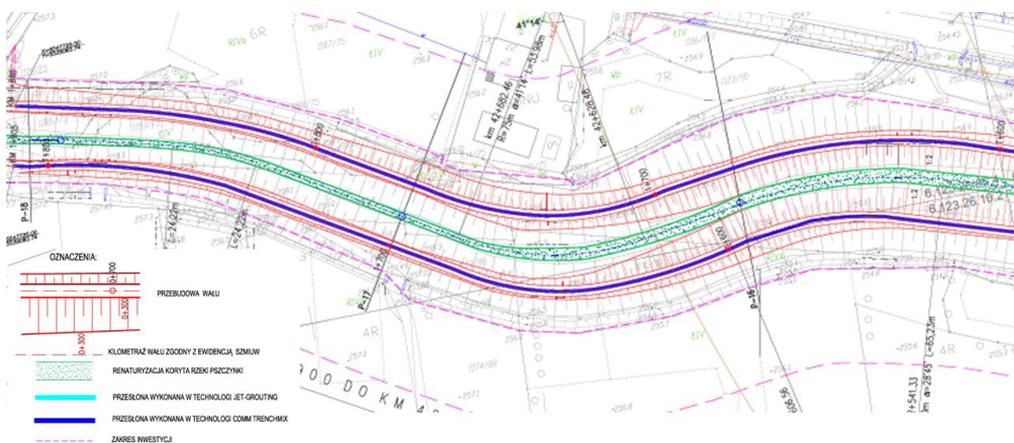
investment buildings. Therefore, particular construction works were undertaken in relation to the requirements of flood safety, proper water streaming in the riverbed and the preservation of satisfactory technical and hydraulic parameters (Fig. 5). These works involved [5]:

- ▶ repairing the existing flood protection dykes by raising the levee crowns and levee corpus development;
- ▶ raising and broadening the left and right levee corpus in the section with the largest surface subsidence;
- ▶ rebuilding perimeter drainage ditches colliding with the renovated flood protection dykes;
- ▶ rebuilding outlets of the drainage pump stations;
- ▶ rebuilding and protecting the hitherto-existing technical infrastructure intersecting with the flood protection dykes and the Pszczynka river in the discussed section.

Fig. 5. Fragment of topographical map: river section with inserted design solutions

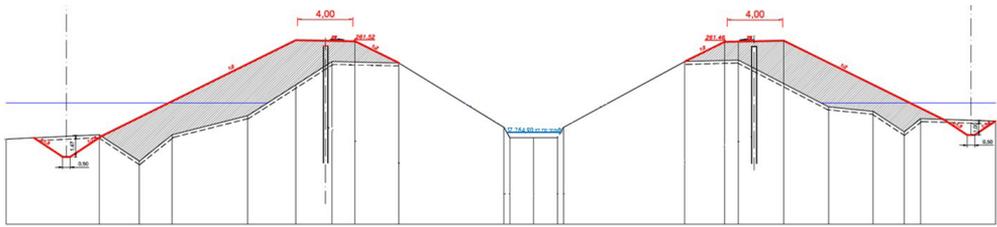
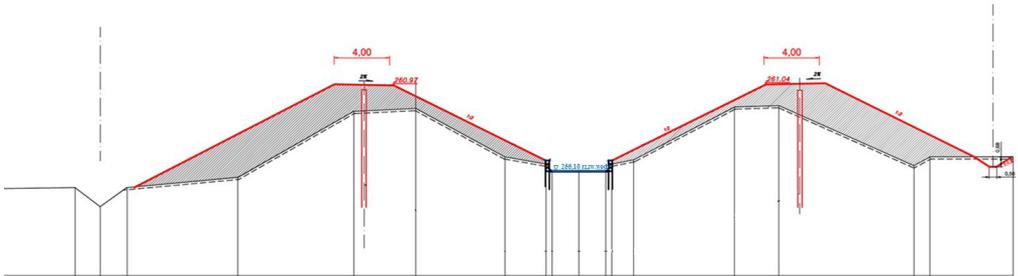
Irregular subsidence of the riverbed of the Pszczynka causing a lack of adequate gravitation slope and serious decrease of the water flow velocity resulted in the creation of the water ponding zone. Therefore, the riverbed had to be stabilised in the section of 1 km. As part of the re-profiling process, the river bottom was reinforced with stone riprap, assuming a waterbed with a maximum bottom width of 4.0 m (Fig. 6) [5].

Fig. 6. Characteristic cross section of left and right embankment of the river Pszczyńska

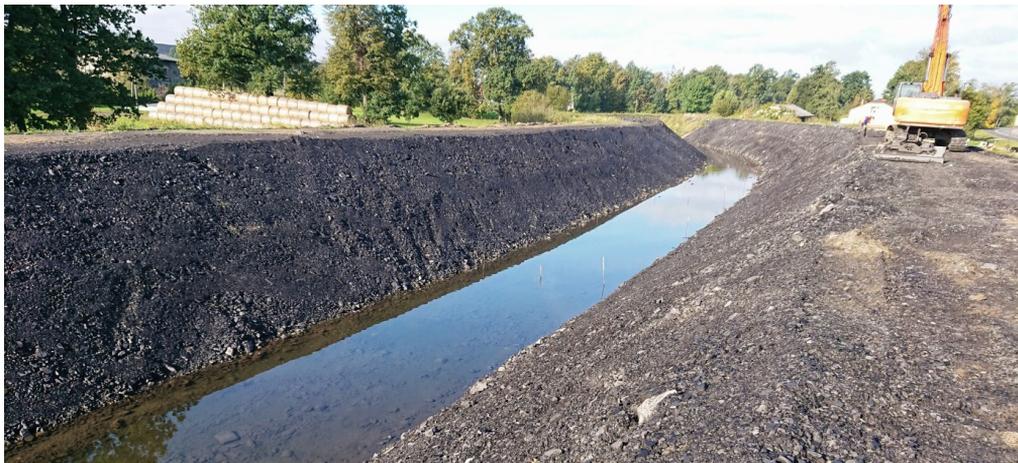
Fig. 7. Preparing riverbed for restoration

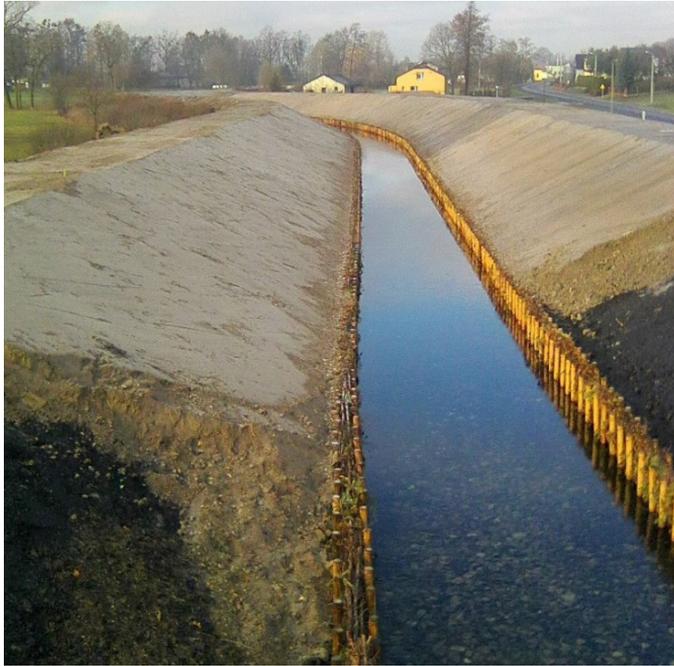
The restoration of the river Pszczynka will help to re-establish the original width of the riverbed from before the process of subsidence. In order to make the works in the river current possible, a special steel wall will be installed at depth of 6.0 m along the riverbed and the works will be executed on both sides of the wall interchangeably (Fig. 8).

Fig. 8. Topsoiling of slopes

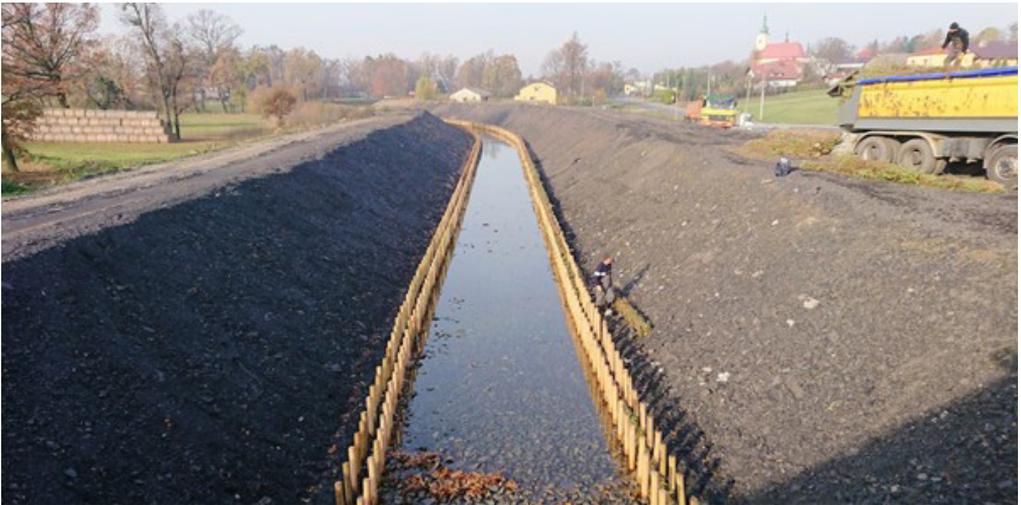
As soon as the river bottom is stabilised, the Ø 25 cm fascine bands will be laid between the rows of poles in the footing of the slopes, followed by the formation of the slopes of the embankment. Most importantly, the fascine will be made after the river bottom stabilisation and before forming the embankment slopes. The total length of the fascine bands is 4 km (Fig. 9).

Fig. 9. Fascine construction works

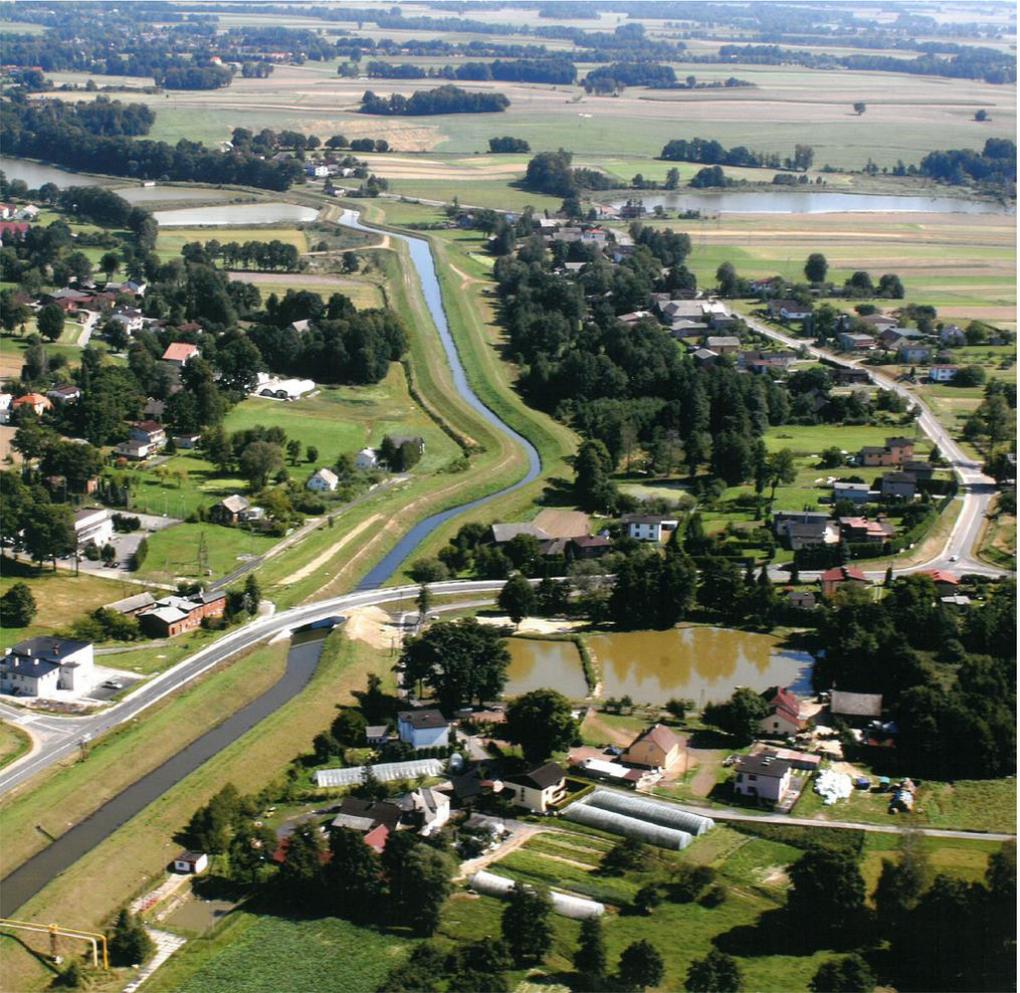
The method of restoration presented above proved most effective in the given local conditions (Fig. 10).

Fig. 10. Completed works after the most recent restoration
