## THE REASONS FOR HYBRID LIGHT POLE FAILURES – AN ANALYTICAL STUDY

This paper presents the results of a durability analysis of a hybrid light pole. The developed model includes a supporting structure of a pole with photovoltaic panels, a wind turbine and a boom with a light case. Due to various operating conditions, these poles may be characterised by a different configuration of the mutual spatial distribution of individual components. This results in a large diversity in the analysis results, hence the fact that the research was performed for the selected configuration variant for which the most unfavourable operating conditions were forecasted. In order to reveal potential stress concentration areas, a series of structural analyses was applied using the finite element method. As part of the work, changes to the supporting structure of the pole were proposed and to confirm the possibility of improving the resistance of the structure, additional analyses were conducted.

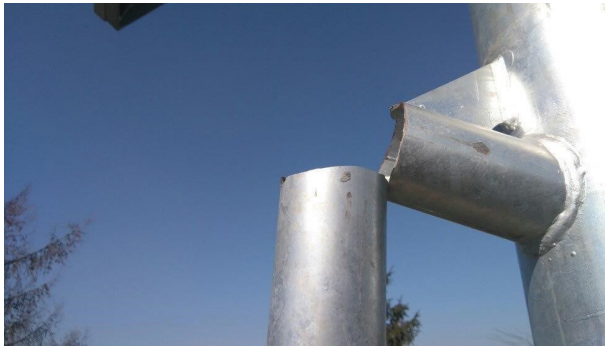
Fig. 1. Photograph of sample damage

The inspiration for addressing the problem of hybrid poles was the suggestion of one of the manufacturers. They described a situation in which a proportion installed poles were damaged in the form of fatigue cracking of the boom arm bearing element after a short period of time (Fig. 1). The attempts made by the manufacturer to improve the structure by adding a reinforcing rib, shown on the picture presented below, did not bring the desired results.

It is interesting that this damage occurred in only a few cases. After obtaining assurance that the same production conditions were maintained for all poles, the assumption was made that the individually selected configuration of modules mounted on hybrid poles could be the cause of damage.
