Barbara Zin

Institute of History of Architecture and Monument Preservation, Faculty of Architecture,
Cracow University of Technology

ON THE EUROPEAN CULTURAL HERITAGE ROUTE OF RESIDENCE OF THE RADZIWIŁŁS – CASTLE IN OŁYKA, VOLHYNIA

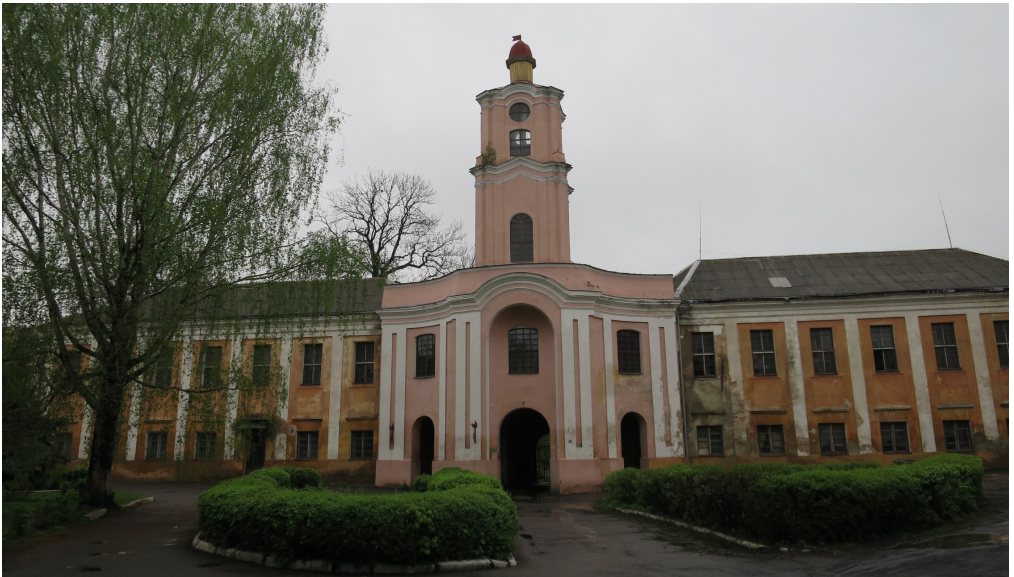
Fig. 4. Castle in Olyka, entrance gate, condition as of 2019 (photo by B. Zin)

progresses, and these processes result in the loss of authenticity of the palace complex with its entire historical legacy. Splintered and crumbling fragments of the bastion walls, leaking roofs of the edifice of the palace, collapsed ceilings, cracked and damp walls – this is a picture that depicts an annihilation of a centuries-long heritage. Current protective repairs carried out by the hospital staff are performed without any supervision of building and conservation services and unfortunately they are not capable of stopping the degradation of this valuable monument of architecture. Architectural heritage of the bygone centuries is slowly sinking into nothingness. The technical condition of the buildings calls for an immediate intervention of building and conservation services. For this purpose, it will be necessary to compile scientific documentation, opinions of experts on monument conservation and construction, as well as architectural studies. Developing in details each phase of transformations of the castle complex will allow to restore the today non-existent architectural design. The documentation compiled this way will constitute a foundation for developing an architectural and conservation project, aiming at the restoration of the former splendour of the residence. Regrettably, local authorities are not interested in the preservation of the cultural heritage of this magnate residence in Volhynia. A centuries-long architectural legacy of one family slowly falls into ruin.

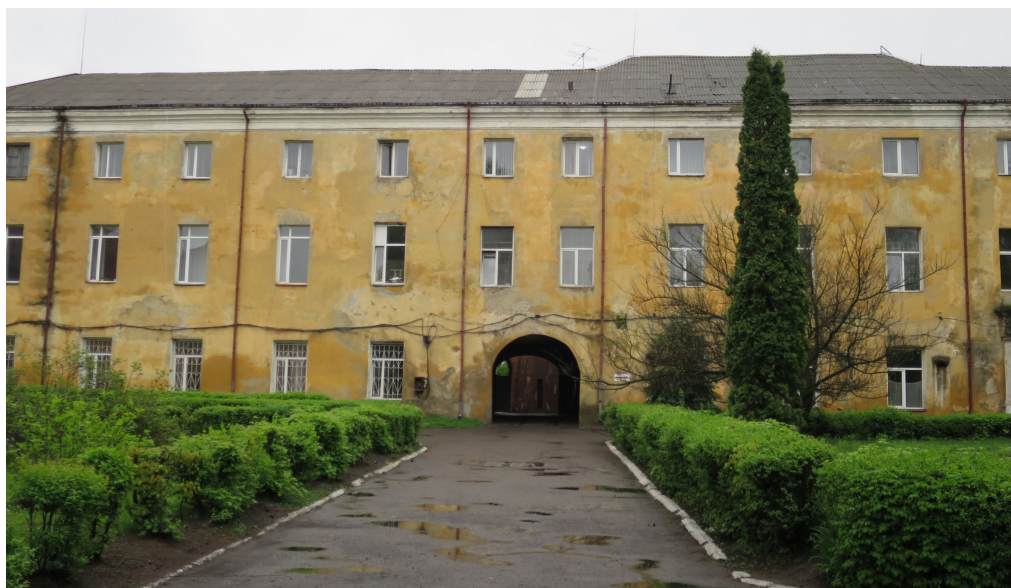
Fig. 6. Castle in Olyka, view of the wing of the palace facing the courtyard, condition as of 2019 (photo by B. Zin)

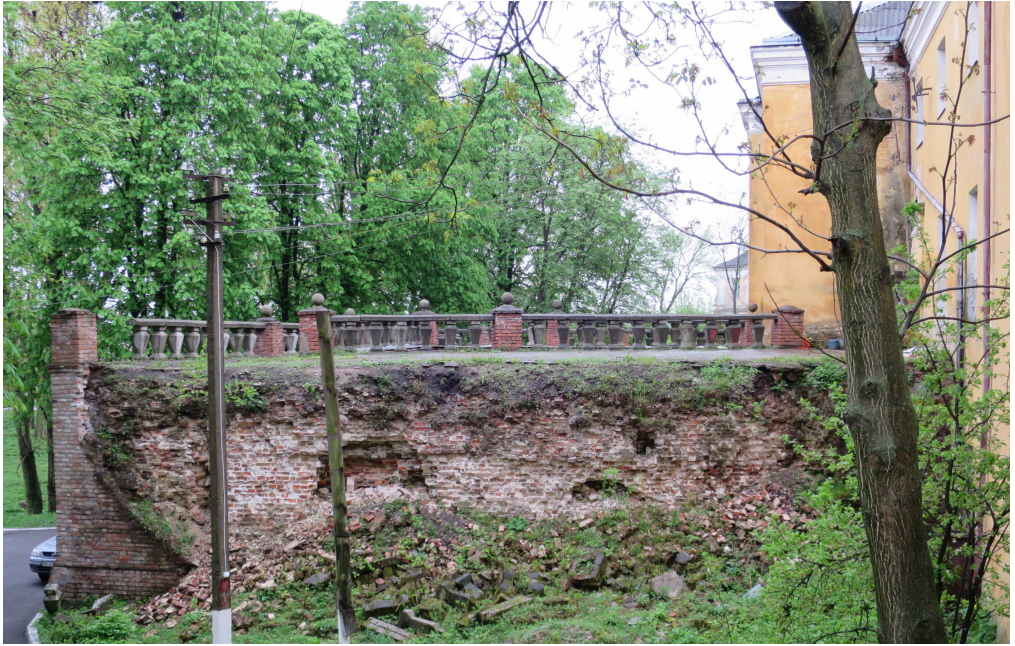
Fig. 7. Castle in Olyka, entrance gate facing the collegiate, condition as of 2019 (photo by B. Zin)

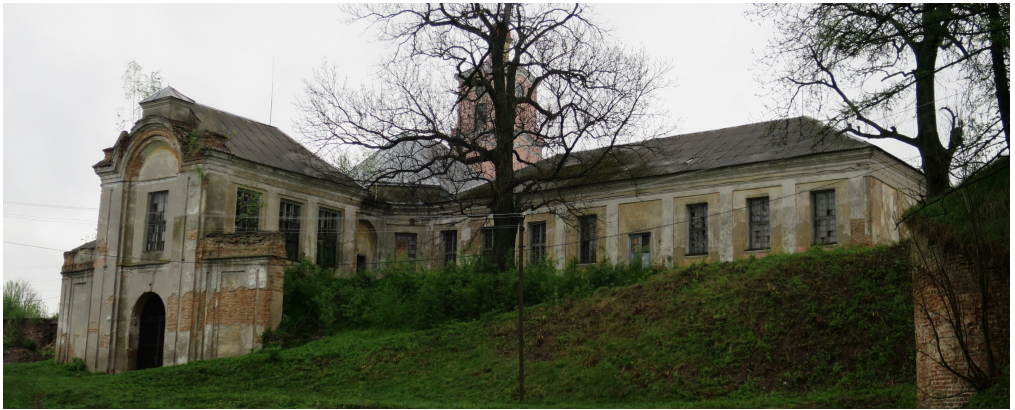
Fig. 8. Castle in Olyka, entrance gate facing Turczyn, condition as of 2019 (photo by B. Zin)
