Piotr Trojnieł

Department of Architecture of Local Cultures, Faculty of Architecture, Białystok
University of Technology

THE PROBLEM OF THE ARCHITECTURAL ADAPTATIONS OF SYNAGOGUES IN NORTH-EASTERN POLAND

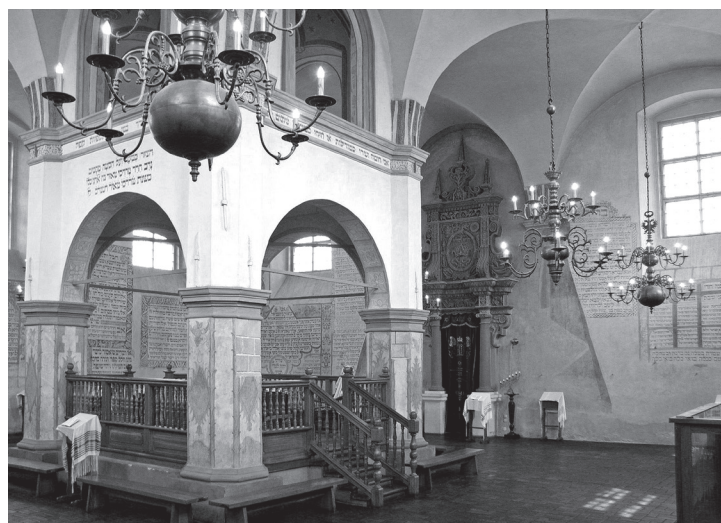
Fig. 2. The Great Synagogue in Tykocin – interior, 2013 (photo by Piotr Trojnieł)

predominated in the conversion of former synagogue buildings. Functions associated with the promotion of culture, and, by association, tradition and history, aided the preservation and recreation of the architectural decoration of the synagogues that underwent adaptation. The adaptation to a museum building is the option that interferes the least with the structure of former synagogues. Such an adaptation makes it possible to preserve the integrity of the prayer hall and preserve the aron hakodesh, as well as the centrally-located bima. The best examples of this type of adaptation are synagogues in Włodawa and Łęczna, and in Podlachia (Podlasie Region) – the Great Synagogue in Tykocin (Fig. 1). In these buildings, the original interior structure was preserved with the maintenance of the former form of the main prayer hall being a priority (Fig. 2).

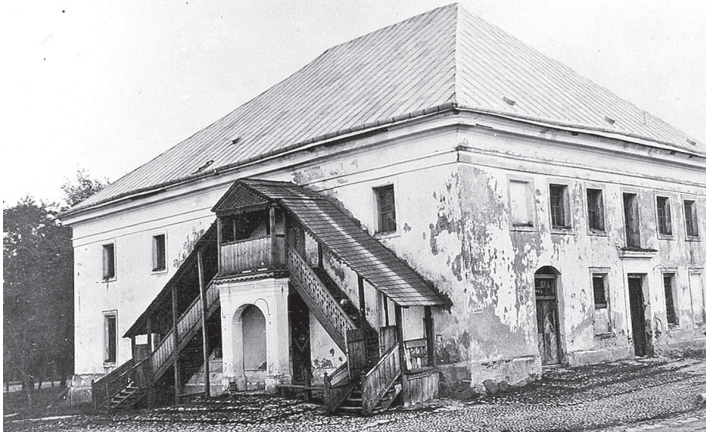
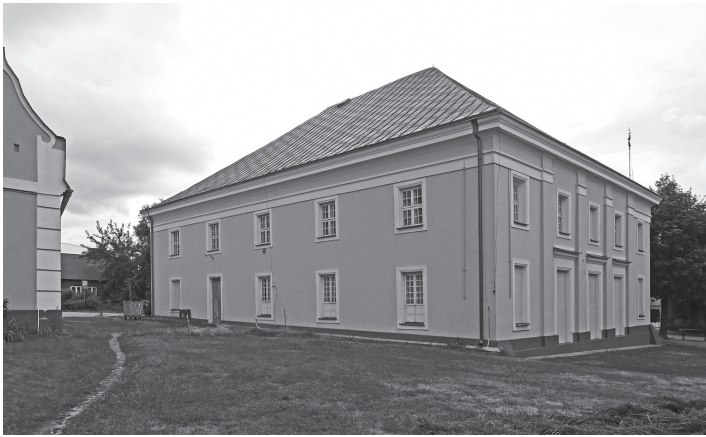
Fig. 3. The Great Synagogue in Siemiatycze, 1925 (photo by Jankiel Tykocki)

Fig. 4. The Great Synagogue in Siemiatycze, 2019 (photo by Piotr Trojnieł)

One of the examples of the aforementioned adaptation method in the area of north-eastern Poland is the Great Synagogue in Siemiatycze (Fig. 3, 4) – an original building that is important because of the use of an elongated spatial layout which would go on to become the typical solution found in nineteenth-century synagogues. The basilica-type layout of the prayer hall is particularly noteworthy; it is probably the first instance of its use in a synagogue in Podlachia and one of the first in Poland. The building played the role of a storage building during the occupation and survived the war as a result; however, its interior and furnishings were destroyed. During a renovation project performed in the nineteen-sixties, the synagogue was converted into a community centre with a cinema hall. Due to the adaptation assuming the function of the main prayer hall as an audience area, the bima was removed. The historical spatial structure of the building interior was preserved. Arched arcade openings in the gallery-mezzanine in the prayer hall were, however, sealed with walls, while partitioned-off spaces were adapted for the purposes of the community centre's exhibition halls (Fig. 5).

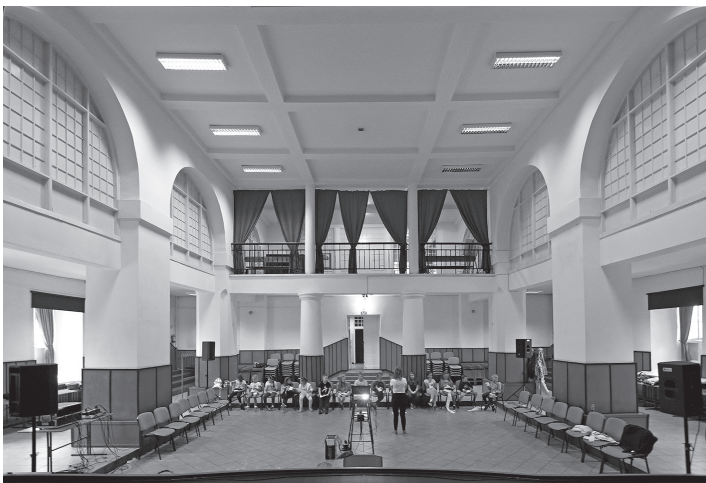
Fig. 5. The Great Synagogue in Siemiatycze – interior, 2019 (photo by Piotr Trojnieł)

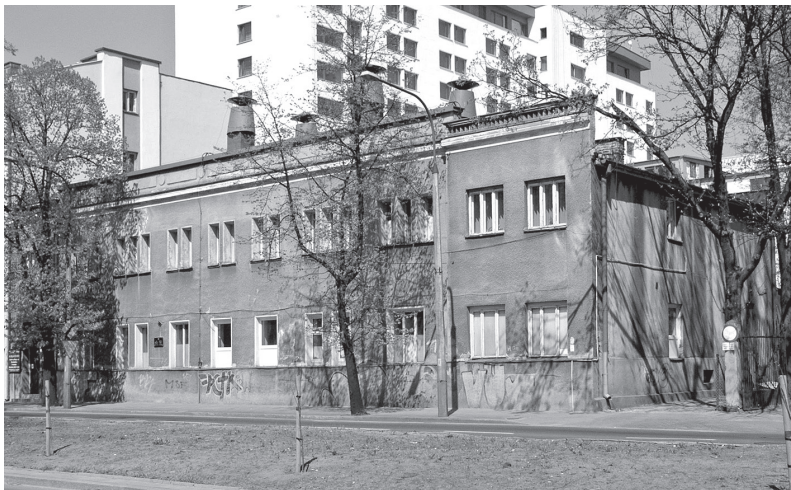
Fig. 7. The Samuel Mohilewer synagogue – adaptation and extension, 2013 (photo by Piotr Trojnieł)

The Samuel Mohilewer synagogue, also called *Beit Szmuel*, was one of the most interesting synagogues of Białystok. The architectural design of the synagogue was submitted to the Construction Department in Grodno in 1897; however, its exposed site and proximity to the palace of the Branicki family led to an extension of the construction permit issuance procedure. The Beit Szmuel synagogue was a temple of progressive Jews, which is probably the reason behind the Gothic revival style of its architectural detail, which is rarely encountered in synagogal architecture in Podlachia, and which was further combined with the Baroque composition of the frontal facade [1, p. 53–55]. The design of the richly-decorated two-storey facade was performed in such a way as to feature certain simplifications relative to the design (Fig. 6). The synagogue is also an example of an adaptation to a sports-related function. Adaptive reuse in the form of a sports-related function was facilitated by the traditional functional and spatial layout of the synagogue, with its large main prayer hall space. In the case of these types of solutions, the main hall was typically remodelled into a gymnastics hall or some other form of space used for practicing sports, while the remaining spaces were converted to auxiliary functions (locker rooms, bathrooms, etc. – Fig. 7, 8). This is similar to the case of the synagogue in Suchowola, which was also adapted into a sports hall and the only elements that allow one to glean the previous function is the axial composition of the back facade with tall, arched windows and an external addition that housed the aron hakodesh niche. Only renovation work that was technically essential was performed, with the facade details being removed and the building extended and remodelled during the adaptation to the new function.

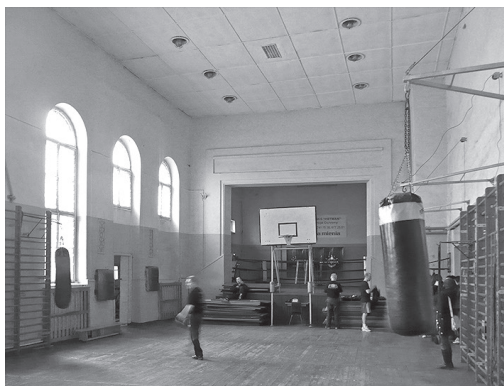
THE SAMUEL MOHILEWER SYNAGOGUE IN BIALYSTOK
PLAN OF ADAPTATION AND EXTENSION

Fig. 8. The Samuel Mohilewer synagogue – photo of former Main Prayer Hall, 2013
Plan of adaptation and extension (drawing by Piotr Trojnieł)

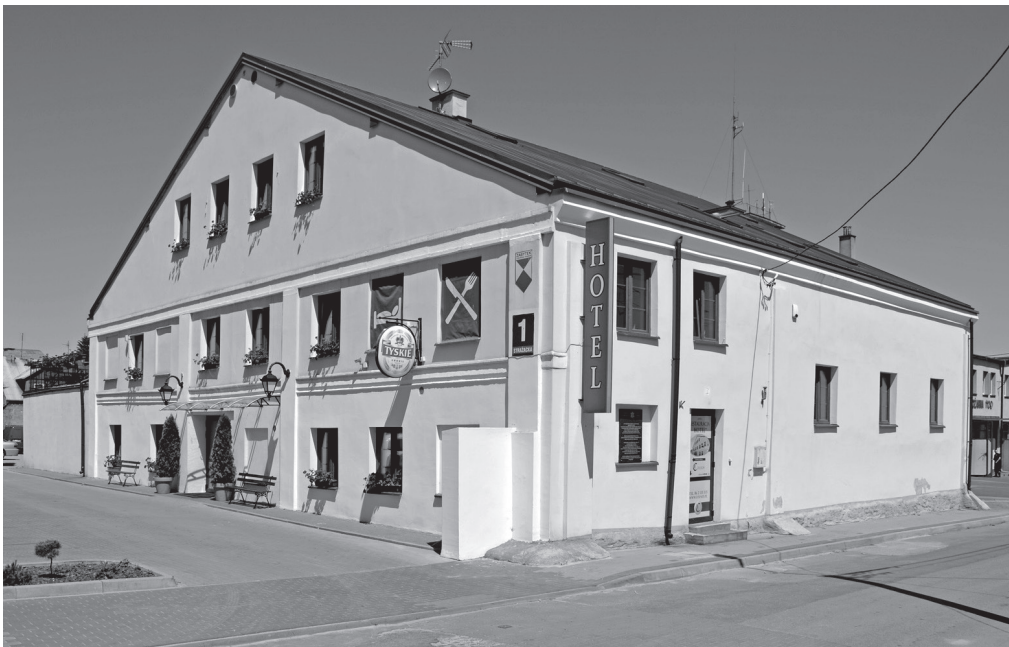
Fig. 9. The Synagogue in Kolno, 2016 (photo by Piotr Trojnieł)

The surviving building of the former synagogue in Kolno (Fig. 9) was rebuilt after wartime destruction, erasing the traces of the former function and adapting it to a storage building [6, p. 139]. After 1958, it was adapted to a country department store and functioned in this form up until the end of the nineteen-eighties. In later years, the building was not in use; this was probably associated with the unclear legal situation of the former synagogue. It was only in 2008 that the building was taken over by the Jewish Religious Community in Warsaw and its adaptation to a function associated with providing services to tourists was planned. The building was sold, however, and the new owner adapted it to a restaurant with a hotel section. The design was prepared in 2009 by the Expans design office from Łomża [8] and assumed the preservation of the state of the external massing that was the result of post-war remodelling and subsequent adaptation projects. The post-war single-storey extension located in the north-western corner was preserved and converted into a kitchen for the coffee shop and the main restaurant space. The architectural design did not use the opportunity to recreate the tall arched windows in the side facades of the former prayer hall. The small rectangular windows that had existed prior to the adaptation were preserved, although earlier conceptual design proposals assumed the recreation of these windows in an earlier form. The gables of the frontal and eastern facades were also designed to feature additional rectangular windows, which is associated with the function of the hotel placed in the attic spaces of the existing building. As part of the adaptation, the vestibule on the ground floor was designed to house an entrance hall with the hotel's reception

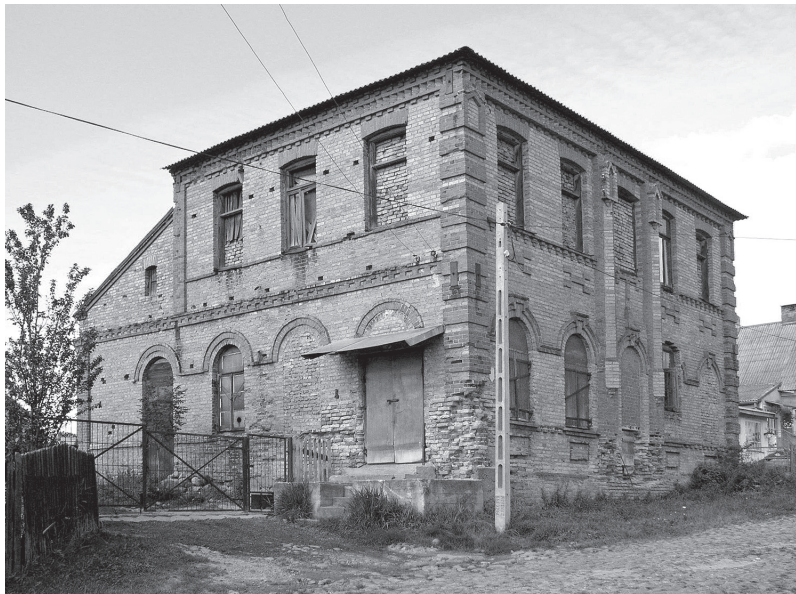
Fig. 12. The Jentes Bet Midrasz synagogue in Krynki, 2013 (photo by Piotr Trojnieł)

The Jentes Bet Midrasz synagogue in Krynki was built in the second half of the nineteenth century; it was founded by Jenta Rafałowska-Wolfson, hence its name. The hypothesis concerning the building's construction at the end of the nineteenth century is supported by the eclectic architecture of the building in the so-called brick style, which was distinct for Podlachia towards the end of the nineteenth century (Fig. 12). The building was built on a floor plan with a shape similar to that of a square, in the frontage of what is now Czysta Street (formerly Łazienna Street), with its eastern facade facing towards the street. The synagogue was orientated, as demonstrated by the niche in its eastern facade and a pair of lesenes signifying the placement of the aron hakodesh. The building survived the war and was adapted to an outbuilding storage space and has served its successive owners in this form to this day.

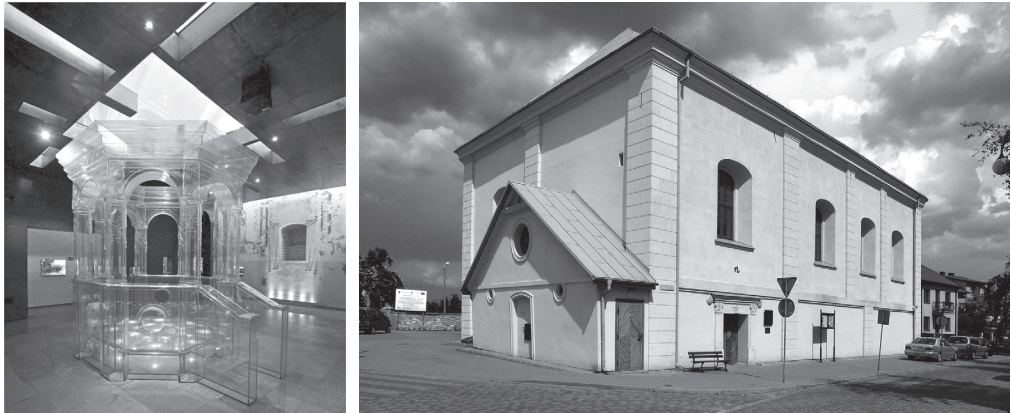
Fig. 15. The Synagogue in Chmielnik, Design of adaptation: Nizio Design, 2018 (photo by Piotr Trojnieł)

The function associated with culture, which is the most suitable in the case of the adaptive reuse of historical synagogues provided that functioning in their original capacity is no longer possible, must be combined with an informed shaping of their functional programme tailored to the building being adapted. Only this combination of programmatic assumptions associated with recreating forms of historical architecture will allow us to properly respect the surviving solutions of the internal structure of the buildings undergoing adaptation, which in the case of synagogues, should be based on preserving the integrity of the prayer hall spaces. It appears that such assumptions have been implemented in the latest successful adaptations of historical synagogues in Płock, Chmielnik (Fig. 15) and Ostrów Wielkopolski.
