Institute of Urban Design, Faculty of Architecture, Cracow University of Technology

LIPNICA MUROWANA – HISTORIC HERITAGE AND ITS CONSERVATION PROTECTION

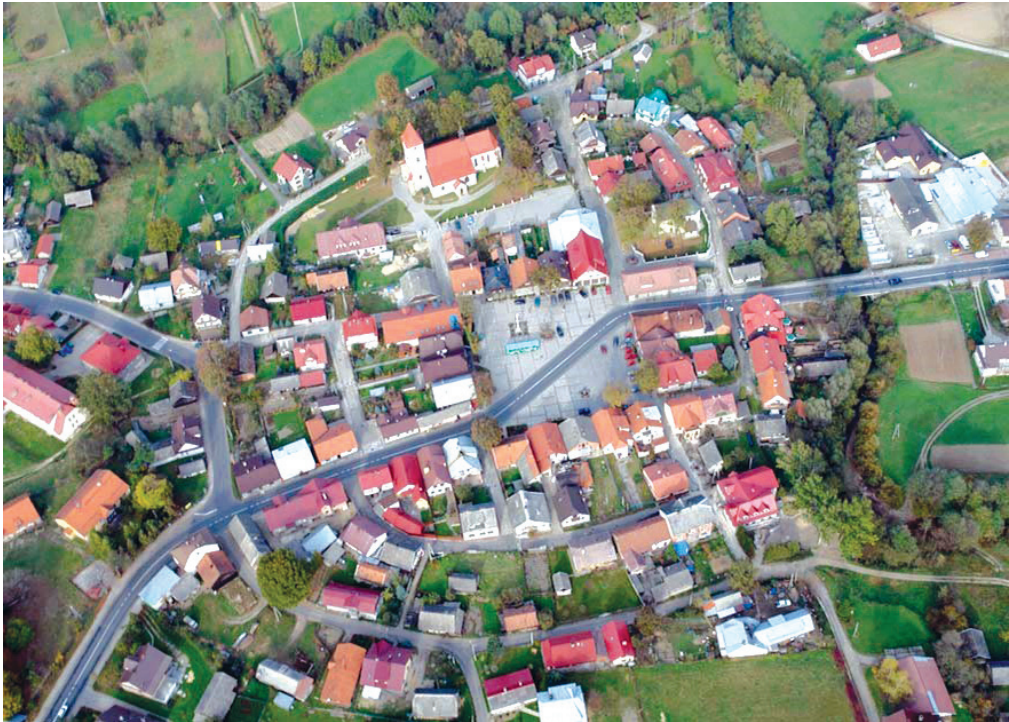
The historic urban layout of Lipnica Murowana, which has been very well preserved since the mediaeval period, is of great importance in terms of the voivodeship. The layout is a defined, orthogonal urban structure with a market square, streets running from its corners, inscribed within the oval of the town walls [3, 4]. The houses around the market square are single-family houses, farmhouses and utility buildings, sometimes adapted for trade and service functions. The houses are mostly one-storey buildings with an attic, and multi-storey. A few buildings from the 19th and the beginning of the 20th century have survived till today, but buildings from the inter-war and post-war periods are predominant. The majority of buildings are traditional structures typical for the town, though there are some rescaled buildings with modern details which clash with the historic cultural landscape.

Fig. 1. Bird's-eye view of the mediaeval urban layout of Lipnica Murowana nowadays (photo by W. Gorgolewski)

In the authors' opinion, the urban layout of Lipnica with its picturesque market square requires special and well thought-out conservation protection. The market square should undergo complete restoration; ahistorical elements such as the fountain should be removed; the division into plots, the form and dimensions of buildings should be preserved whenever possible. It is also worth considering the possibility of creating a catalogue of building patterns – materials, colours, details – to be used by owners of properties located within the protected zone.

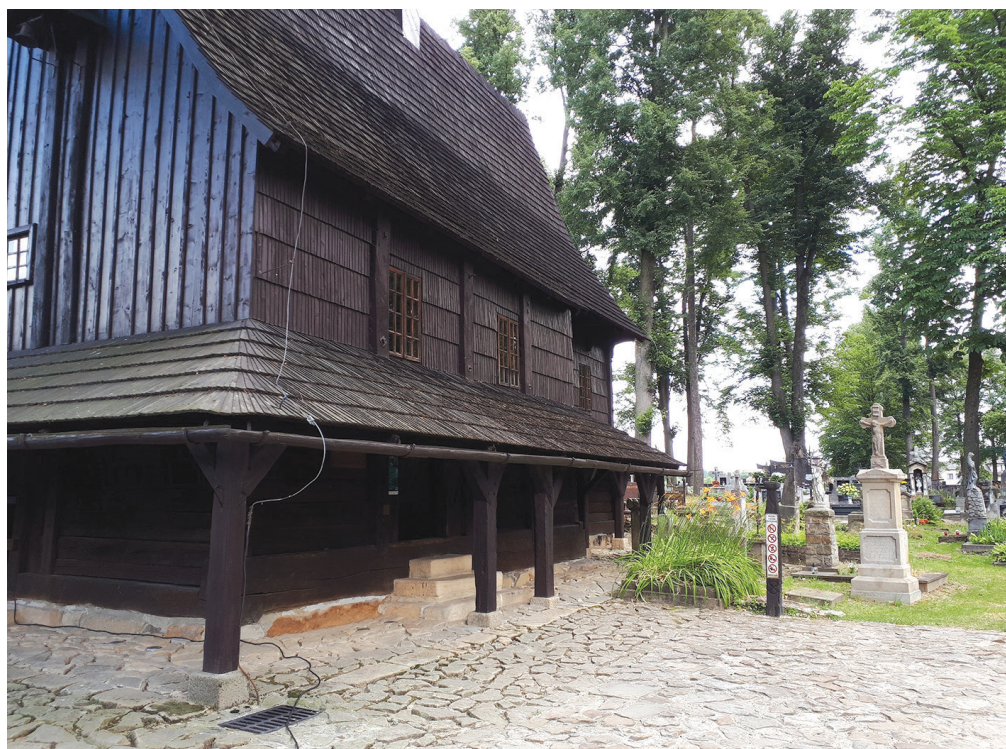
The church is well preserved. Recently its grounds have been tidied, the surrounding fence has been modernised, cemetery paths have been paved and a parking lot has been built. Inside the church there is the alleged “Światowid column”. According to local tradition, the church was erected on the site of another one built in 1141, which in turn had replaced a pagan temple of which the “column” was a part. However, radiocarbon dating carried out by Prof. Natalia Piotrowska from the Institute of Physics, Silesian University of Technology, on the initiative of M. Budziakowski, ruled out the pre-Christian origins of the column, dating the time of tree felling to the turn of the 15th and 16th centuries (which corresponds to the assumed time when the actual church was built). The church interior is decorated with paintings from various periods, from the end of the 15th till the beginning of the 18th century. The presbytery is decorated with polychromes depicting the Crucifixion, the Last Supper and the Final Judgement; and the nave – scenes from the Passion and the Decalogue [6, 7].

Fig. 2. View of the church of St. Leonard in Lipnica Murowana nowadays (photo by authors)

Writing about conservation guidelines, one has to emphasise the church surroundings where the traditional forms of tombstones ought to be used, ruling out light materials such as pink marble, or not refined enough like terrazzo. Particular care should be taken of characteristic, heavy sandstone slabs, on which inscriptions and ornaments are gradually effaced by weather conditions.

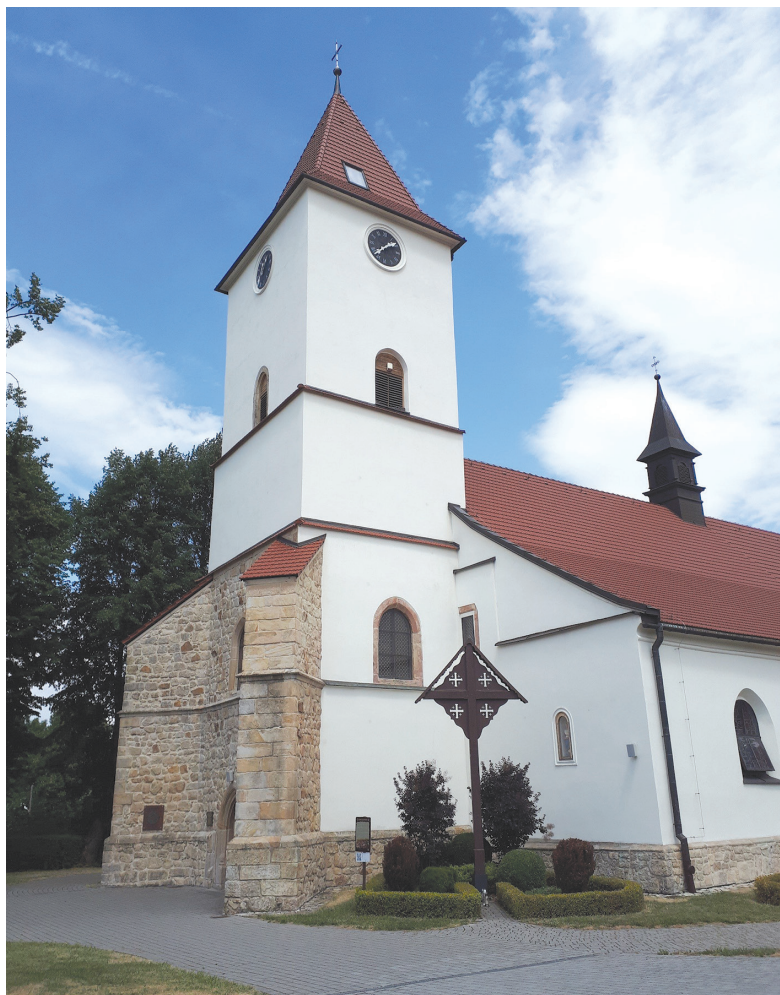
In the context of protecting the cultural landscape in Lipnica, another valuable building is the parish church of St. Andrew the Apostle. It was founded by King Kazimierz Wielki (Casimir the Great) in 1363 [8]. The church has one nave, a narrowed presbytery, and a tower on massive buttresses which dominates Lipnica. Six altars, a Gothic sculpture of Our Lady with Child from the 14th century, a 17th-century figure of Crucified Christ and two mediaeval baptismal fonts are of considerable cultural value. The church is in good physical condition. A decade ago the roofing of the tower was replaced and the vertical insulation of foundations was made.

Fig. 3. View of the parish church of St. Andrew the Apostle in Lipnica Murowana nowadays (photo by authors)

As far as conservation guidelines are concerned, it is necessary to revitalise the church surroundings by restoring the outside stairs.

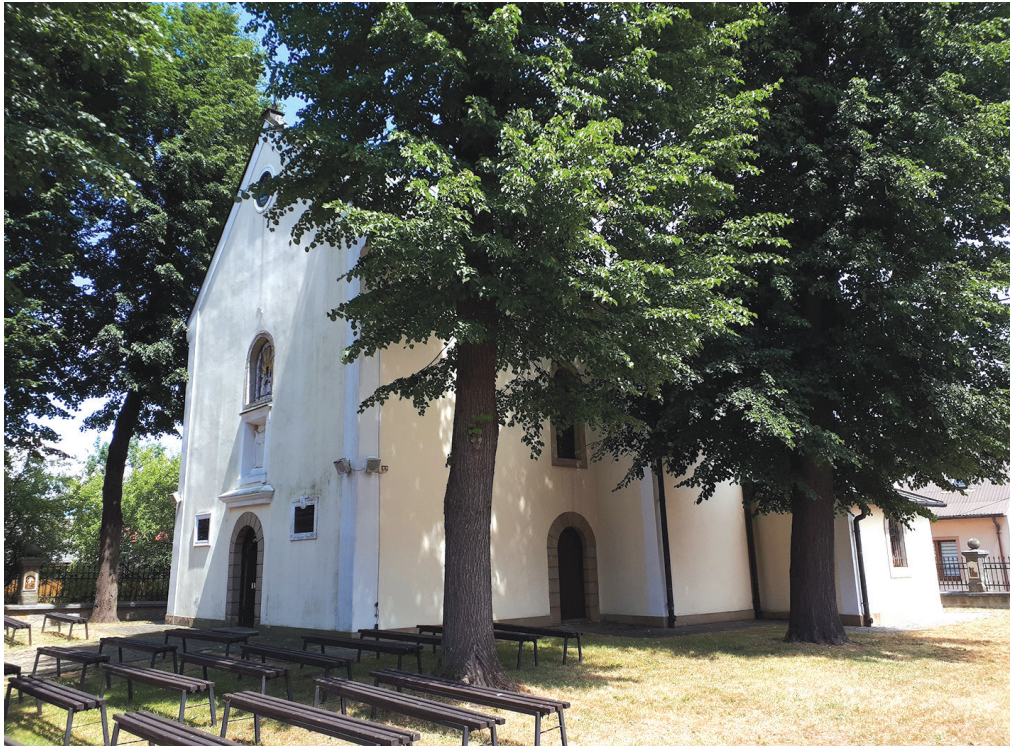
The state of preservation of the church can be described as very good. The church furnishings – the altar and pews – were renovated during the last decade.

Fig. 4. View of the church of St. Simon in Lipnica Murowana nowadays (photo by authors)

Because of the very good condition of the church it does not require conservation treatment at present.

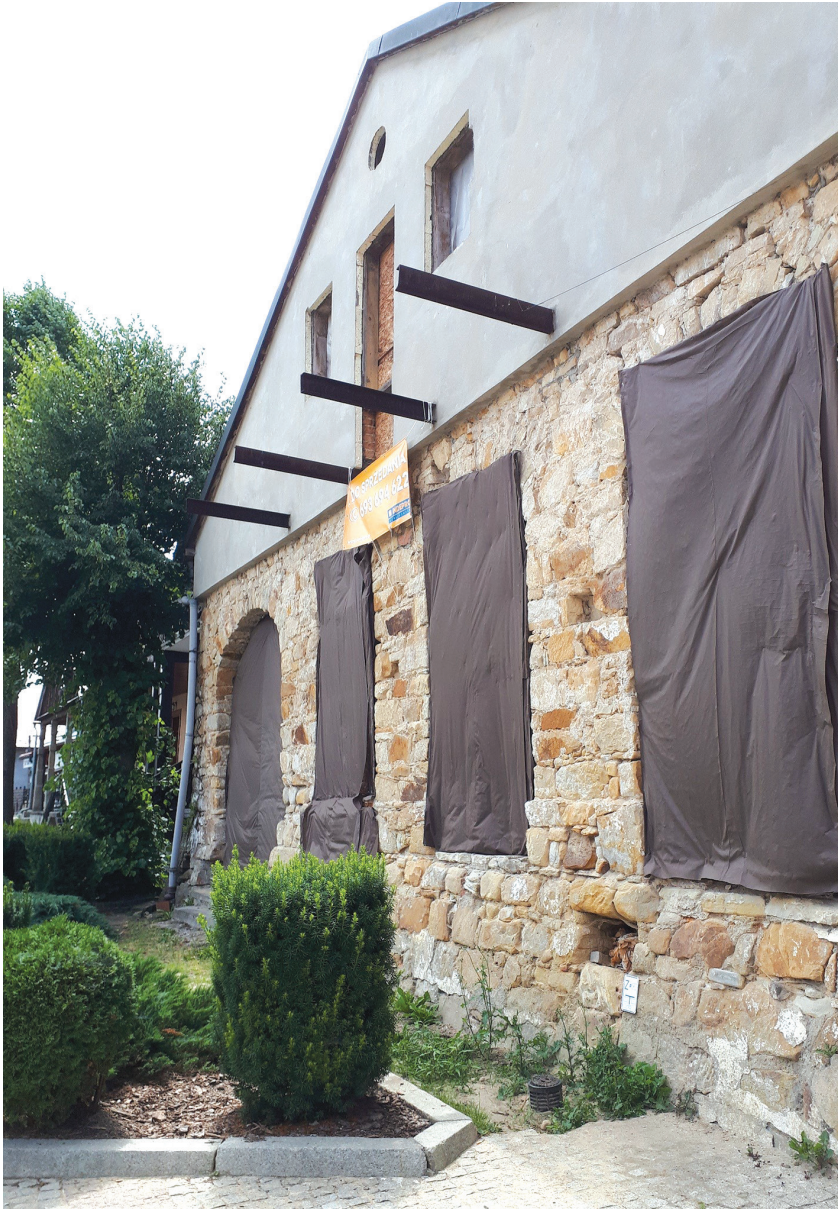
Despite statutory conservation protection, for ten years the object has been under renovation which has not been completed yet. During this period, a new tiled roof covering was made with ahistorical, disproportionate dormers. It is worth mentioning that the analysed object requires a new inventory and current valuation. A possible renovation or conversion should be related to adapting the building to a new function, using traditional forms and local materials.

Fig. 5. View of the Starost's manor in Lipnica Murowana nowadays (photo by authors)

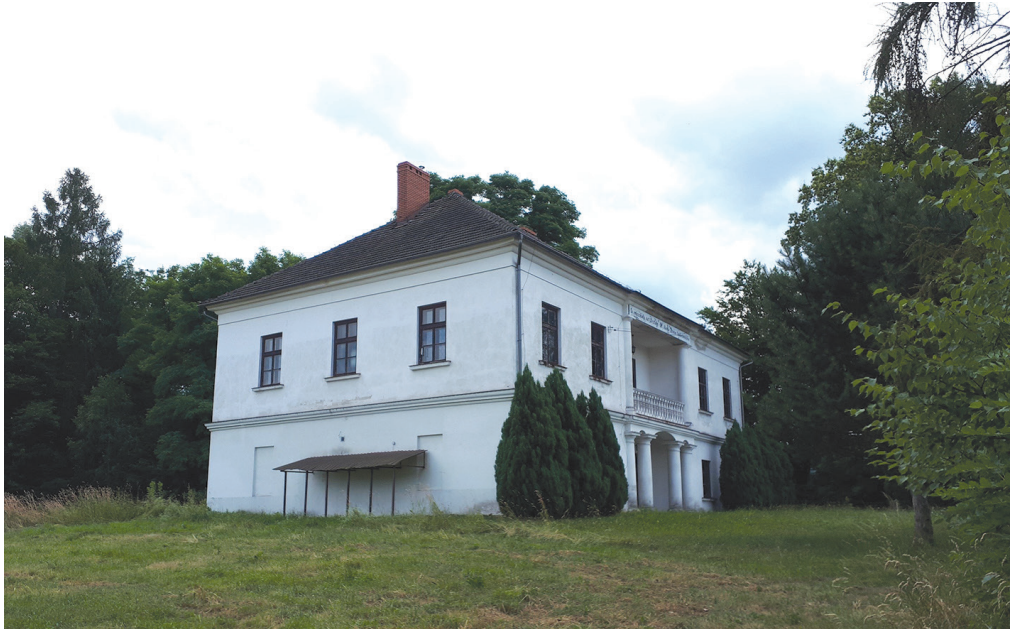
At present, despite its satisfactory physical condition, the building remains unused, which is a pity because it might house a local museum, a cultural centre or a gallery. In order to do that, besides adapting the structure to a new function, the roof truss and covering would have to be replaced.

Fig. 6. View of the Ledóchowski Manor in Lipnica Murowana nowadays (photo by authors)

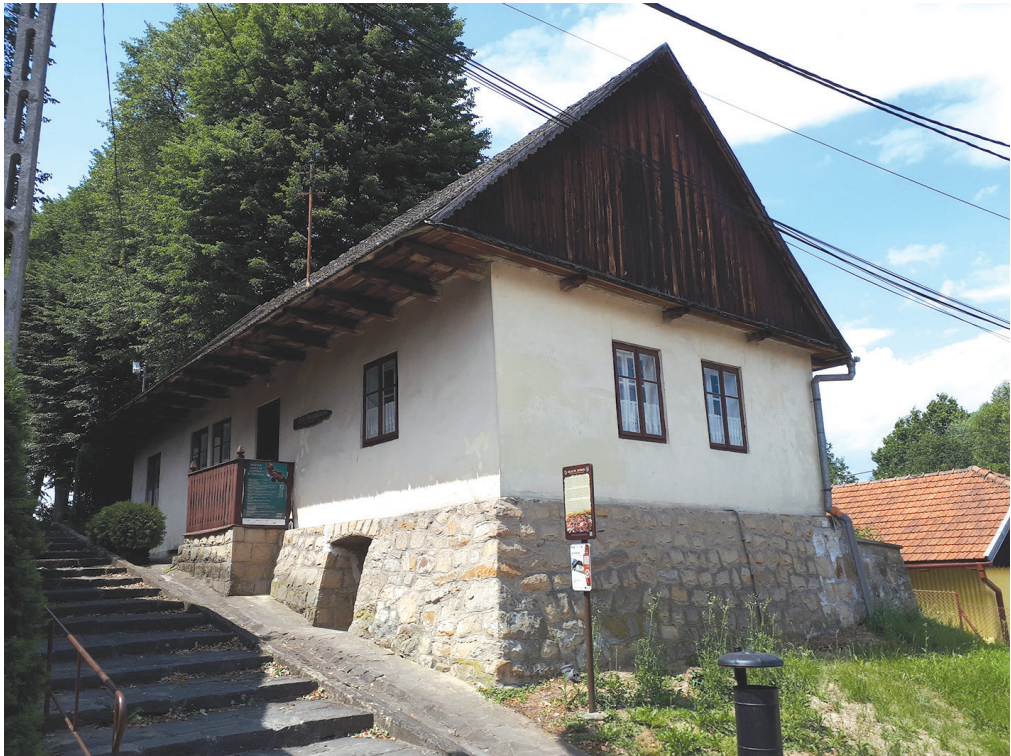
Fig. 7. View of the former school building in Lipnica Murowana nowadays (photo by authors)

Its state of preservation is good, yet requires restoration which should include roof repairs and adapting the building to its new function, related, for instance, to tourist services.

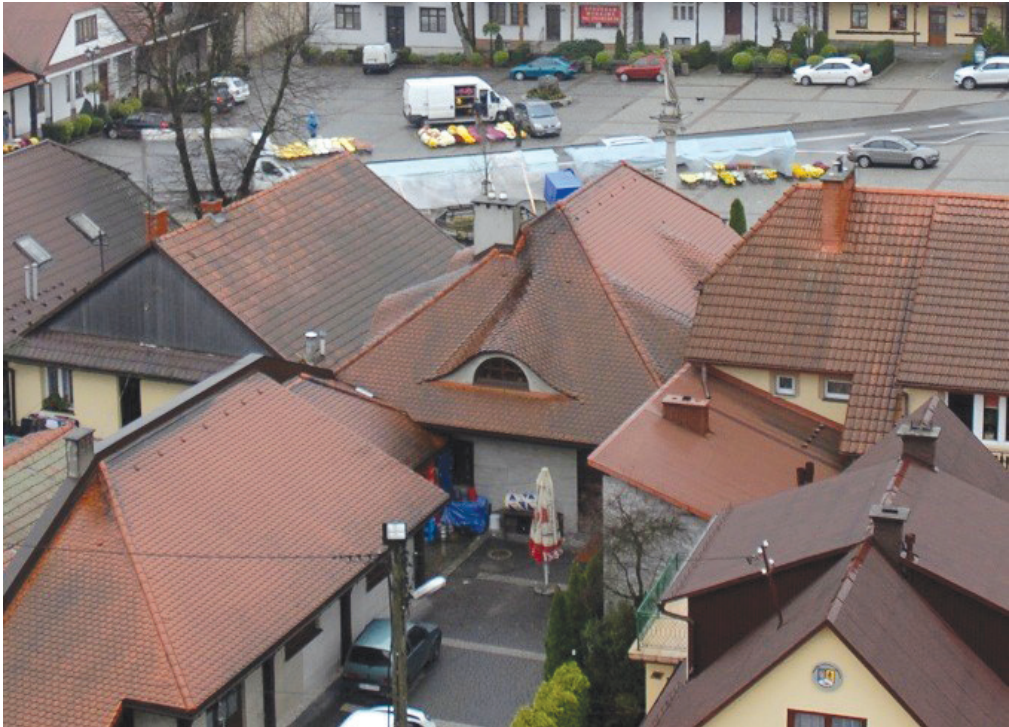
Besides the already mentioned well-known historic structures located in Lipnica Murowana, valuable relics of former housing can also be found in this former town. They are one-storey houses from the turn of the 20th century, typical for small, historic towns [10]. Unfortunately, most of them are in poor condition and are gradually falling into disrepair. They certainly require better conservation protection and restoration, as well as listing in the county heritage register. The latter remark refers primarily to the houses surrounding the market square, and those located within the mediaeval urban layout (no: 106, 142, 34, 113, 108, 145, 132, 76 and 134). It is also suggested that selected utility buildings reflecting the agricultural character of the village be protected as well [11].

Fig. 8. View of the historic houses near market square in Lipnica Murowana nowadays (photo by authors)
