PERMANENT SHM FOR HISTORICAL KOSCIUSZKO MOUND IN CRACOW AND THE POSSIBILITY OF ITS IMPROVEMENT

Abstract:

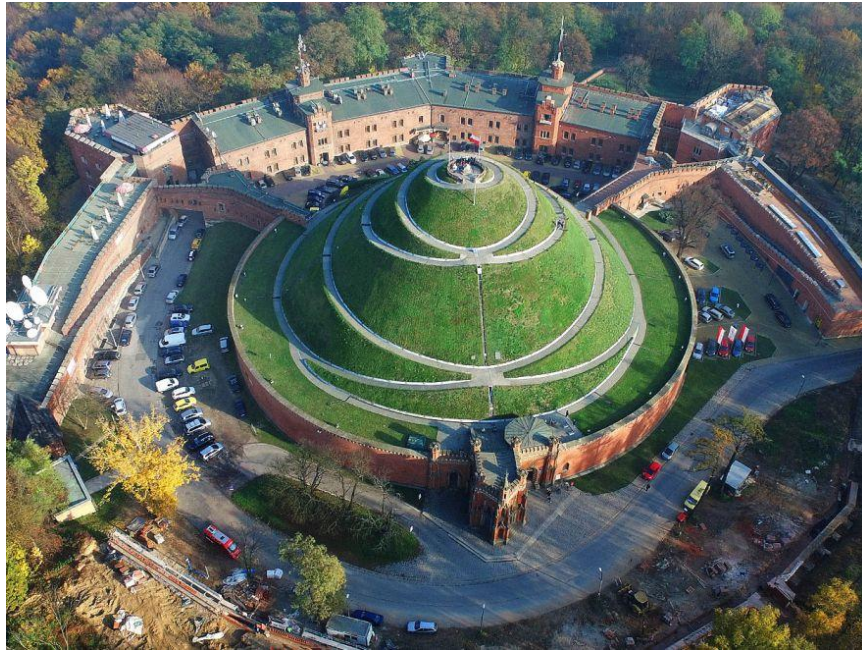
Fig. 1. Kosciuszko Mound in Cracow seen from above, current state.

The monumental Kosciuszko Mound in Cracow (Fig. 1) is an artificial hill of 34.1m relative height, heaped up by Poles in the years 1820-1823 in order to commemorate the national hero – Tadeusz Kosciuszko, in recognition of his merits. It is a geotechnical structure especially sensitive to deformation, mainly due to the unfavourable structural material and very steep slopes. In the past it failed several times. The most significant structural failure occurred after the flood of 1997. Then the state of the mound reached the level of building disaster, and this in turn resulted in closing of the mound to the public for

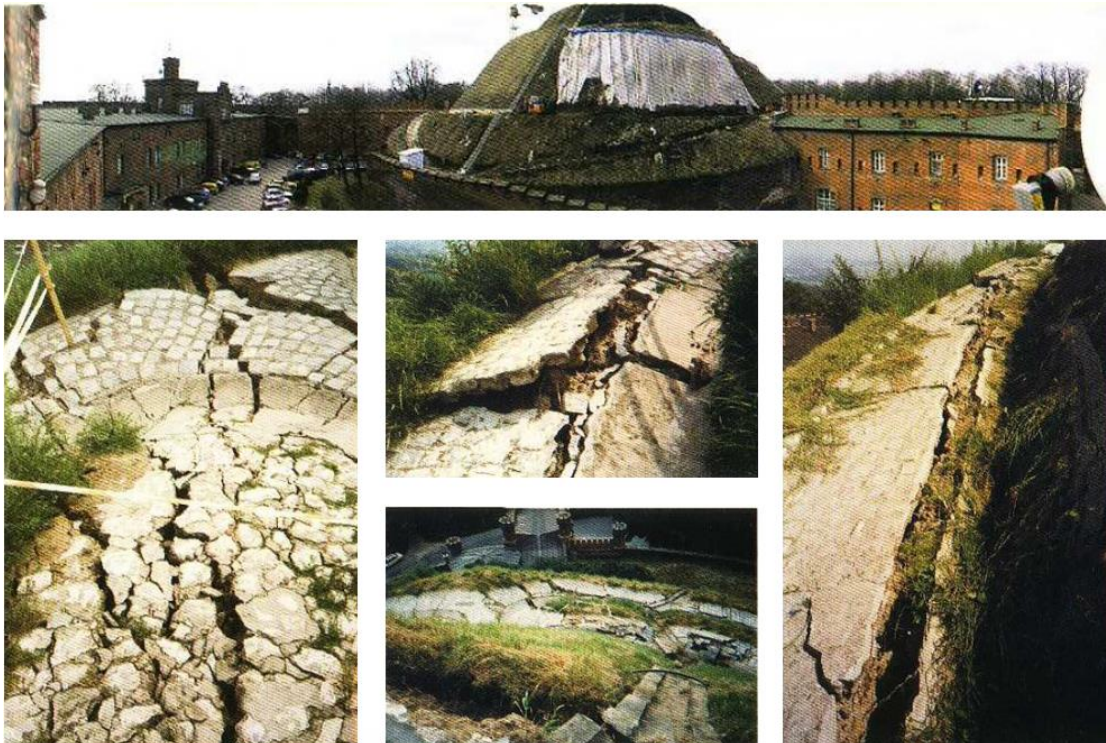
Fig. 2. Destruction of the mound in the year 1997.

about 3 years. The intense rainfall induced significant erosion of the slopes triggered the almost total destruction of footpaths leading from the bottom to the top of the mound (Fig. 2). Furthermore, the condition of the mound seriously worsened after the rainfall in the year 2010.

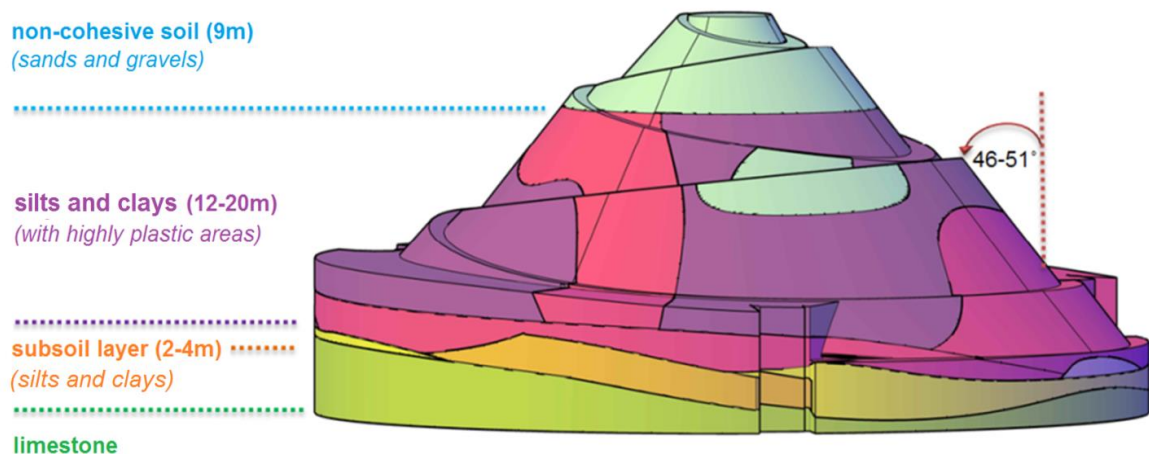
Fig. 3. Internal soil structure of the Kosciuszko Mound.

Kosciuszko Mound is an artificial, man-made geotechnical structure erected on a sloped rock bed of indigenous limestone (Fig. 3). It was mainly made of loess type soils, generally in the form of silty clays and silts with a substantial addition of man-made dump ground. Soils of this type proved to be extremely susceptible to the environmental actions during the service time, and especially sensitive to the rainwater infiltration and multiple freeze thaw cycles. The way the mound was heaped up determined extremely unfavourable layered structure of the tambour, exhibiting heterogeneous and locally variable layer thicknesses. Extreme slope of the tambour side, reaching up to $46-51^\circ$ significantly affects the behaviour of the structure as well, as it substantially exceeds the angle of internal friction of soils used.

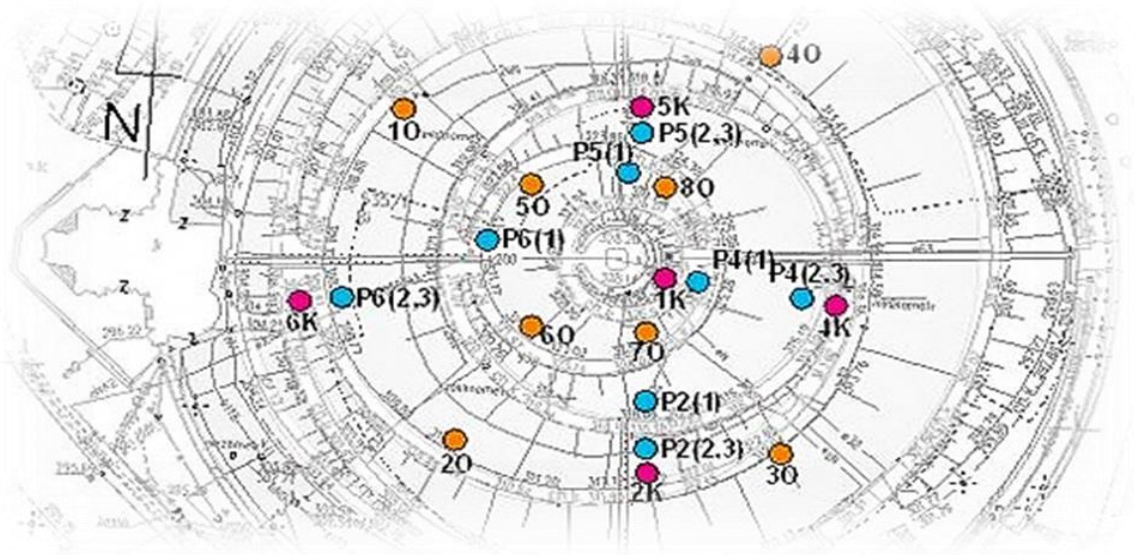
Fig. 4. Horizontal projection of the mound with indicated locations of measurement stations (denotations: K - sensors measuring vertical displacements, O - sensors measuring horizontal displacements (radial and circumferential) and soil humidity, P - sensors measuring pore water pressure and humidity of the external soil layer.

The monitoring system applied in 2012 yields detailed information on the vertical displacements and hoop as well as radial deformations [1]. Location of sensors used to perform such measurements is depicted in Fig. 4. Vertical displacements are measured by the vertically oriented string sensors (Fig. 5) installed at five locations. The horizontal deformations are measured by another group of string sensors [2] installed at the perimeter of the mound and oriented circumferentially and radially towards the inside of the mound structure (Fig.6). The pore water pressure within the interior of the structure as well as the humidity of the top layer are monitored as well by piezometric sensors located in four measuring stations, at three different depths (Fig. 7). All the string sensors have been equipped with thermistors in order to measure the soil temperature at respective measurement stations. The obtained results are related to the geodesic measurements and

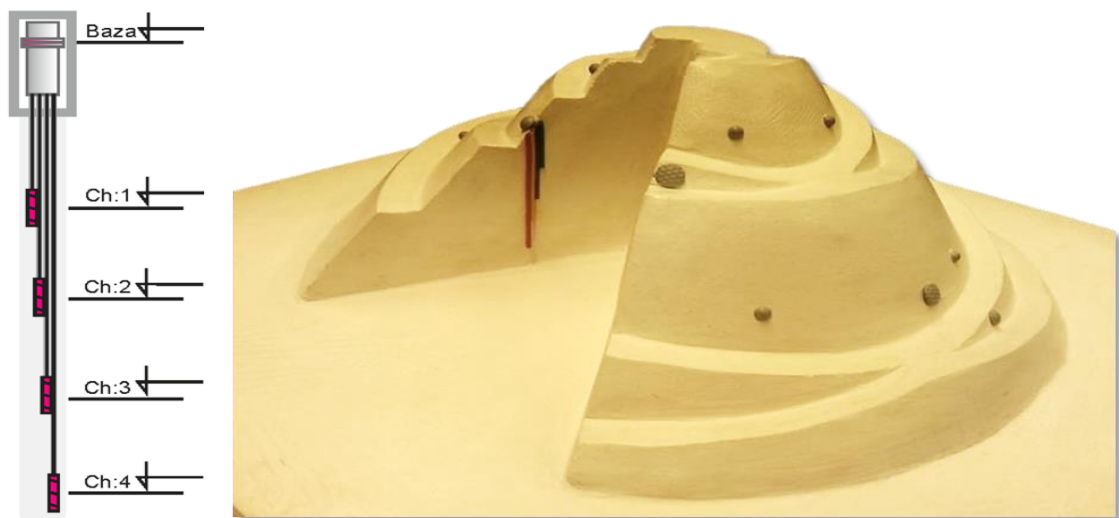
Fig. 5. Details of vertical displacement measurements.

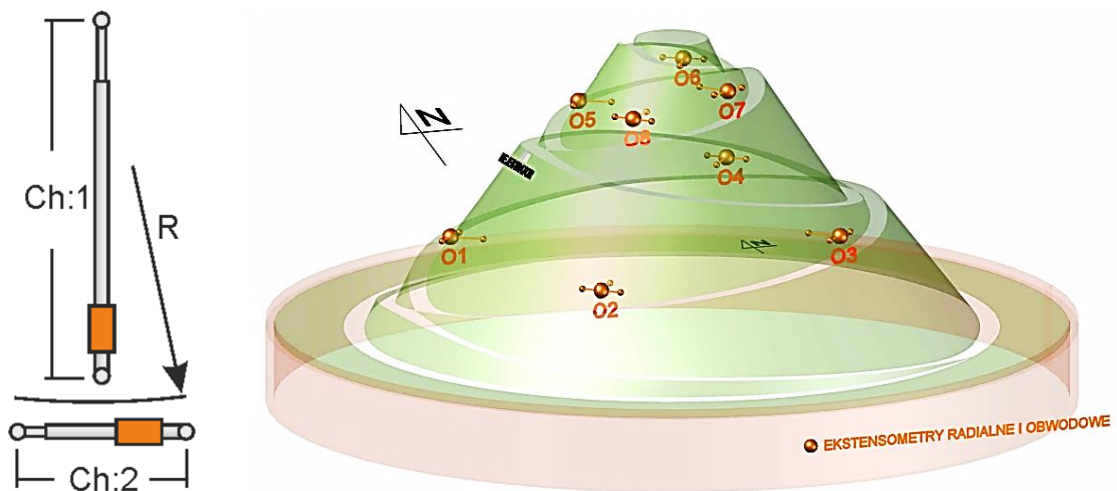
Fig. 6. Details of horizontal deformation measurements (along the radius and circumference).

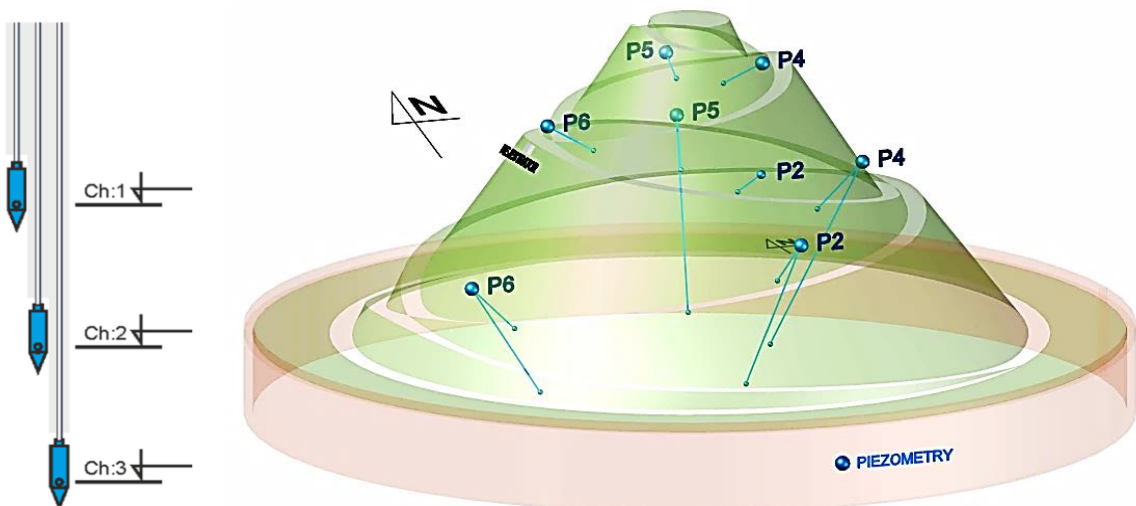
Fig. 7. Details of the pore water pressure and external layer humidity measurement stations.

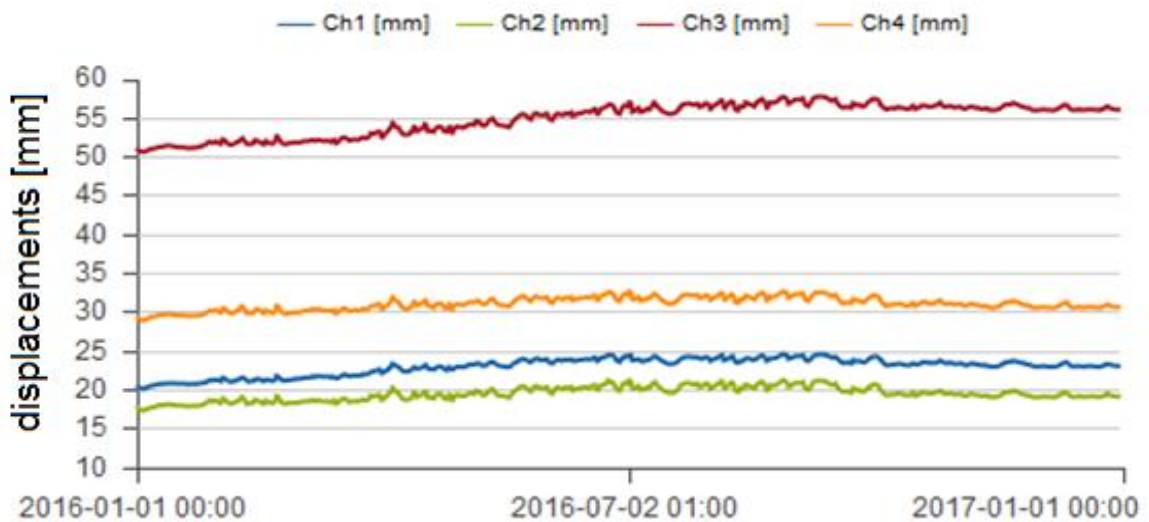
Fig. 8. A segment of the graph depicting monitored vertical displacements in the 1K measurement station at the boundaries of subsequent soil layers.

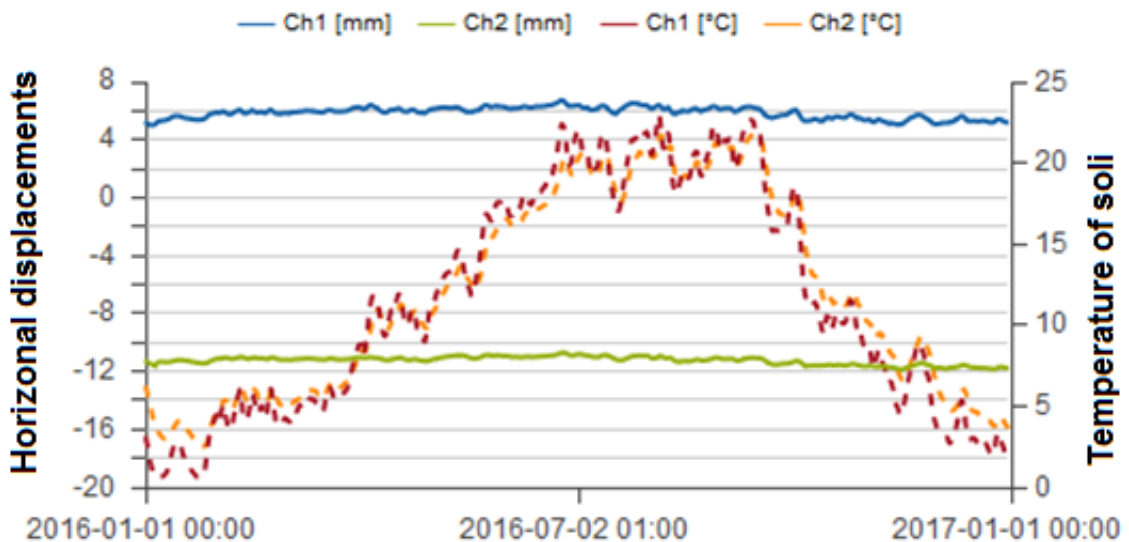
Fig. 9. A segment of the graph depicting monitored horizontal displacements in the 2O measurement station at the boundaries of subsequent soil layers accompanied by the soil temperature graph (yearly fluctuations of the soil temperature are clearly visible).

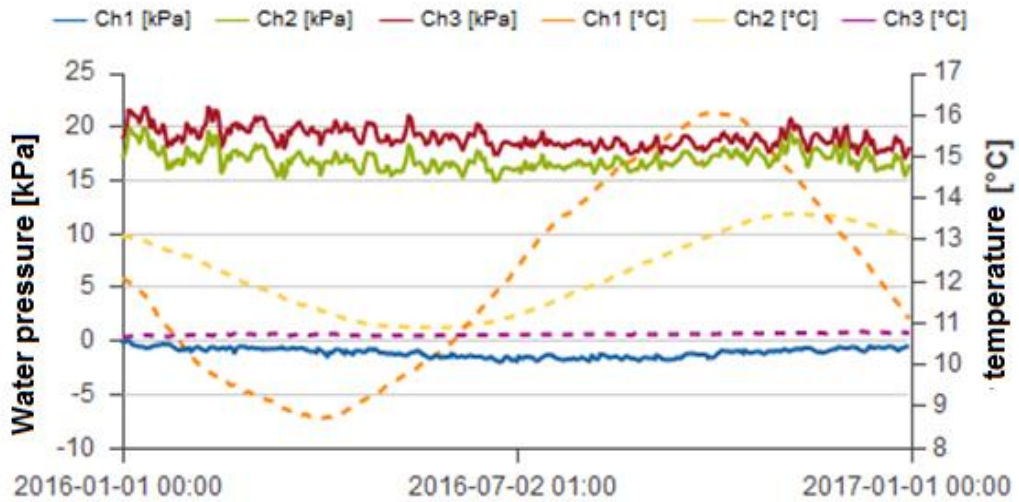
Fig. 10. A segment of the graph depicting monitored pore water pressure and corresponding soil temperature values measured at the 2P station (yearly fluctuations of the soil temperature are clearly visible).

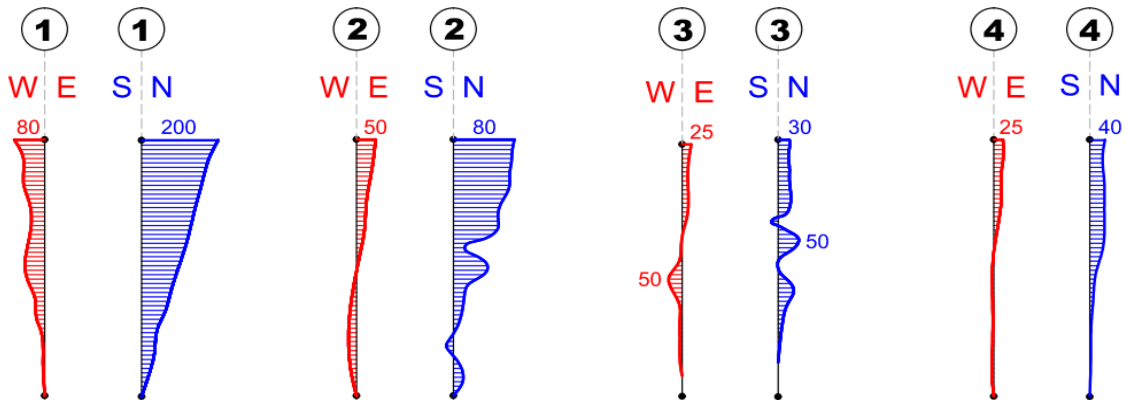
Fig. 11. Results of the inclination measurements at a given moment in time.

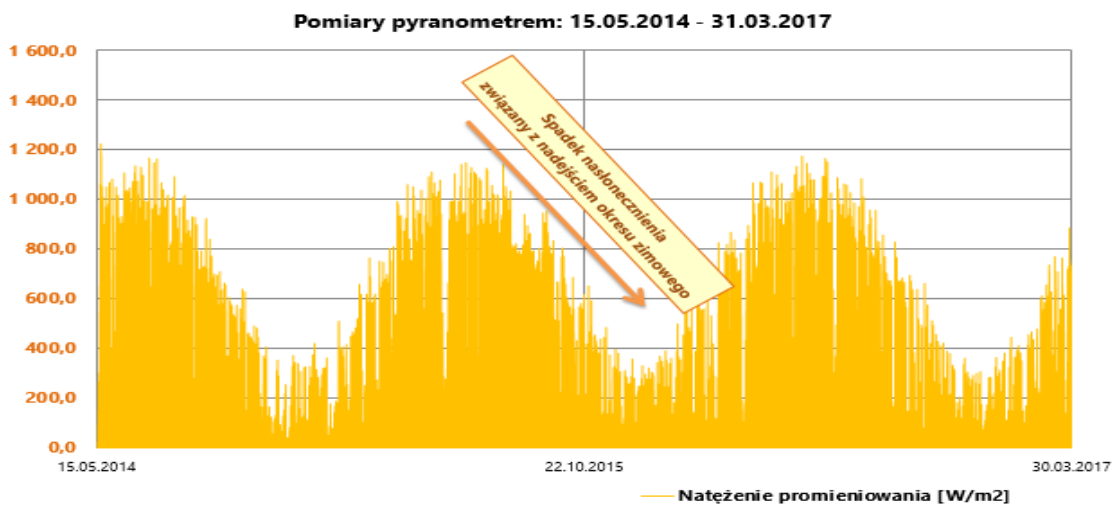
Fig. 12. Changes in the mound insolation in a yearly cycle recorded by pyrometer.

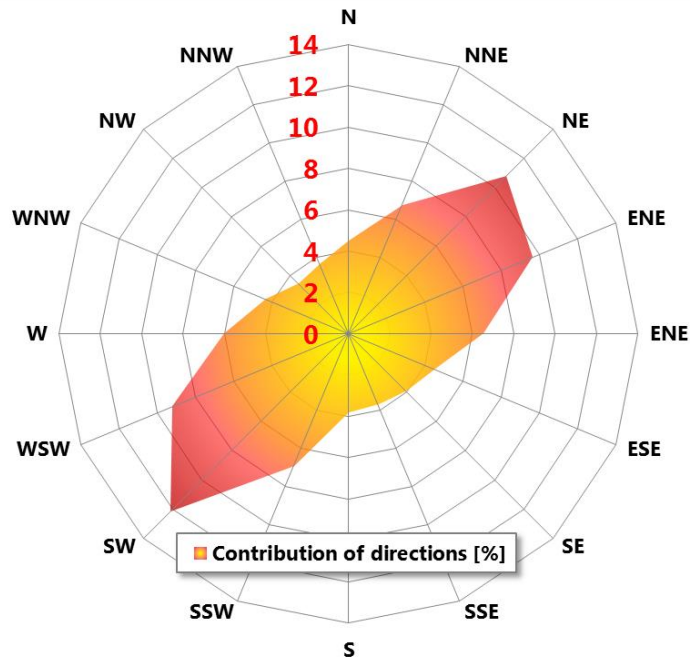
Fig. 13. Monitoring obtained wind rose for the mound location.
