The reconstruction of the Museum of Warsaw – current architectural interventions in a monument of great significance for the history of conservation in Poland

Jerzy Wowczak

Faculty of Architecture and Fine Arts, Andrzej Frycz Modrzewski
Krakow University

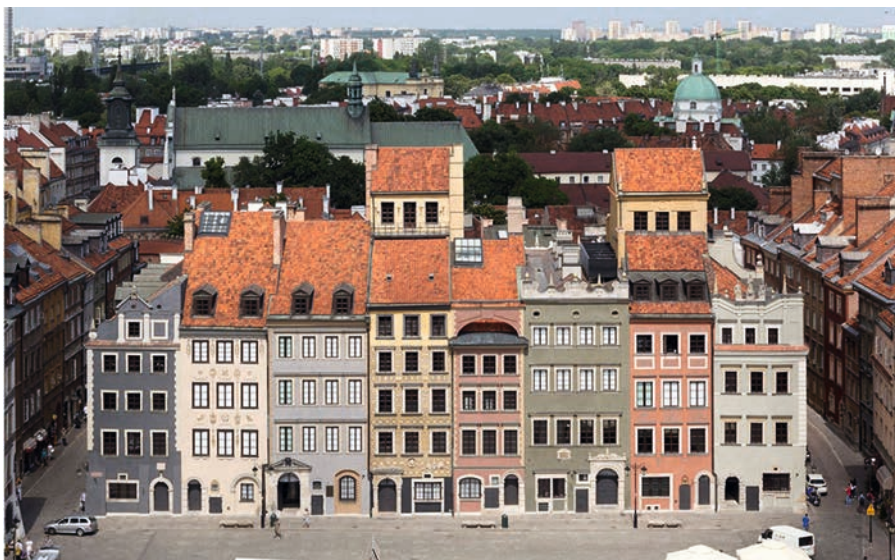
Fig. 1. The Old Town Market Square in Warsaw, tenement houses on the Dekert’s Side, the seat of the Museum of Warsaw (photo by Marcin Czechowicz, 2018, property of the Museum of Warsaw)

The last reconstruction of the building complex forming the Museum of Warsaw’s frontage on the Strona Dekerta Starego Miasta na Rynku (Dekert’s Side of the Old Town Market Square) took place from 2016 to 2018 (Fig. 1). These eleven tenement houses located in the very heart of the capital’s Old Town are an example of typically Polish conservation interventions marked by the experience of losing monument substance as a result of warfare. Additionally, associated with this location are ideas of conservation that, despite being widely accepted in the era of the monument’s creation, have been a subject of dispute among experts in the field over the last few decades.

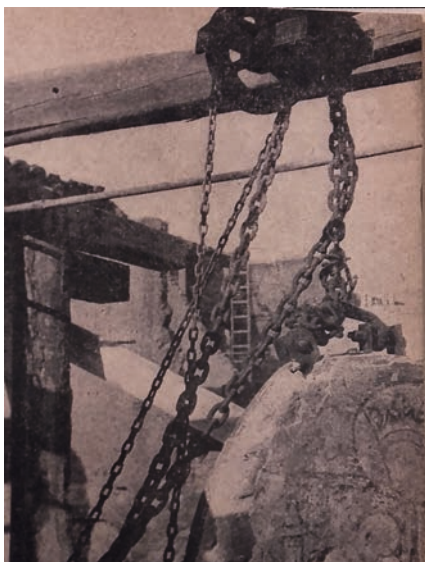
Fig. 4. Transfer of the Gothic polychrome from the tenement house at 17 Market Square in Warsaw (source: Żaryn, 1953b: 171)

houses at 28, 38 and 42 Market Square were deprived of stairwells (Żaryn, 1972: 97). Authentic pieces of relic value were preserved and displayed. They included: fragments of walls with vaults, basement floors, stone portals, the attic crowning of the front elevation of the Baryczka tenement house, stone elements of the interior stairs, some details of the original masonry and moulding, linings of sheet metal, door fittings and grates (Wojciechowski, 1953a; Sulimierska, 1953; Grzelachowski, 2010). Most importantly, three ceilings with polychrome decorations were saved on the first and second floors of the tenement house at 34 Market Square. In the years 1949–1954, conservation of the ceilings was performed and the decision made to unveil the oldest paint layers of the ceiling of the first-floor room at the back of the rear track, which remained untreated during the post-war restoration works (Dąbrowski, Żaryn, 1955). During the renovation, a Gothic niche was discovered and displayed in the vestibule of the tenement house at 40 Market Square. The wooden ceiling on beams embedded in the preserved sockets was also reconstructed, causing functional disturbances on the first floor where the floor was raised in part of the front track. Discovering Gothic relics encouraged the conservators to place a mural painting featuring in the museum interior Madonna and the Child moved from the nearby Godswiller (Swignowska) tenement house at 17 Market Square (Fig. 4).

The preserved polychrome was transferred from a piece of wall to then be clarified with the use of conservative methods (Żaryn, 1953b; Koczorowska, Kozarzewski, Kułakowska, Zalewska, 2019). Żaryn's team decided that the new fragments of the object, which previously did not exist in such forms, including stairs, windows, portals, grates etc., be treated "in the spirit of the epoch", in line with the principle established in the previous century. The Gothic (in the cellars and some vestibules), Renaissance (attics, lintel details and doors) and Baroque elements were indicated as being appropriate for such treatment. The eclectic manner of design resonated with the scale of the place and the romantic character of its picturesqueness. This is how the tenement houses were enriched with prime craft details. From the point of view of purist doctrinaires, these elements could be regarded as forgeries. For us, they are proof of the mastery of the then designers and craftsmen in how they dealt with materials' properties. The biggest project challenge predominantly concerned the parts of the architectural decor that were not directly based on historical patterns. In these cases, traditional techniques already used within the object were applied, adding modern expression. Craftsmen and artists worked in agreement with the changes in art characteristic of the epoch, thus bringing an additional value to the complex. Socialist realist details can be observed here, namely forged or welded grates, balustrades, lamps and door fittings inspired both by historic (mainly Baroque) details and folk art (Fig. 5).

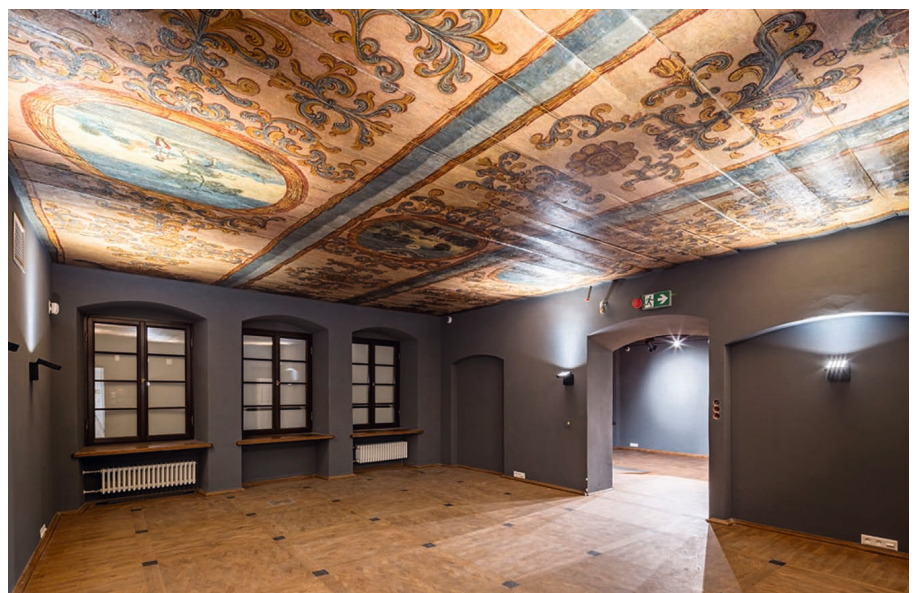
Fig. 11. The Museum of Warsaw, the room with a polychrome ceiling in the Szlichtyng tenement house (photo by Marcin Czechowicz, 2018, property of the Museum of Warsaw)

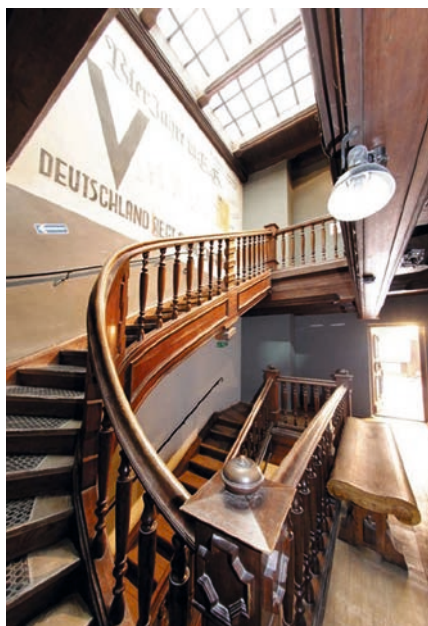
Fig. 12. Museum of Warsaw, the stairwell in the Baryczka tenement house (photo by Marcin Czechowicz, 2018, property of the Museum of Warsaw)

Smoke extraction from the historic stairwell of the Baryczka tenement house was made possible by the stepped formation of the skylight, imitating the former architectural form. The smoke window installed in the actual skylight became invisible when looked at from the stairwell. A gas fire-extinguishing installation in the rooms with polychrome ceilings came as a big challenge. It consisted of the highly discrete conducting of conduits for fire-fighting substance, separating and concealing a proper zone for gas bottles and fixing fire detectors with consideration for the historic ceilings, all of which had to be taken care of by the designers and the contractor. Of extreme difficulty was the development of the ventilation installation. Mechanical ventilation of all utility rooms needed to be ensured, which resulted in a high number of autonomous systems with ventilation control units (Fig. 10). The latter had to be hidden in tight attics with the roof geometry remaining unaltered. Challenges resulting from the construction burden were accompanied by problems concerning the construction of large-size channels and waterproofing, as well as thermal and acoustic insulation. In line with the project assumption to conceal all ventilation ducts in the walls and ceilings, a complex distribution plan was designed taking into account the different widths of the walls on respective floors. The amount of ventilation systems and the lack of possibility to install ducts beneath ceilings or pilasters in the exposition interiors, forced the team to significantly perforate

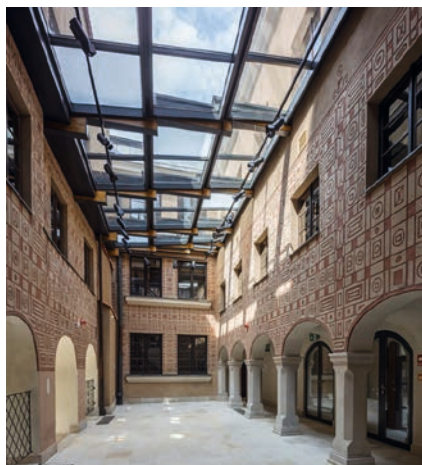
Fig. 14. Museum of Warsaw, the inner yard, 2018 (photo by Marcin Czechowicz, 2018, property of the Museum of Warsaw)
