Operational problems of tramway infrastructure in sharp curves

Włodzimierz Czyczuła

Maciej Rochel

Cracow University of Technology, Faculty of Civil Engineering, Department of Roads, Railways and Traffic Engineering

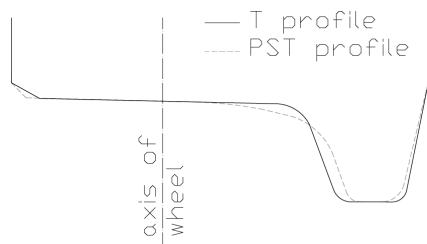
Fig. 1. Comparison of T and PST profiles, own elaboration based on (PN-91-K-8825, 1991)

There are two types of tramway wheel rim profiles: T and PST. The T-type profile is an older solution, while the PST profile is its improved version, based on the wear analysis of its prototype. The PST profile was designed and implemented at the end of the 20th century for the purposes of the Poznań Fast Tram (Staśkiewicz & Nowakowski, 2016). The profiles differ mainly in the shape and position of the flange. In the PST profile, the dimension of the guide length is selected so that the gap between the rail and the flange is 5 mm, while for the T profile, it is 2.5 mm.

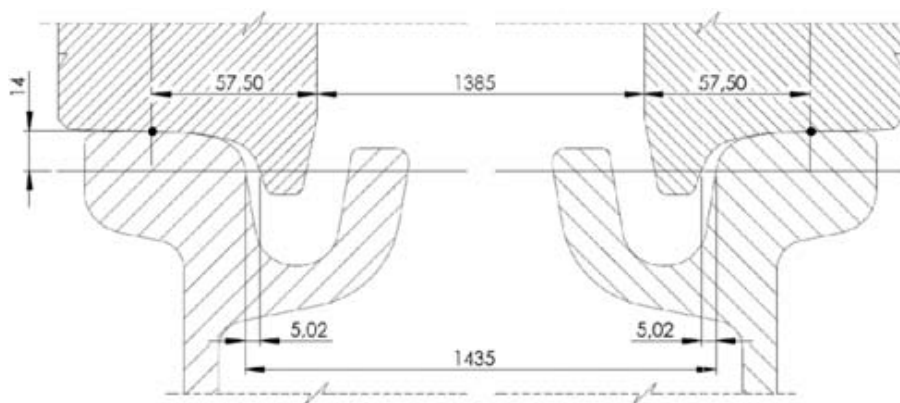
Fig. 2. Points of contact of wheel profiles with rails on the straight line (Staśkiewicz & Nowakowski, 2016)

Figure 2 shows the shape of the wheel-rail system on a straight section in a situation in which the infrastructure is relatively new and in good technical condition.

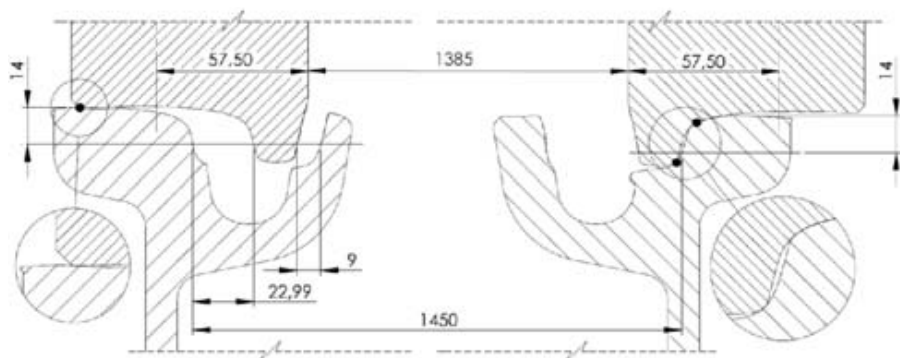
Fig. 3. Points of contact of wheel profiles with rails in the curve in the case of significant rail wear (Staśkiewicz & Nowakowski, 2016)

In the curve, the gap between the check on the inner rail and the flange of the inner wheel decreases with increasing wear of the side of the outer groove rail head and the rim of the wheel. In the limit state, the phenomenon of the two-point contact of the wheel with the rail also occurs on the inner rail track. After exceeding the critical value, the edge of the rail wheel may climb onto the rail, which may result in derailment (Grulkowski, 2009). Figure 3 shows how the contacts run in the wheel-rail system on the worn track. The track is located in the left horizontal curve with a radius of ~ 25 m. The right rail is the outer rail.

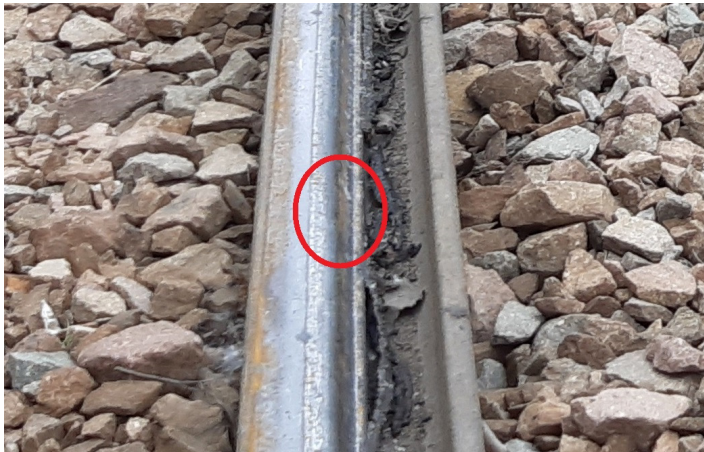
Fig. 4. Lateral wear of the outer rail head on a curve with a radius of 30 m (red - worn part of the rail) [own study]

As shown by the analysis of the wheel-rail system, the wear of the rails on the curves is gradual. After the track is put into operation, the outer rail wears out. Under the influence of passing trams, the side of the outer rail head is worn by the flange of the wheel. The described situation is shown in the Figure 4.

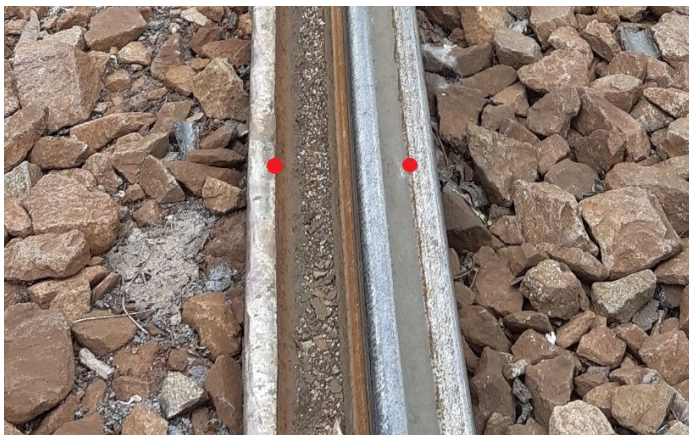
Fig. 5. Vertical wear of the inner rail head and the check on a curve with a radius of 30 m (red – places of two-point contact) [own study]

In the next stage of operation, after reaching the wear limit of the outer rail, the phenomenon of two-point contact of the tramway wheel on the inner rail occurs. This leads to progressive wear of the check on the inner rail, which may lead to a derailment when it is in a critical condition. Figure 5 shows a fragment of the inner rail on a small radius curve.

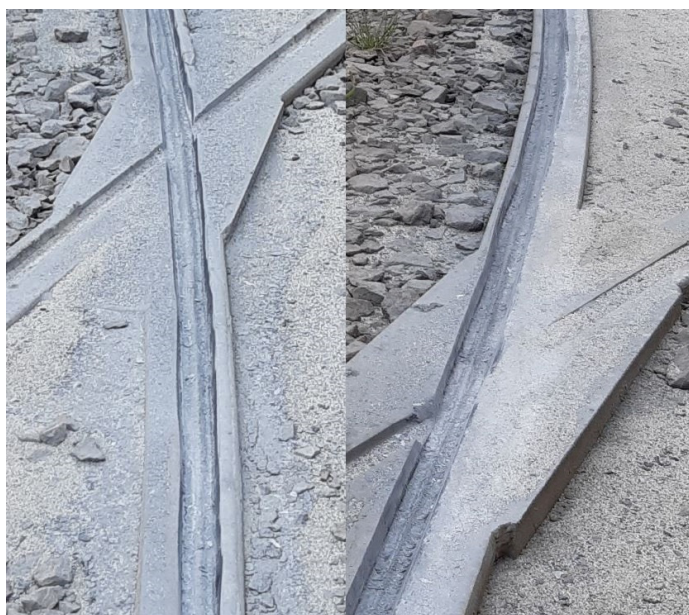
Fig. 6. Wear of a frog element and closure rails on a curve with a radius of 20 m, on the left – fracture of the left railroad, on the right – fracture of the right railroad [own study]

Figure 6 shows the significantly worn-out shallow-grooved frogs of a tramway turnout. Two traces of the flange of the wheel are visible where the groove is shallow. Also the undulating nature of the wear of the closure rail check and significant amounts of sand from tramway sandboxes are visible on the figure.

On a sharp curve with a radius of 20 m, the tramway boggie is positioned obliquely in the track and the phenomenon of snaking occurs, which makes it possible to observe the undulating nature of the wear of the track components (Grulkowski & Zariczny, 2015). Two traces of the flange of the wheel result from the different travel paths of the trailer boggie and the loco boggie. However, the wheel slip resulting from the difference of the rolling radius on the rails causes the tramway systems to detect the lack of adhesion (different rotational speeds of the wheels) and apply sand from the sandboxes.

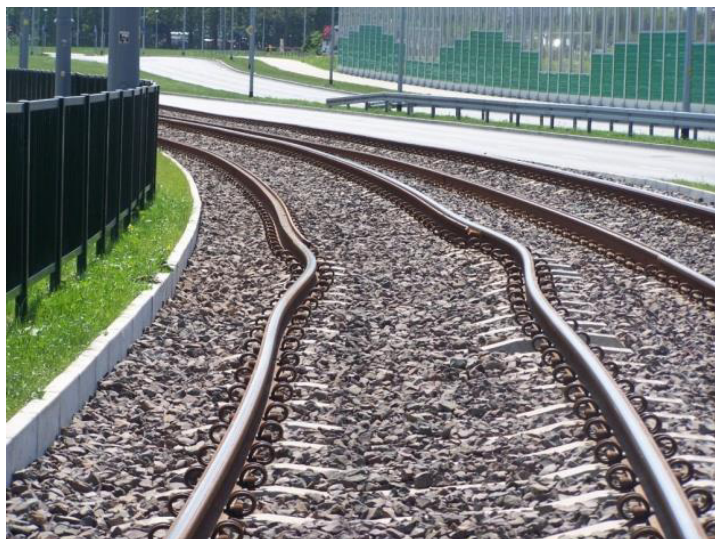
Fig. 7. Buckling of a tramway track where the rail cross-section changes (Bujak et al., 2017)

Figure 7 shows the buckling of a CWR track at the contact point of the cross-section change from grooved rail (60R2) to railway rail (49E1). By contrast, Figure 8 shows buckling of the tramway rail visible in the right rail track at the junction of the classic (ballast) surface with the tramway track surface made of prefabricated concrete slabs (ballastless track). The visible buckling is due to the threshold effect resulting from the change in surface stiffness (Sołkowski, 2009). To counteract this phenomenon, transition zones can be used, but they are not justified in tramway infrastructure. The solution to this problem is the appropriate design of locations of the change of surface type so that such buckling does not occur on the curves.

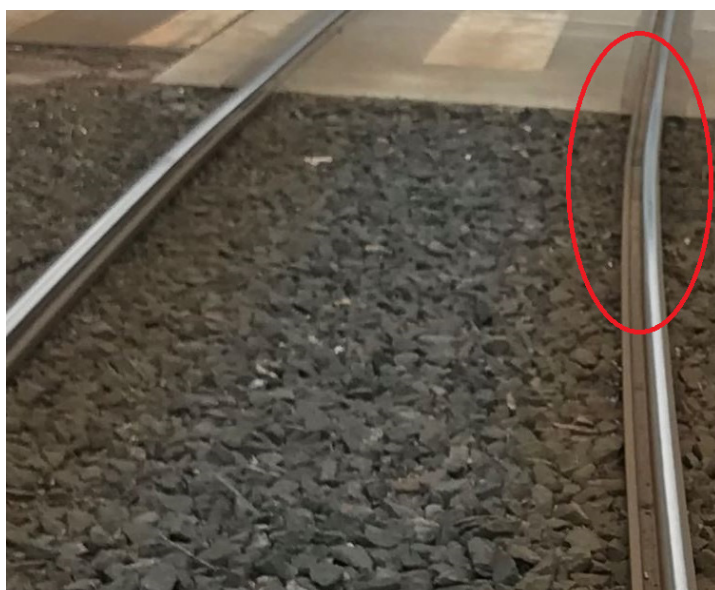
Fig. 8. Buckling of a tramway track (red) - change of the tramway track surface type from ballast track to track on a concrete slab [own study]

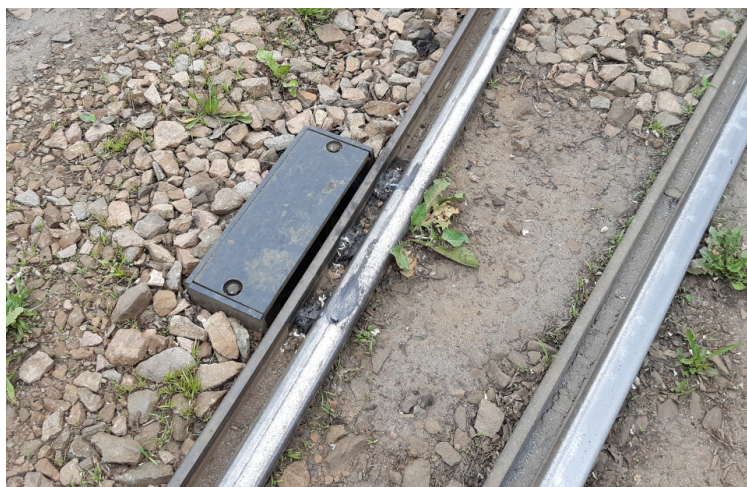
Fig. 9. Track lubricator on the closure rail in the tramway junction [own study]

- ▶ lubrication of tramway wheel rims;
- ▶ lubrication of the running surface or groove of the tramway rail;
- ▶ use of ballastless slab tramway surface filled with crushed stone or soil with grass (or sedum). The lubrication of rails and wheel rims is aimed at reducing the value of the coefficient of friction in the wheel-rail system, as a result of which, apart from reducing noise, the wear of friction elements in the tramway (rims) and infrastructure (rail heads) is also reduced (Zariczny & Grulkowski, 2009). The rails are lubricated with lubricants or friction modifiers. Most often, grooved rails used in small radius curves are lubricated through a hole in the rail head or in its groove. The method of application depends on local conditions.
