Historical, non-existing synagogue in Przeworsk

Citation: Mikrut-Kusy, A. (2021). Historical, non-existing synagogue in Przeworsk. *Technical Transactions: e2021019*. <https://doi.org/10.37705/TechTrans/e2021019>

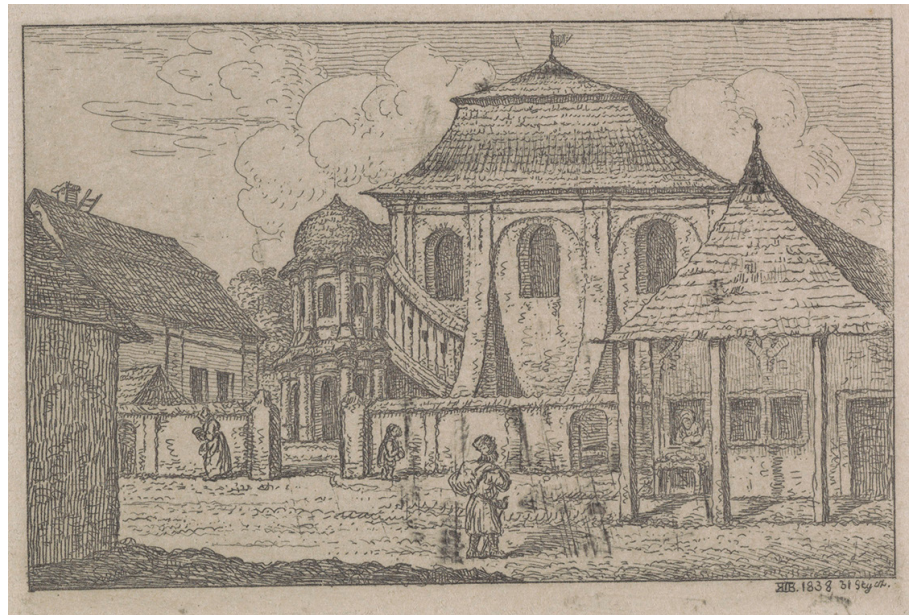
Fig. 1. Przeworsk synagogue. etching from 1838 by Kajetan Kielisiński (source: <https://polona.pl/item/boznica-w-przeworsku,NzgwMDA1Mjc0/#info:metadata>, date of access: 2021/09/02)

the eastern and western facades, had the following dimensions at their bases: ca. 1.5 m width and ca. 2 m length. Apart from an essential structural role based on transferring the thrust from the ceiling to the ground, they also had a symbolic meaning. They were made with arched volutes, which was depicted in detail on an etching from 1838 by Kajetan Kielisiński (Fig. 1). Their shape was most probably to reference impressive buttresses with so-called volutes, presented on a reconstruction of the Temple of Jerusalem as imagined by Juan Bautista Villalpando. The buttresses with arched volutes added a certain lightness to the heavy massing of the building. It should also be noted that Przeworsk's synagogue was the only such building to feature these types of buttresses (Michalski, 2020).

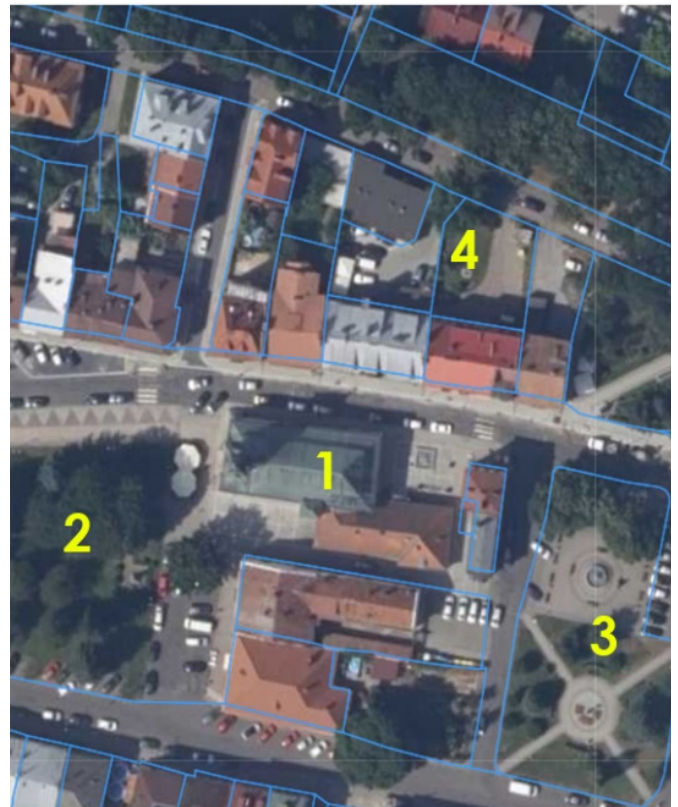
Fig. 3. Fragment of the northeastern development near the market square in Przeworsk – birds'-eye view. Markings: 1 – town hall, 2 – market square, 3 – Mickiewicza Square, 4 – supposed location of the historical synagogue. Markings: original work (source: <https://www.geoportal.gov.pl>, keyword: Przeworsk, confine: 181401_1.0003.3243/9, date of access: 2021/09/07)

The synagogue was situated on a plot between Kazimierzowska Street and Mickiewicz Square, close to the town hall and the market square. Its location resulted in the gradual takeover of the land in this part of the city by the Jewish population. The synagogue was set back relative to the building line of the northern frontage of the market square and was separated from the street by a wall (Fig. 6). In the northwestern corner of the plot there was also a masonry rabbi’s house, whose gable faced the road. Unfortunately, the exact location of this development complex is in no way visible in the present-day spatial layout of the city. In post-war times, the borders of plots were changed and secondary alterations were made, with the land being successively developed afterwards. The former location and outline of the synagogue were clearly presented on the city’s cadastral plan from 1852 and the field sketches from 1849 that had preceded it (Fig. 2).

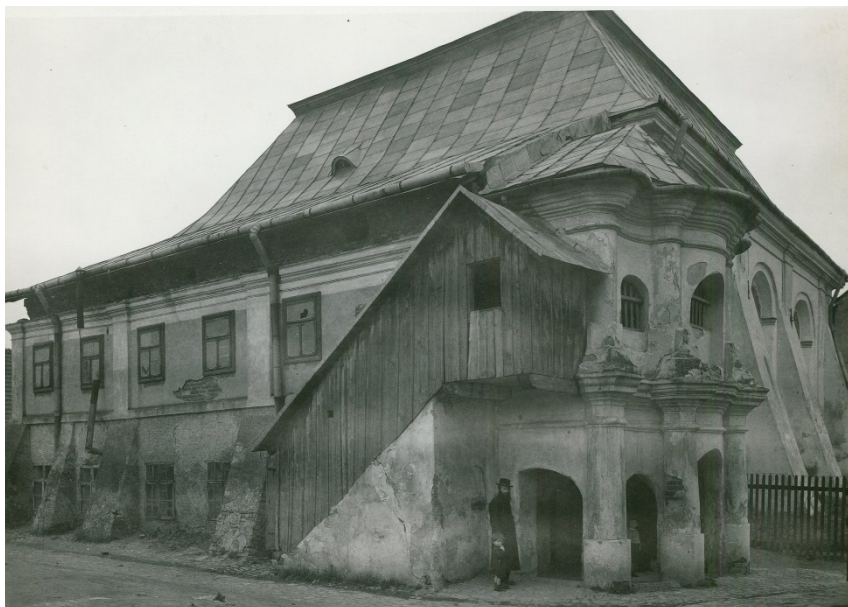
Fig. 5. Przeworsk synagogue, 1934 (BN, sign. F.118219/II)

In addition, the southern and eastern facades of the synagogue were enhanced by pilasters, above each buttress, that reached up to the topmost cornice. The walls were dominated by tall, arched windows, typical of synagogues, placed between the buttresses. The building was covered by a tall hipped Mansard roof, which initially featured shingle roofing. Synagogues in Tykocin or Tomaszów Lubelski also had such roofs (Gliński, 2020).

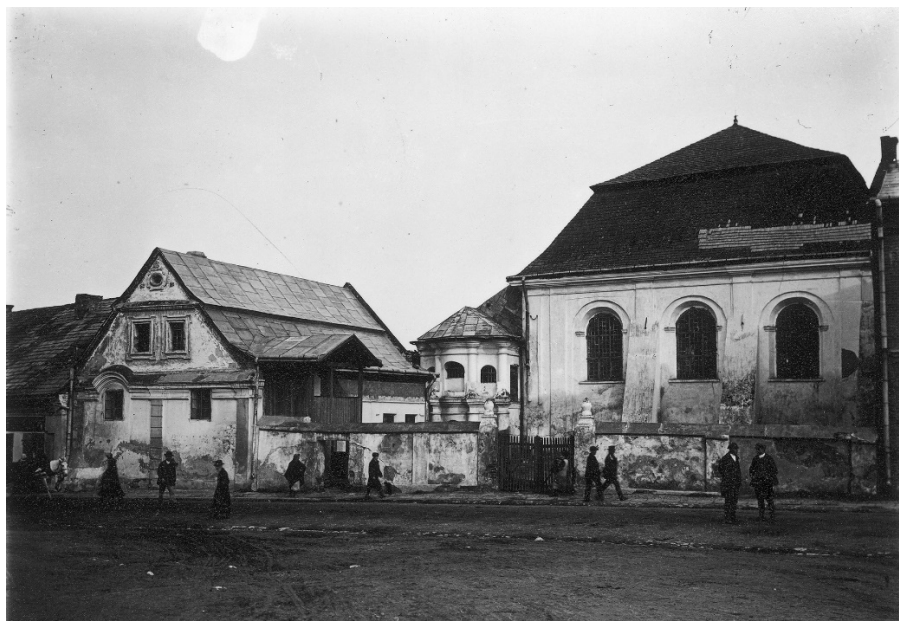
Fig. 6. Synagogue in Przeworsk and the rabbi's house with a library (ca. 1880–1939) (NAC, sign. 3/41/0/-/1163)

galvanized steel sheets. Unfortunately, in that same year (12 September 1939) German forces set fire to the synagogue (Rosenberg, 1997). Nearby buildings, including the rabbi's house, which included a valuable library (Fig. 6) were consumed along with it. The ruins of the burnt-down synagogue, and those of Jewish houses, were dismantled in the spring of 1940 (Kozak, 2018: 48).

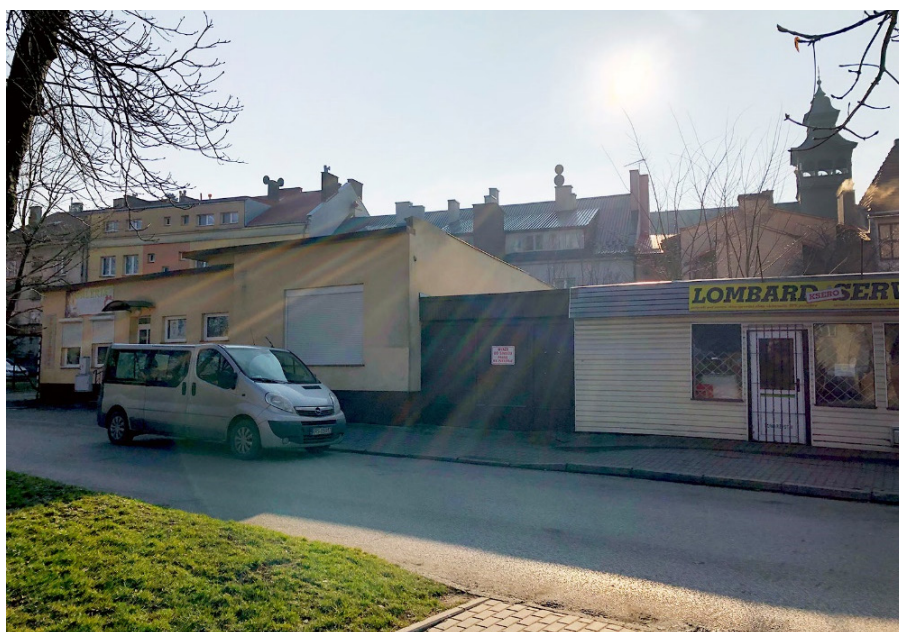
Fig. 7. Contemporary development at the site of the historical synagogue and Jewish quarter in Przeworsk. Photo by author
