Methods for Protecting, Conserving, Repairing and Reinforcing Highly Vulnerable World Heritage Sites: Guidelines for the Sector BI of the Former KI Auschwitz II-Birkenau Master Plan for Preservation

Auschwitz II-Birkenau, sector BI

Research project

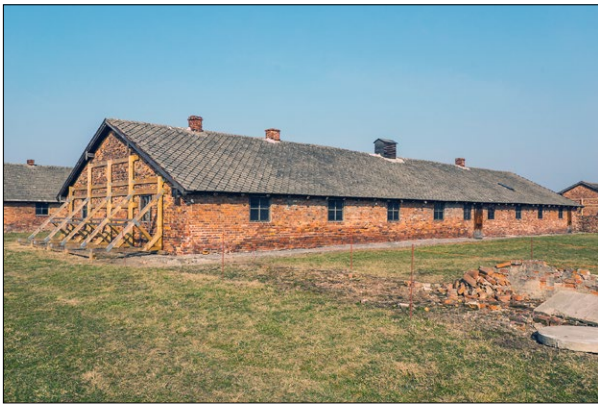
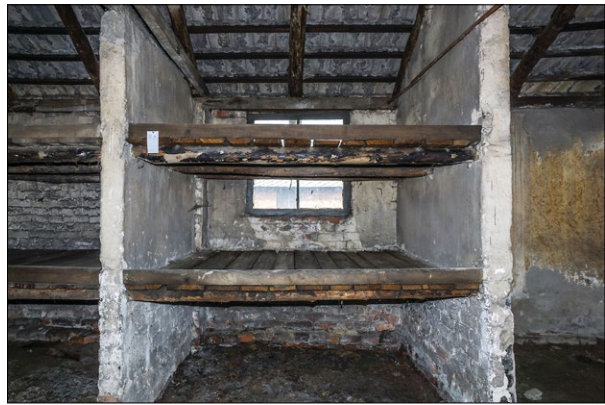
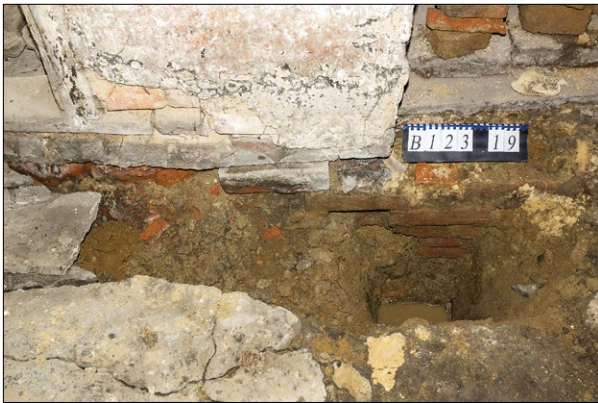
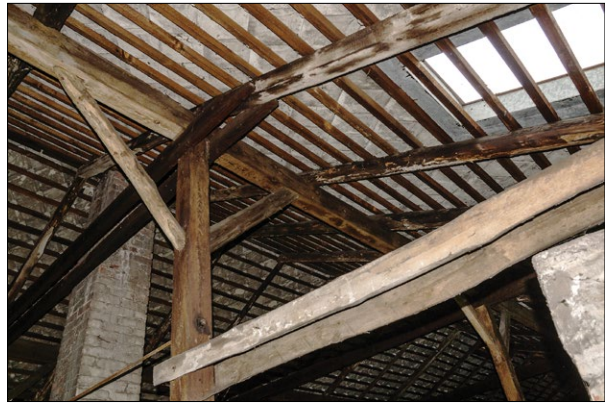
Fig. 3. Barrack B-123, photographic documentation from field research: a—general view, gable wall supported by scaffolding and anti-collapse corset; b—view of the interior, so-called bucks; c—view of the interior, excavation in the floor; d—view of the interior, deformation of the roof truss; photos by B. Krcha 2015.

and constructional conditions required the preparation of individual methods of reinforcement, conservation, and protection. The most difficult tasks in the case of prisoner barracks B-123 and B-124 included restoring the original geometry and original features of deformed and cracked external walls while preserving the original structure of the buildings, ensuring the required level of safety and functional features of the roof load-bearing structure, and stabilizing the foundations of the residential barracks, In particular, protecting the foundations and floors from blow-out phenomena, ensuring the protection of masonry structures and furnishings, including partition walls from capillary rising damp and moisture generated by plant growth and microorganisms.

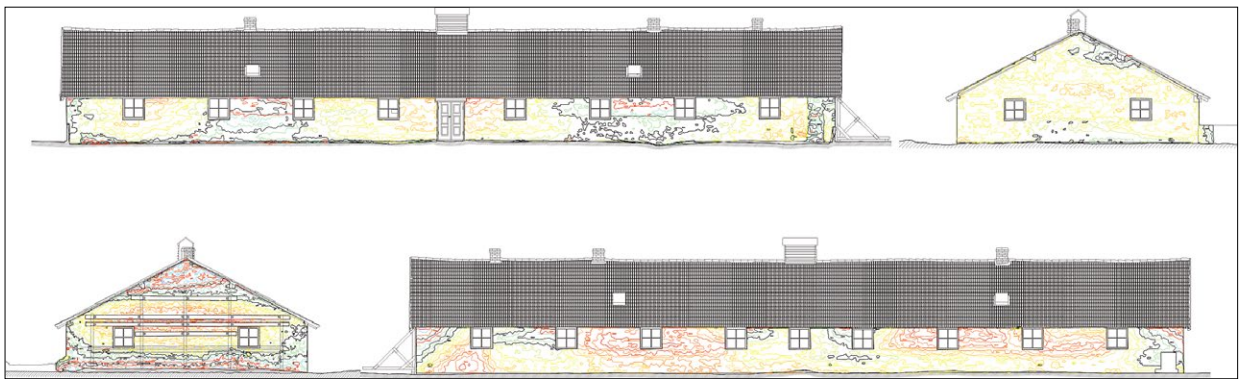
Fig. 5. Scan image of the gable wall of barrack B-123 based on scans provided by Geotronics Poland; source: S. Karczmarczyk et al., op. cit., by R. Paruch.
