Reasons for Deterioration of Historical Buildings and the Significance of Memory in the Adaptive Reuse Process of Architectural Heritage: Case Study of Saint Vincent de Paul School in Istanbul

Case study: St. Vincent de Paul French School Complex

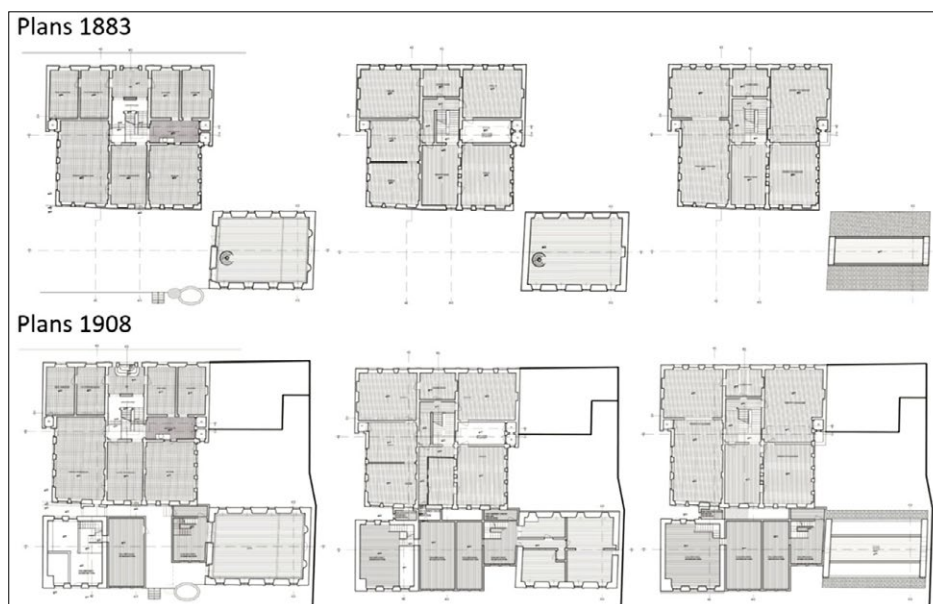
Fig. 3. Plans of the school complex in 1883 and 1908 according to restitution projects; by H.A. Doğan
Ryc. 3. Rzuty zespołu szkolnego w latach 1883 i 1908, na podstawie projektów rewaloryzacyjnych; opr. H.A. Doğan

According to the certificate, which was found in the Ottoman Archives, due to not having enough space in this brick building, one brick and two wooden structures were added in 1908 to the backyard of it. The school was listed in the list of French institutions in Istanbul by the Ottoman-French reconciliation signed in 1913. The same document stated that the school included a convent, church, boarding and day school, workshops and dispensary departments [Polvan 1952, pp. 176–177]. Furthermore, it is stated in various sources that the school had 120 female students when it was first opened in 1883 [Polvan 1952, pp. 177–178; Belin 1894, p. 468–469]. However, during the First World War, the school had to close again. In this period, while the nuns left with some students and returned to France, the priest of the chapel stayed in Istanbul. According to the Necip Bey maps from 1918, the building accommodated the police station of the district in this period. However, when the history of the police station is investigated, there is no information found regarding moving to this building around those dates.

The changing conditions over time and the new demands that arise accordingly tend to lead to the devaluation and deterioration of historical buildings. The first deterioration in the main building occurred during its occupancy by the nuns, who were the first owners. The increasing number of students over the years made it necessary for the nuns to build new structures in the backyard as an extension. Three buildings were added in the backyard in 1908, which led to changes in the planning scheme of the building to provide circulation between the new buildings and the main building (Fig. 3).

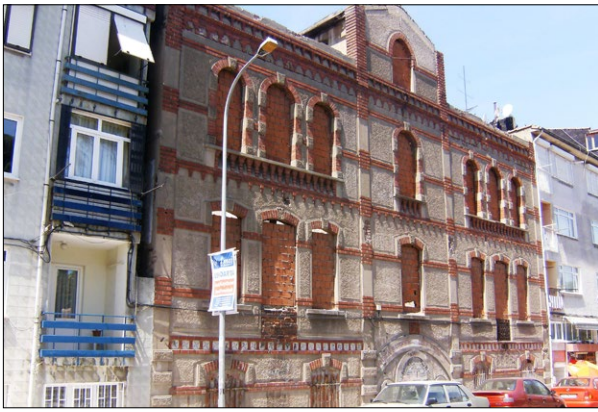
Fig. 4. Front facade of the building, 2009; photo by H.A. Doğan
Ryc. 4. Elewacja frontowa budynku, 2009; fot. H.A. Doğan

The door and window openings on the front facade of the building were removed and closed with bricks to prevent homeless and addicted people from entering the building (Fig. 4). The wooden structures in the backyard of the main building disappeared entirely due to neglect and natural conditions.

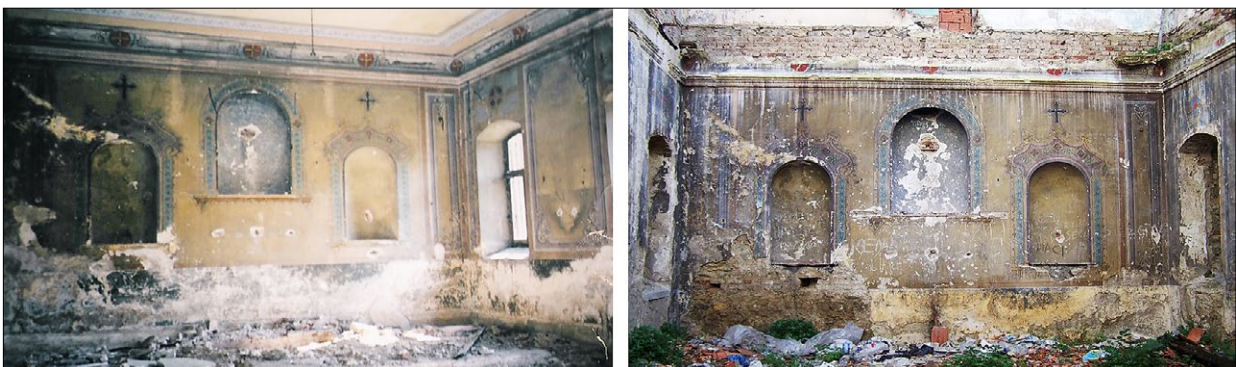
Fig. 5. Interior of the chapel in the 1980s, from the archives of Nezhil Uzel, and in 2009, by H.A. Doğan
Ryc. 5. Wnętrze kaplicy w latach osiemdziesiątych XX w., z archiwum Neziha Uzela, oraz w 2009 r., fot. H.A. Doğan

According to the photographs found in the personal archives of Nezhil Uzel, the first floor of the chapel existed until the late 1980s. The ground floor of the chapel was used with its original function until the nuns left the building. However, the first floor was divided into smaller rooms during the changes of 1908, and this floor started to be used as an extra living space. The frescos on the ground floor were affected by the weather conditions even when the first floor existed (Fig. 5). However, the deterioration aggravated after the first floor and the roof collapsed.

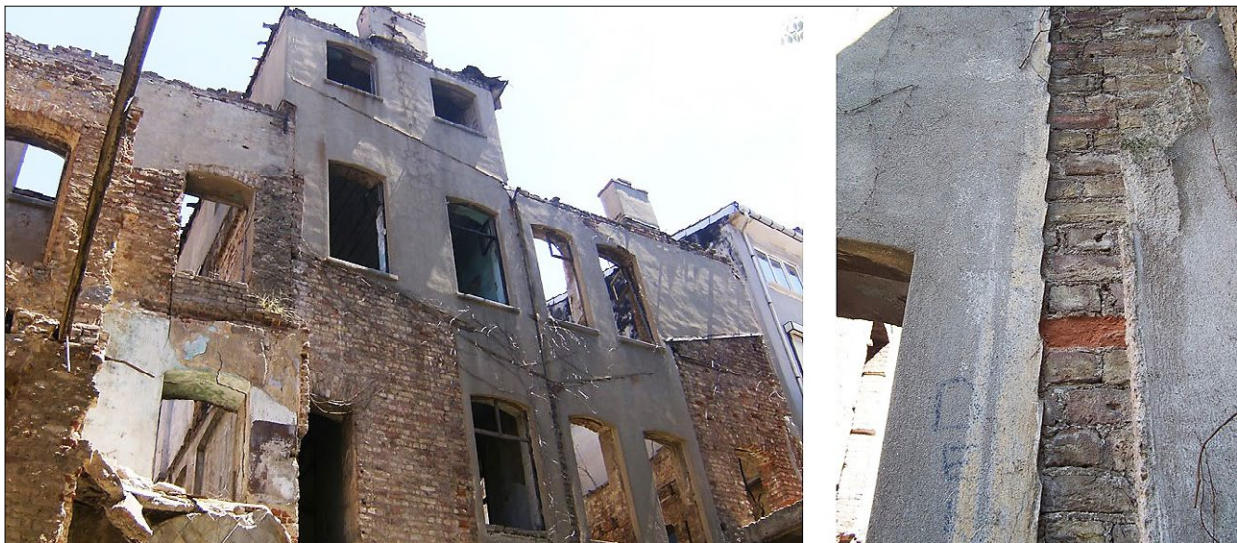
Fig. 7. Traces of the wooden structures at the rear facade of the main building; photo by H.A. Doğan
 Ryc. 7. Ślady obiektów drewnianych przy tylnej elewacji budynku głównego; fot. H.A. Doğan

Even though the expertise reports of June 1994 suggested demolishing and reconstructing the building, since it was thought that it might not be possible to restore the building, the commission for the preservation of cultural heritage decided to protect the building the way it had been in the very same month. When the preparation of the restitution and restoration projects began, the school complex consisted of the main building, the chapel and the added brick building, and the wooden structures no longer existed at the time (Fig. 7). It was possible to fol-

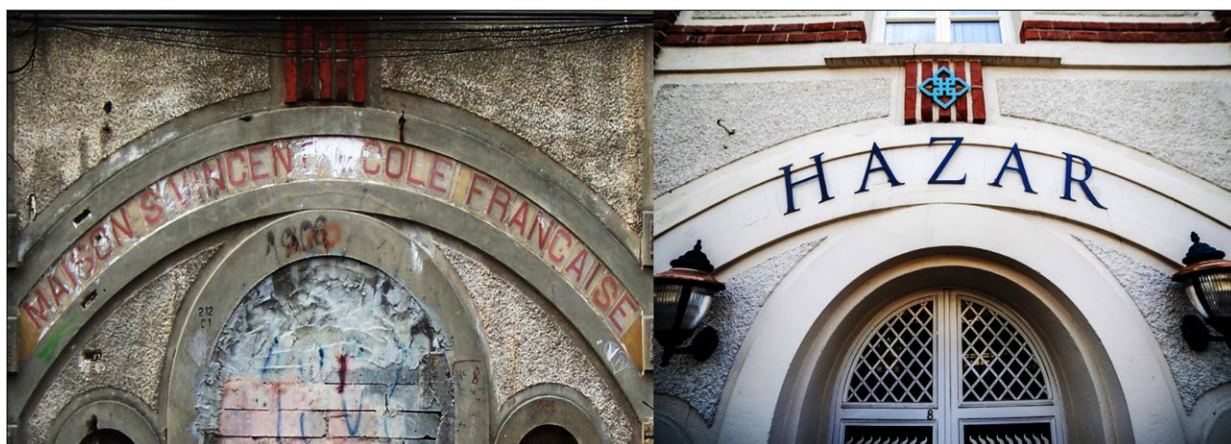
Fig. 10. The sign on top of the entrance – before and after the restoration; photo by H.A. Doğan
Ryc. 10. Znak nad wejściem – przed i po rewaloryzacji; fot. H.A. Doğan

Moreover, the sign at the entrance of the building, which used to state that it was a French school, is also removed from the facade (Fig. 10). Deleting the sign of the French school has a direct effect on the cultural memory of the neighborhood. The building used to be known as the French school in the district for many years. However, the change of the sign would make this forgotten by the new generations.
