First Seasons of Work and Research of the Polish-Egyptian Conservation Mission El Darazya – Marina el-Alamein (Architecture, Archaeology, Conservation)

Introduction (by Rafał Czerner)

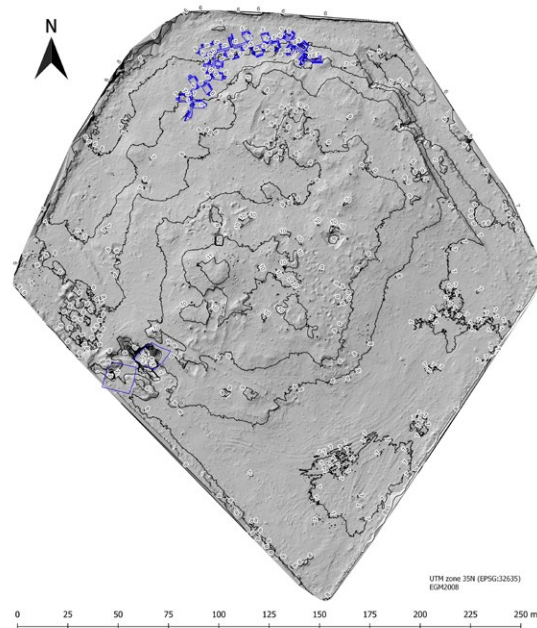
Fig. 2. Digital terrain model of the Darazya site with contours and layout of the underground structures; by B. Ćmielewski. Ryc. 2. Cyfrowy model terenu stanowiska Darazya z warstwicami i układem podziemnych struktur; oprac. B. Ćmielewski.

Nine geodetic points were established. We chose one of the points as the first one and determined its coordinates using the GNSS-PPP method (based on 5 hours of observation). It was then used as constant for creating a net of the GNSS vectors between successive points. In the next step, the vectors were calculated and adjusted to create a spatial network of points. These were used for traditional land surveying and georeferencing photogrammetry projects. Then, the surveys were successively taken using a 3D camera combined with distance measuring sensor, respectfully to a network of control points. This made it possible to collect spatial data describing the site in terms of elevation (Fig. 2), and also indicated the location of some underground structures—shelters, cisterns.

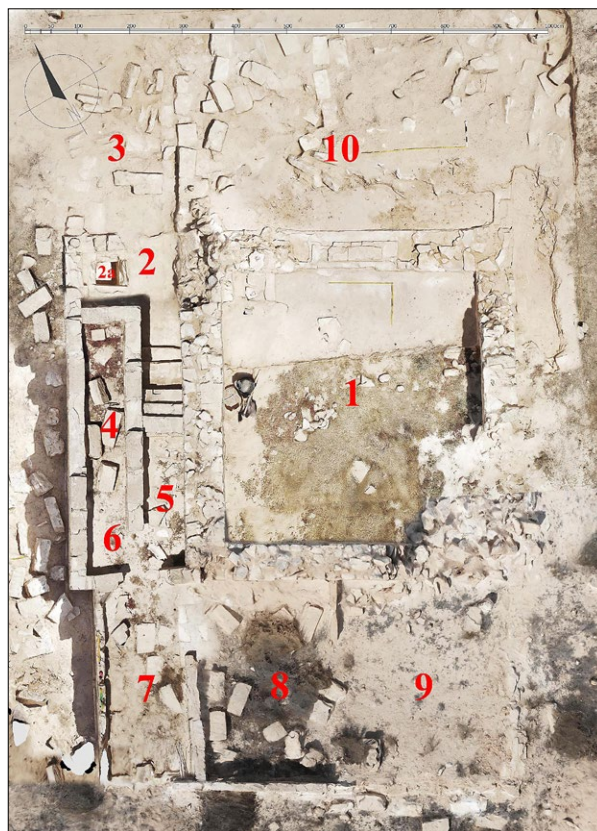
Fig. 3. House H1, topographic photoscan with room indications; by S. Popławski.

The investigation found that the house functioned as an oikos-type residential house—i.e., with a main reception hall organizing its layout. The house consisted of several rooms. Apart from the oikos hall (1), the following spaces led from it: from the west, a stairwell (2, 4–6) and three interconnected rooms (7–9) from the south. Two entrances from the north led to the main hall and a stairwell from the rest of the house, which has not yet been fully explored. Therefore, the extent of the next rooms from the north (3 and 10) and the question of whether this was also the boundary of the building remains undetermined.

The remains of the main hall measuring 5.14 m (north–south) by 4.94 m have walls 0.76 m thick, built from rubble masonry, bonded with clay and plastered with lime mortar. In the northern wall, the remains of a central entrance were discovered—1.61 m wide, framed with limestone blocks, preserved to a height of

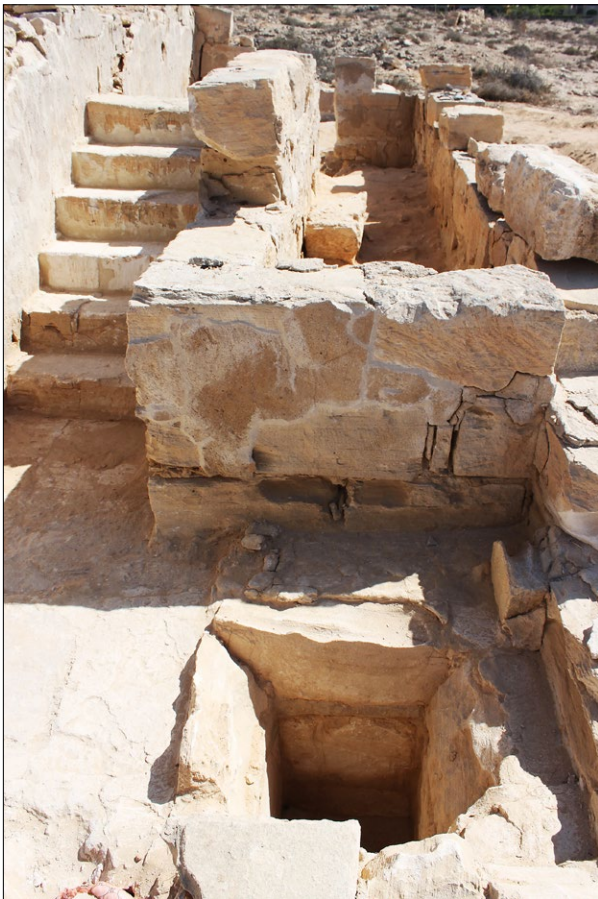
Fig. 4. House H1, vestibule 2; photo by R. Czerner.
Ryc. 4. Dom H1, przedsionek 2; fot. R. Czerner.

× 1.9 m), added to the main hall from the west during the secondary phase. Its walls are made of regular limestone ashlars. The entrance to it and to the stairs starting in the eastern flight led from the north. Alongside, in the northwest corner of the vestibule (2), a casing of a square well opening (0.44 × 0.45 m), possibly with the function of a latrine, made of limestone slabs, with a depth of 0.84–0.95 m, was discovered, from which a canal led northwards at the bottom, perhaps towards an underground reservoir, probably a cloaca. (Fig. 4). The floor in the vestibule was made from limestone slabs.

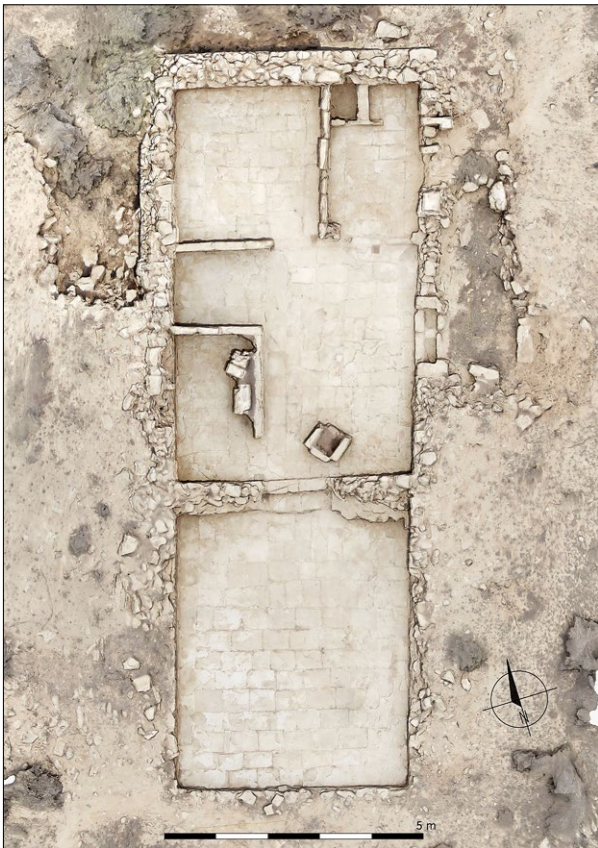
Fig. 6. House H3, topographic photoscan; by S Popławski.
Ryc. 6. Dom H3, fotoskan topograficzny; oprac. S. Popławski.

A preliminary analysis of the relics of these houses was conducted in 2021. In the next season, a topographic survey of the remains of both structures was made via the photo-scanning method. H3 is an oikos-type house with a main reception hall to the south, open with a wide entrance onto a courtyard surrounded by four smaller rooms to the west and north. Two entrances to the house were from the east (Fig. 6). House H2 appears to have a more developed use (Fig. 7). While studying the house, some relics of a small added-on structure were found, adjacent to the lower part of the column preserved in situ (up to a height of about 1.5 m). A fragment of architectural decoration that may have come from the top of a wall aedicula was also found, reused as material in a wall made of broken stone. The area of house H3 was decluttered, arranged and cleared in preparation for future conservation.

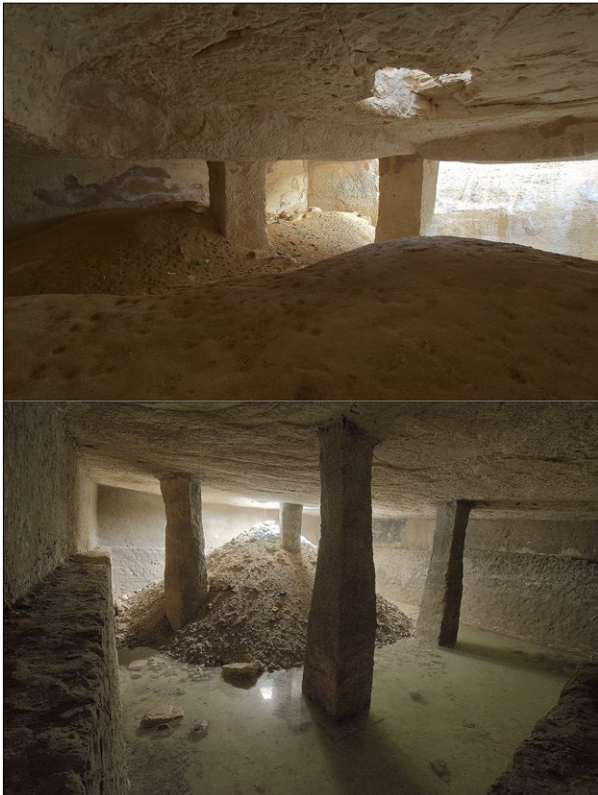
Fig. 8. Underground cisterns C1 and C2; photo by P. Zambrzycki, S. Popławski.
Ryc. 8. Podziemne cysterny C1 i C2; fot. P. Zambrzycki, S. Popławski.

In the southern part of the site, an underground cistern designed as C1 identified by Egyptian archaeologists in 2006, was studied by the mission during its first seasons (Fig. 8). Another cistern designed as C2 was discovered in 2022 fully preserved underground. The channel leading to its inlet from an above-ground pool was also identified. Similar cisterns are known from the Marina el-Alamein site [Bentkowski 1991, pp. 20–23].

Cistern C1 carved into the limestone bedrock is about 4–5 m high and its plan represents an irregular quadrangle with walls ranging from about 10.4 to 12 m long. Its ceiling is supported by two pillars. The vertical shaft of the well and the remains of the channel supplying water to it have been preserved. The southern wall of the cistern was destroyed during earthworks related to the construction of a modern road, which was abandoned as a result.

Cistern C2, similar to a square in layout, measures approximately 13.42 × 13.5 × 4.8 m. It was completely carved into the parent limestone. Its ceiling is supported by four unevenly spaced pillars. The inlet to the tanker from the top is located on the east–west axis, one quarter of its length from the western wall. In the lower part of the cistern stands a circular bench 0.35–0.95 m wide and 3.0 m high above the bottom of the tank.

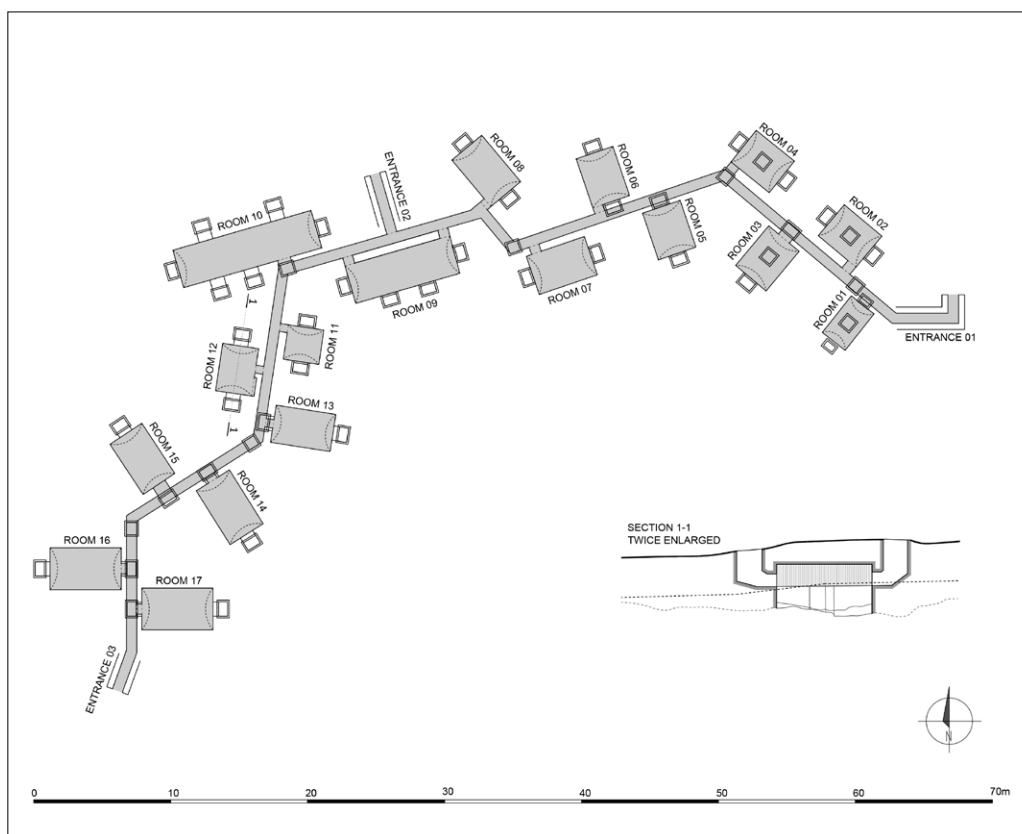
Fig. 9. Map of underground structures from the Second World War; drawing S. Popławski.
Ryc. 9. Plan podziemnych struktur z II wojny światowej; rys. S. Popławski.

The relics of structures from the Battle of El Alamein preserved at the site were distinguished as a result of 3D prospecting, photo-scanning and then field surveying. A total of 17 underground rooms were revealed, connected by a shared corridor with three entrances from the ground level (Fig. 9). In addition, the remains of three small structures have been noted on the surface, one of which has survived in fairly good condition.

The underground complex was built of limestone blocks and covered with reinforced concrete coatings poured over corrugated sheet formwork. The corridors are topped with a flat ceiling, while the halls are vaulted. Each room is illuminated and ventilated by openings located in the gable walls of the rooms and led slightly above the ground level through rectangular brick chimneys. The highest recorded height in the interior is 2.30 m. The dimensions of the individual rooms vary between 2.53 × 2.62 m and 2.84 × 10.50 m. The corridors have their own lighting panes, square in cross-section. Underground passages are between 0.74 and 0.78 m wide.

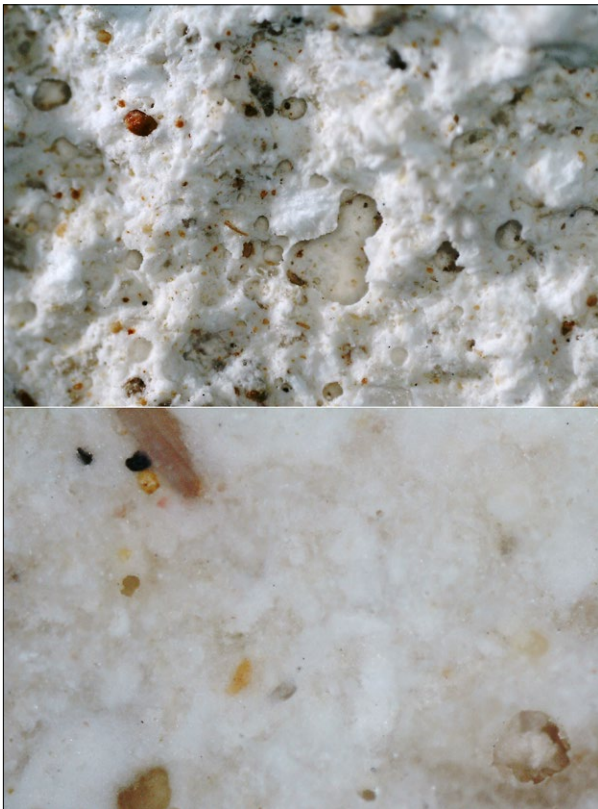
Fig. 10. Top: fragment of plaster from the eastern wall of the stairwell in H1 house, image at X20 magnification; bottom: fragment of the mortar pointing the ashlars from the western wall of the stairwell, house H1, X200 magnification; photo by P. Zambrzycki.

As a result of the analyses, it was found that lime-sand mortar was used to plaster the walls of the stairwell. Most of the mortar filler is finely crushed local limestone or sea sand. In places, thick, well-dusted grains of quartz sand are visible with a highly crystallized binder (CaCO_3) (Fig. 10). In the case of the steps, most of the mortar filler consists of finely crushed local limestone or sea sand. In places, thick, well-dusted grains of quartz sand are visible with a highly crystallized binder (CaCO_3). This kind of mortar was also used for pointing the ashlars used in the wall structure and the floor slabs (Fig. 10).
