A Crime against Historical and Cultural Heritage: Destruction of the Architectural Image of the Main Street of Kyiv in 1941

Keywords: destruction of buildings, Kyiv, Second World War, Khreshchatyk architecture

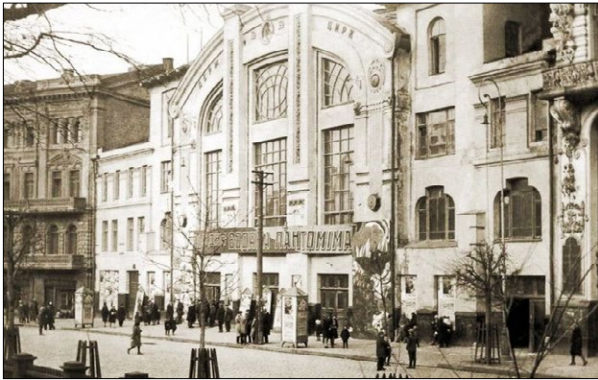
Fig. 3. Kyiv Horse Circus, 1941; source: Collection of the G. Pshenychny Central State Archive of Phonographic and Film Documents.

The explosion also destroyed the Hippo Palace, the Horse Circus. The building was designed by architect Eduard Brandtman. The style of the building was dominated by eclecticism, as well as the architect's own style in the spirit of fashionable Art Nouveau. He is also the author of the Art Nouveau mansion of Arshavsky, built in Kyiv on Liuteranska Street later. The architect made extensive use of reinforced concrete, glass, and décor, which are characteristic of the Art Nouveau style. A wide three-part arch-window was placed on the main facade of the building, which became the architectural dominant of the two-story structure with the restraint of the corner décor (Fig. 3).

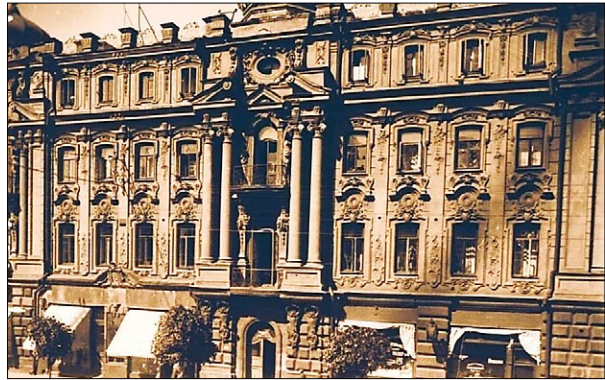
Fig. 4. Khreshchatyk Street, Kyiv National Hotel, 1934; source: Collection of the G. Pshenychny Central State Archive of Phonographic and Film Documents.

No less interesting was K. Pastel's apartment building on the corner of Khreshchatyk and Mykolaivska streets. The building impressed with its Viennese Art Nouveau forms, followed by apartment buildings in the style of "merchant architecture" by Degtyarev, Bisk, Linnichenko, Madame Klug, Kalif, and other eminent homeowners. But the main landmark in this row was undoubtedly the National Hotel (architect Mykolaiv), which closed the odd side of the street. The architect managed to turn an ordinary three-story building into an imposing castle with rooms for visitors by building massive towers with residential premises at the corners. However, the building was destroyed by explosions and fires [Tretiak 1998, p. 104] (Fig. 4).

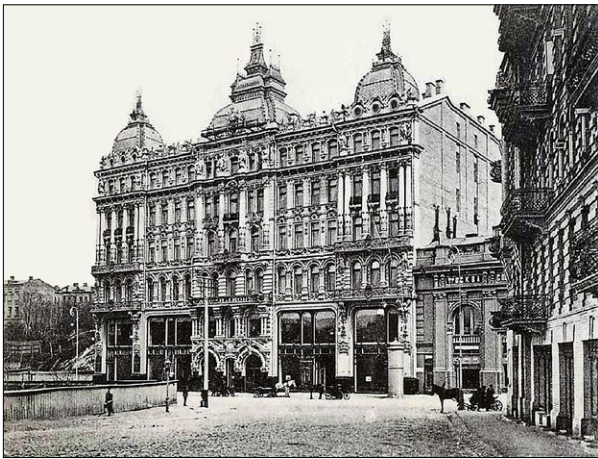
Fig. 5. Khreshchatyk Street, Ginzburg House, 1936; source: Collection of the G. Pshenychny Central State Archive of Phonographic and Film Documents.

The explosion also destroyed the famous Ginzburg Skyscraper (Fig. 5, 6). The building had 2 floors, four-story ceilings, and was 67.5 m high with a tower offering magnificent views. There were no buildings of this scale in Ukraine or in the Russian Empire. Ginzburg's skyscraper was one of the tallest buildings in Europe. 94 apartments (some had eleven rooms), a huge

staff of service personnel: the building immediately became a legend because it was the most modern in Kyiv, with rare forged elevators made by the American company Otis. The first floors were used for grocery stores. It was a comfortable place to live. Many businessmen and celebrities of the time did so [Tretiak 1998, p. 94].

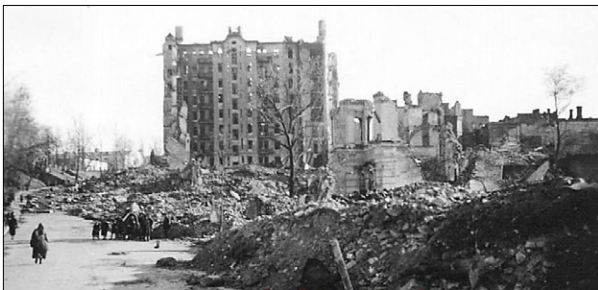
Fig. 6. Remains of damaged buildings along Khreshchatyk Street in the Fall of 1941; source: collection of the Malakov family.

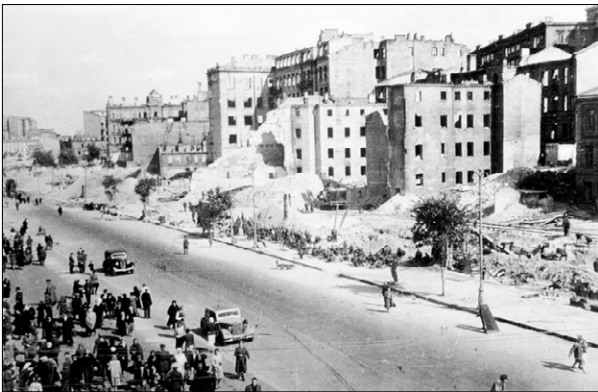
Fig. 7. Remains of the Ginzburg House, 1941; source: collection of the Malakov family

destroyed. The collection of photographic documents of the State Archives of the Kyiv Oblast contains materials that testify to the destruction of the first quarter of Architect Horodetskyi Street (modern street names); Zankovetska Street; Stanislavskyi Lane; the lower part of Lutheranska Street, part of the buildings on Prorizna Street; the outermost houses on Pushkinska Street from Prorizna to Bohdan Khmelnytskyi Street; almost the entire even side of Instyutyska Street [Collection of photographic documents 1942, p. 4]. Here we also find a map of the destroyed central part of Kyiv [Collection of photographic documents 1942, p. 6]. In a matter of days, the capital's residents lost their favorite theaters, cinemas, shops, post offices, hotels, a conservatory, and a music school. The massive explosions turned the historic center of Kyiv into ruins, destroying 324 buildings, some of which were lost forever. The fires killed not only representatives of the occupation authorities, but also a significant number of Kyiv residents. An even greater number of city residents lost their homes (Fig. 7).

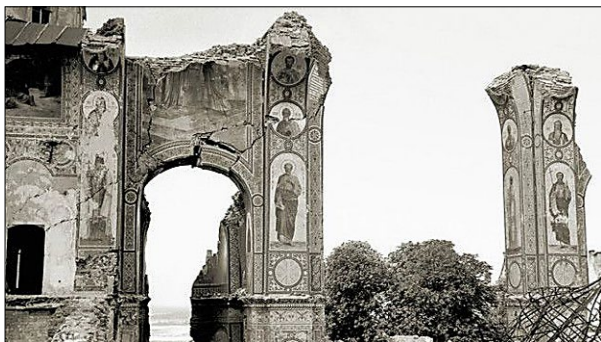
Fig. 8. Ruins of the Dormition Cathedral of the Kyievo-Pecherska Lavra, 1941; source: collection of the Malakov family.
Ryc. 8. Ruiny Katedry Zaśnięcia Matki Boskiej, Peczerska Łavra, Kijów, 1941 r.; źródło: zbiory rodziny Małakowów.

The biggest tragedy for Kyiv residents was the explosion of the Assumption Cathedral of the Kyiv Cave Monastery. For centuries, the monastery has been not only a religious but also a cultural, educational, artistic, and scientific center of the city and Ukraine as a whole. The Assumption Cathedral was founded in 1073 and built from 1075 to 1078. It was originally a cross-domed, six-pillared, three-nave cathedral with one central spherical dome on a cylindrical pediment. There were choirs in the western part. In the eastern part of the church there were three apses, faceted on the outside and cylindrical in the interior. The cathedral was built using the opus mixtum technique, i.e., from plinth and stones with cement mortar. There were frescoes and mosaics on the walls of the cathedral. The spatial composition of the interior was completed by the floor: it was mosaic in the altar, and the rest was partially laid with red slate slabs. In 1767–1769, architects S. Kovnir and Y. Bilynsky crowned the cathedral's facades with Baroque pediments with lush ornamental floral carvings on fresh plaster [Historical and urban planning studies of Kyiv 2012, p. 179] (Fig. 8).

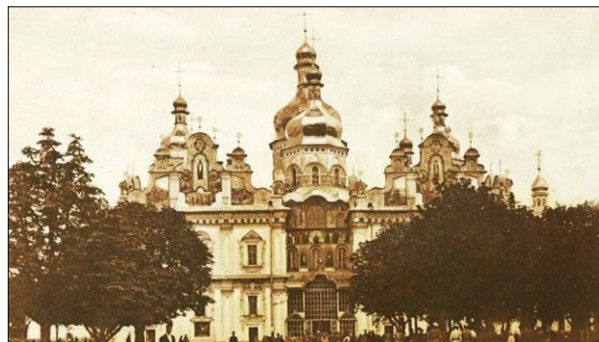
Fig. 9. Cathedral of the Dormition, Kyievo-Pecherska Lavra, 1941; source: Collection of the G. Pshenychny Central State Archive of Phonographic and Film Documents.
Ryc. 9. Katedra Zaśnięcia Matki Boskiej, Peczerska Łavra, Kijów, 1941 r.; źródło: Zbiory Centralnego Państwowego Archiwum Dokumentów Fonograficznych i Filmowych im. G. Pszenicznego.

As a result of the mining of the cathedral by the Soviet secret services, only fragments of the eastern wall, part of the baptistery, the altar of St. John the Theologian, and two pillars of the eleventh century remained of the architectural monument [Kabanets 2011] (Fig. 9).
