# WIADOMOŚCI KONSERWATORSKIE

JOURNAL OF HERITAGE CONSERVATION

83/2025

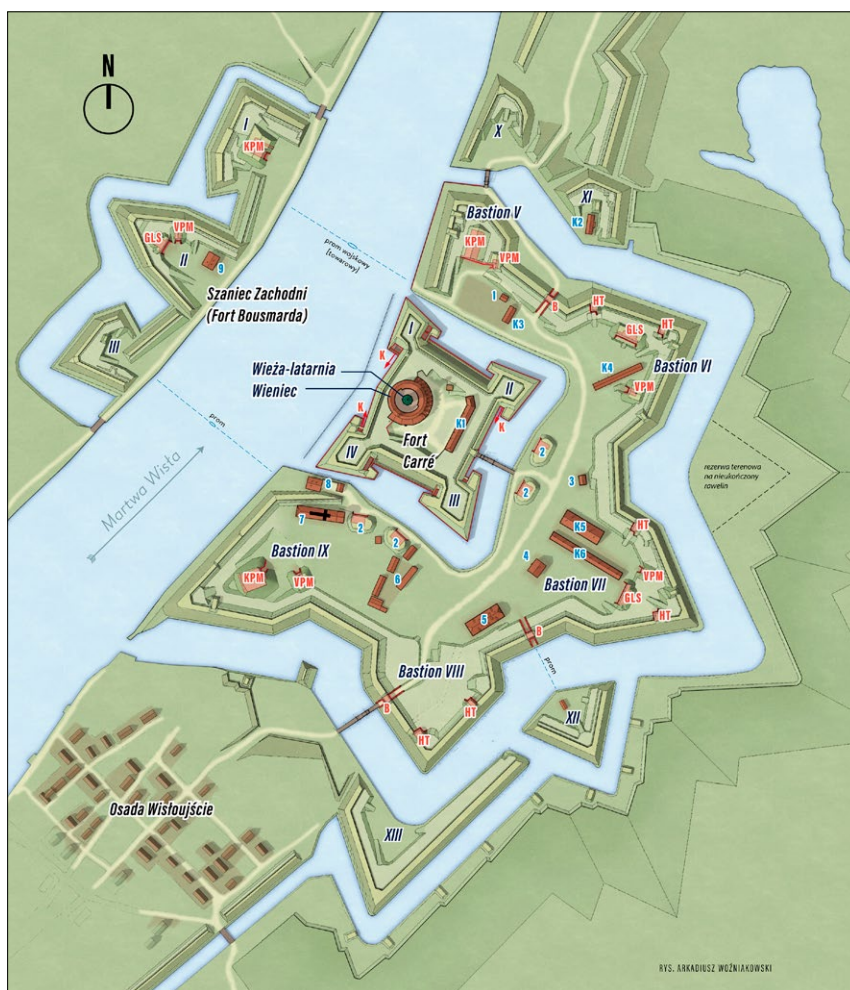
Ryc. 3. Plan Twierdzy Wisłoujście wg stanu na koniec lat 70. XIX w.; na czerwono zaznaczono obiekty fortyfikacyjne z rozbudowy XIX-wiecznej (KPM – wojenny magazyn prochu; VPM – podręczny magazyn prochu; GLS – przygotowalnia amunicji/warsztat amunicyjny; HT – remizy wałowe; K – stanowiska dział kazamatowych; B – bramy forteczne); na niebiesko zaznaczono pozostałe obiekty zaplecza (K1–K6 – koszary; 1 – dom letni komendanta twierdzy z ogrodem; 2 – skazamatowane wartownie z końca XVIII w.; 3 – stary magazyn prochu; 4 – dom walmistrza na Szańcu Wschodnim; 5 – wozownia artyleryjska; 6 – zespół zabudowań składu materiałowego twierdzy; 7 – kościół pw. św. Olafa; 8 – budynek administracji wojskowej; 9 – dom walmistrza Szańca Zachodniego); rys. A. Woźniakowski, na podst. planu wykonanego na zlecenie Muzeum Gdańskie

The modernization works covered not only Fort Carré, but also the former seventeenth-century bastion ramparts on both sides of the Vistula River (Fig. 3). Although both ramparts (the Eastern Rampart and the Western Rampart) were partially dismantled in the eighteenth and early nineteenth centuries, their bastion layout was restored after reconstruction during the Napoleonic period.<sup>4</sup> After the French army occupied Gdańsk, fortification work on the fortress continued, with the two missing bastions and ravelins on the south side being built, and a covering defense at Bastion IV<sup>5</sup> [Stankiewicz 1956, p. 143]. What is more, as late as 1857, there were plans to reinforce the Eastern Rampart by building a ravelin between bastions VI and VII [GStAPK 1857, ref. no. G 70465].

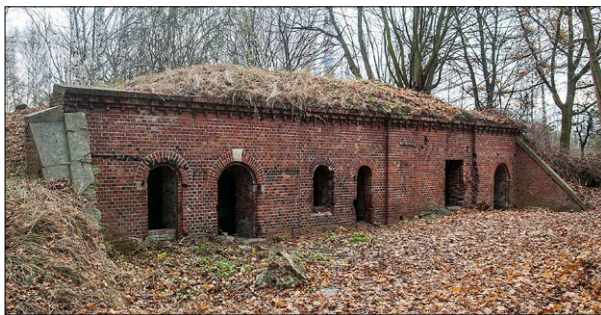
Ryc. 4. Przygotownia amunicji z 1866 r. w bastionie VII

Fig. 4. Ammunition preparation workshop from 1866 in bastion VII

Between 1866 and 1874, a number of buildings related to the storage of gunpowder and the preparation of ammunition were built.<sup>9</sup> On the Eastern Rampart, which at that time constituted the actual defensive ring of the fortress, two ammunition preparation facilities were located (Fig. 4)<sup>10</sup> with adjacent powder magazines (from

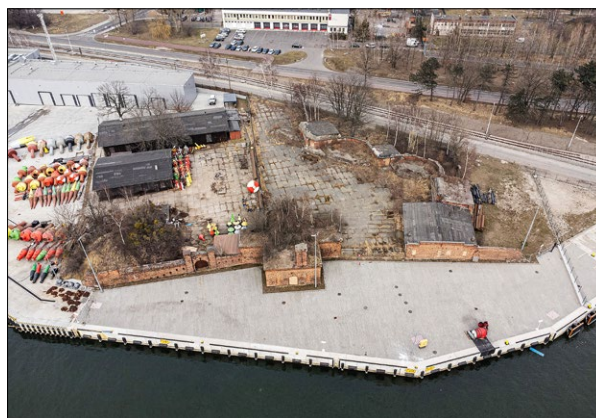
Ryc. 6. Stan obecny Szańca Mewiego – widok z lotu ptaka od strony południowo-zachodniej

Fig. 6. Current state of the Seagull Redoubt – aerial view from the southwest

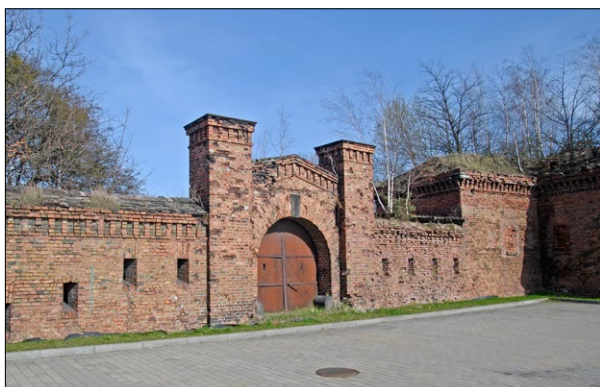
Ryc. 9. Zachowany mur szyjowy z bramą wjazdową – stan obecny  
Fig. 9. Preserved gorge wall with entrance gate – current state

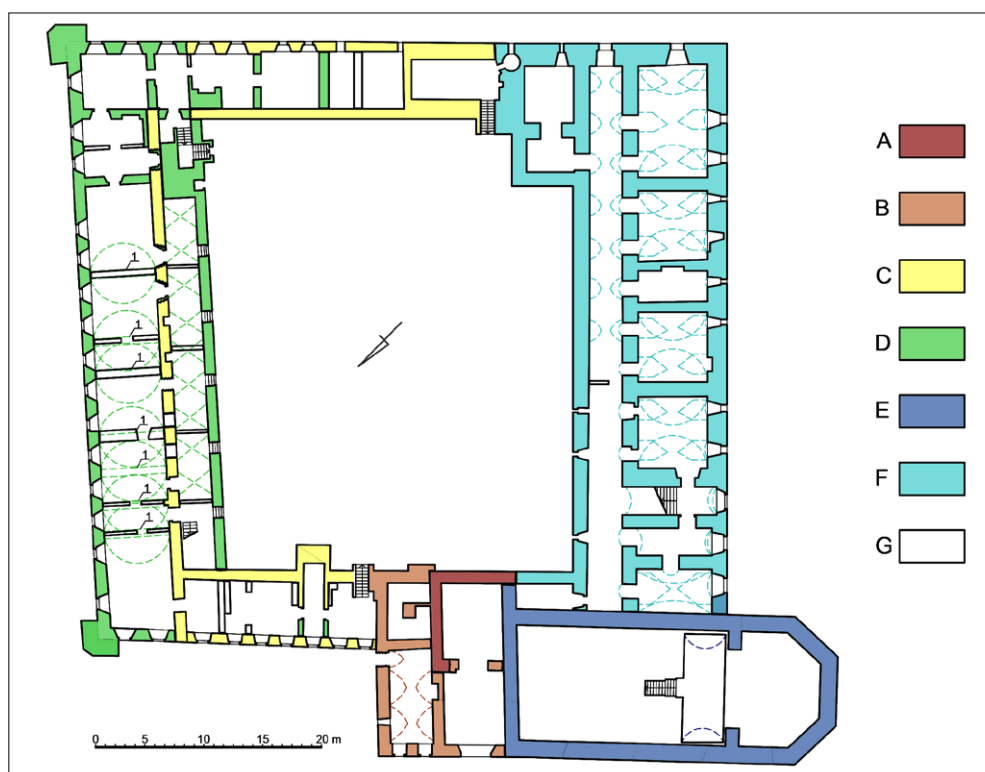
Ryc. 5. Zespół pałacowo-klasztorny, rzut piwnic z chronologicznym rozwarstwieniem murów (oznaczenia jak na ryc. 4); oprac. A. Legendziewicz, D. Dobrasiak

The gatehouse was built on a plan close to a rectangle that had dimensions of 7.9 m by 9.6 m. A passage was located on the ground floor. From the courtyard, it was accessed through a nearly semicircular opening, which was placed in a shallow recess (half a brick deep). Above the passage was a room that measured 5.6 m by 7.7 m. The edges of three openings, which were found on the edges of the walls, indicate that this room was likely lit by six windows—two in each of the southern, northern, and eastern walls. The walls of the room were plastered, as indicated by the worn-out joints. It was covered with a ceiling, the beams of which were placed on a wall offset. The lower edge of the offset was constructed of brick laid in a header course pattern (Fig. 4, 5).

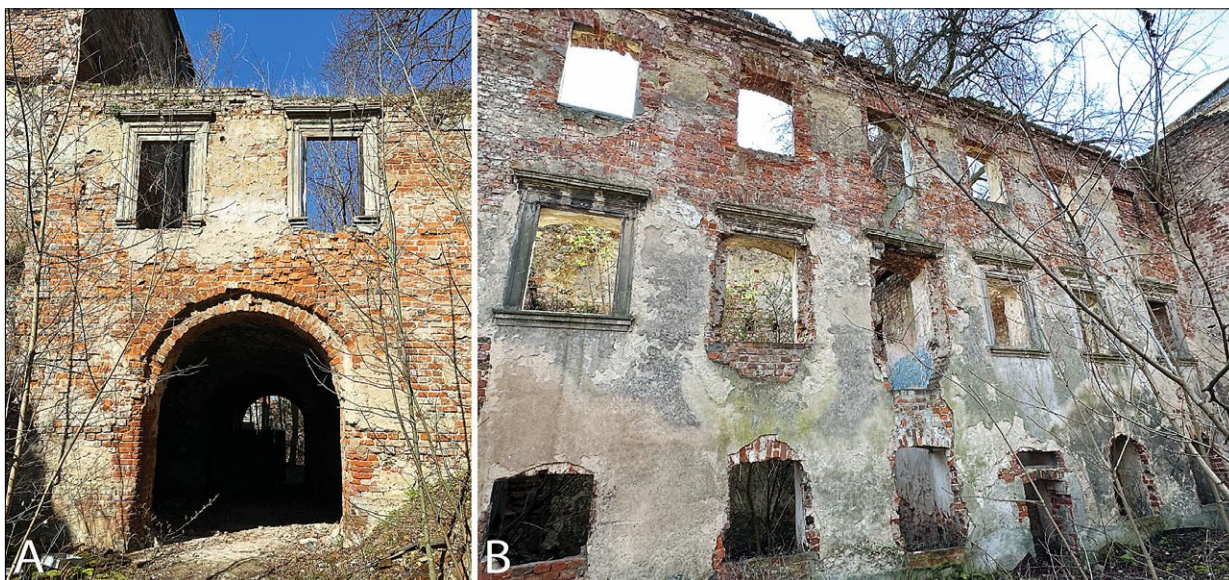
Ryc. 6. Zespół pałacowo-klasztorny: A) budynek bramny, elewacja południowa (otwór bramny z ok. połowy XV w., obramienia z końca XVI w.), B) skrzydło północne (z początku XVII w.), elewacja północna; fot. A. Legendziewicz, D. Dobrasiak

Trójkondygnacyjne skrzydło północne założono na rzucie prostokąta o wymiarach  $18,6 \times 7,4$  m. Elewację północną zakomponowano jako siedmioosiową. Prostokątne okna parteru ujęto w kamienne obramienia z naczółkami. Nad nimi umieszczono otwory piętra – mniejsze niż obecnie. Ich świadectwem są rozkute mury w pasie gzymsu, nadmurowane wnęki oraz widoczne od wnętrza łęki odciążające o grubości jednej cegły. Piwnicę doświetlały niewielkie otwory o nieznanej obecnie formie. Ze względu na różnicę poziomów elewacja południowa, dziedzińcowa, miała dwie kondygnacje. Jej kompozycja była zapewne czteroosiowa, co potwierdzają zachowane we wnętrzach ślady łęków i krawędzie wnęk okiennych. W drugiej od zachodu osi, w płytkim ryzalicie, umieszczono półkoliste wejście na parter. Nad otworem zakomponowano płycinę z dekoracją floralną w kolorze czerwonym z datą „16... [?]”. Zwieńczenie elewacji tworzył gzyms wsparty na konsolach. Prawdopodobnie stanowił on podstawę attyki będącej oprawą „dachu włoskiego, który nie pasuje do naszych okolic” [Hoffmann 1931, s. 188] (ryc. 6, 7).

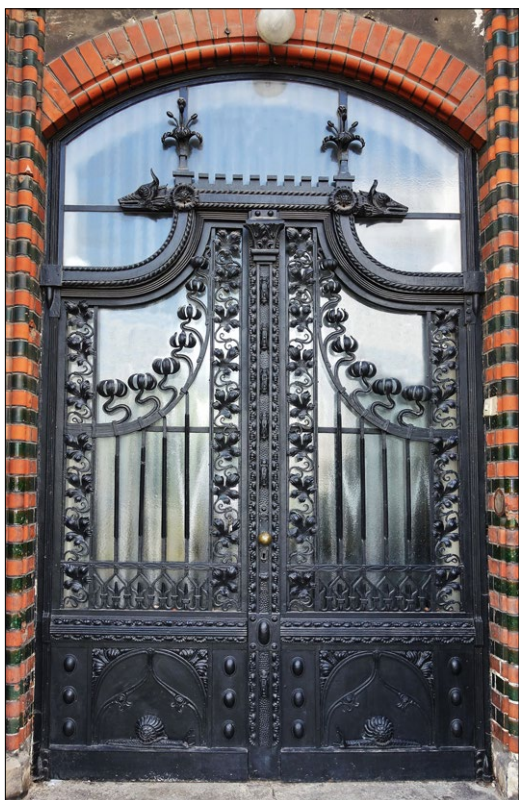
Ryc. 5. Drzwi eklektyczne do Wyższej Szkoły Realnej św. św. Piotra i Pawła

Fig. 5. Eclectic door of SS Peter and Paul's Real School

The door of the former St. Peter and Paul's Real School is also of eclectic style (Fig. 5). This double-leaf door with transom light was fitted in a doorway capped by a segmental arch. The transom is of an unusual design: its middle section projects upwards and the sides take the form of concave arches. The ornamental wrought ironwork features insect motifs, including bees (crawling up the central mullion), a snail, and a wolf's head in the transom. These details were probably carefully selected for their associations with learning and

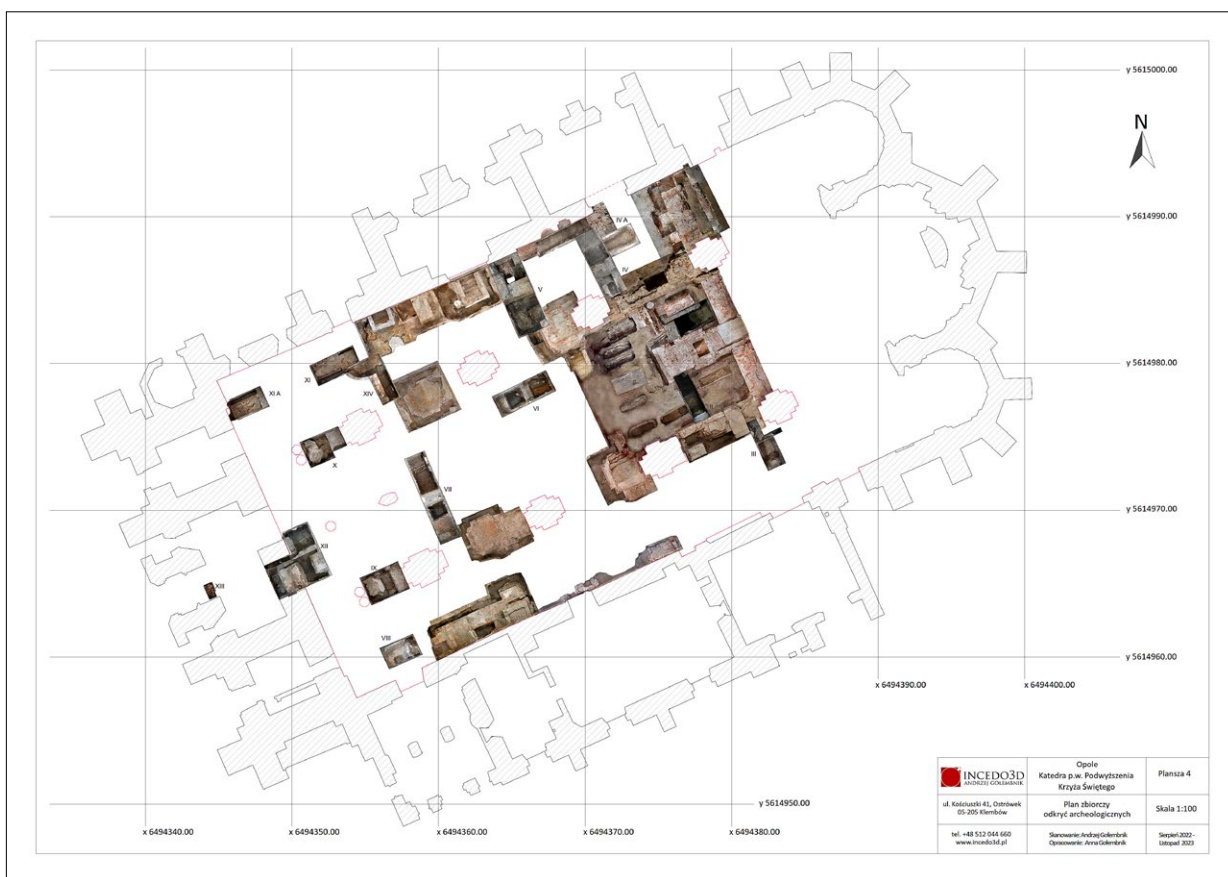
Ryc. 1. Katedra opolska, plan zbiorczy odkryć archeologicznych, skala 1:100; fot. A. Golembnik

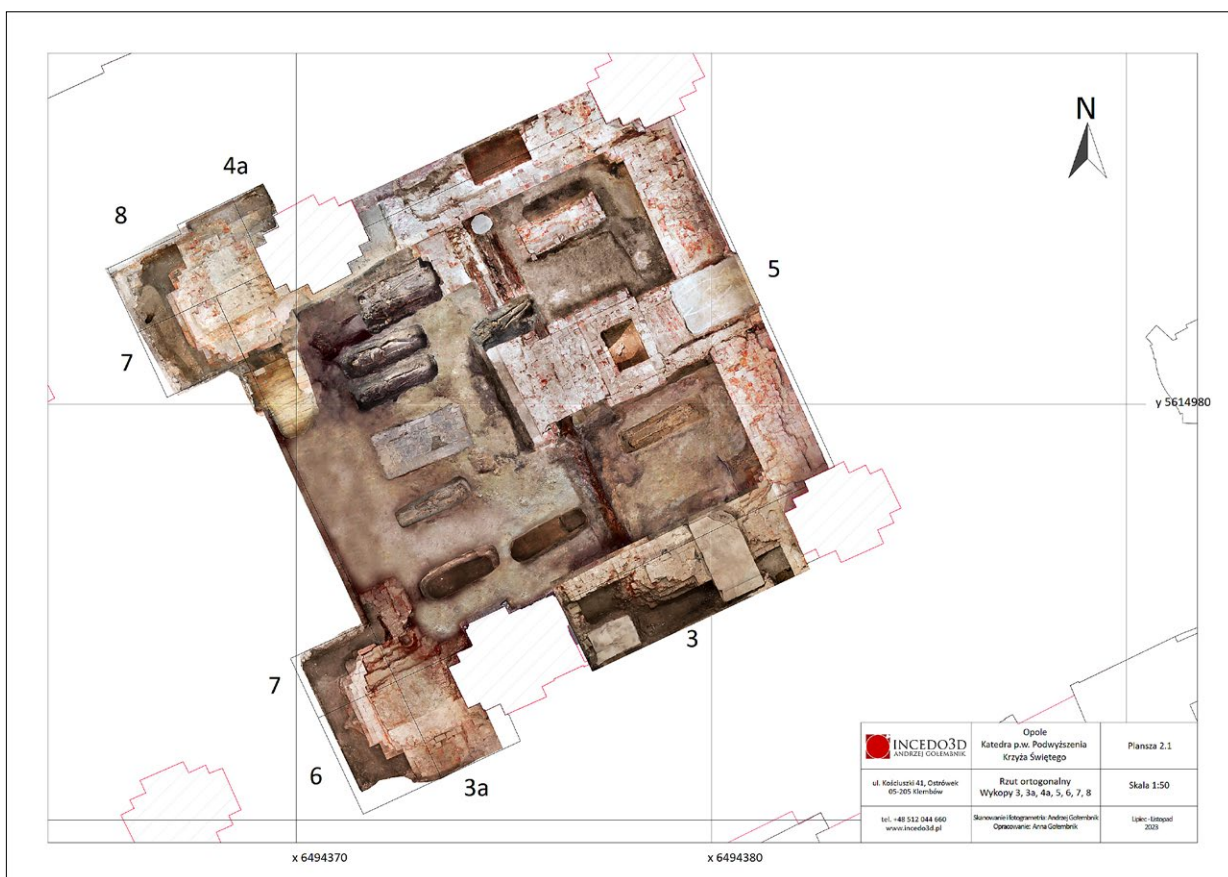
Ryc. 4. Katedra opolska, rzut prezbiterium, wykopy archeologiczne, skala 1:50; fot. A. Golembnik

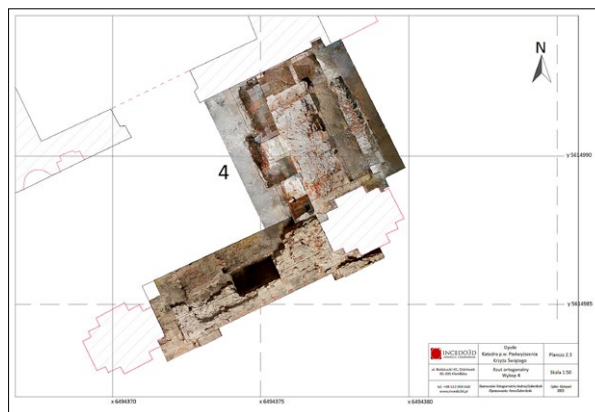
Ryc. 8. Katedra opolska, rzut poziomy wykopu 4, klatka schodowa, skala 1:20; fot. A. Golembnik

Fig. 8. Opole Cathedral, horizontal view of excavation 4, staircase, 1:20; photo by A. Golembnik

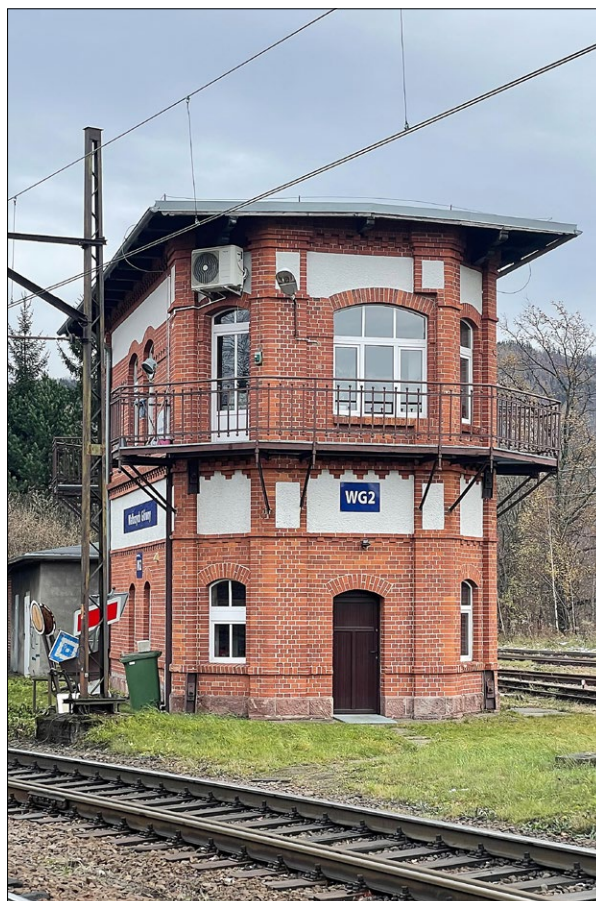
Fig. 2. “WG2” executive signal box at Wałbrzych Główny station; 2024, photo by M. Urbaniak

Such simple structures can still be found today at Kłodzko Główne station (“KG2” signal box), Żary (“Ża2” signal box) or in Tuplice (“Tp1” signal box). On the other hand, at the Wałbrzych Główny junction, attention is drawn to the “WG2” signal box of 1903, with a brick and plaster facade with decoration in the convention of simplified industrial architecture [Dominas 2010, p. 48]. The out-of-service signal boxes from the middle of the first decade of the twentieth century at stations in Strzelin or Żary (“Za3”) look similar, as well as in Wąbrzeźno, where the “Wb” signal box exudes elegant decor with an industrial patina.

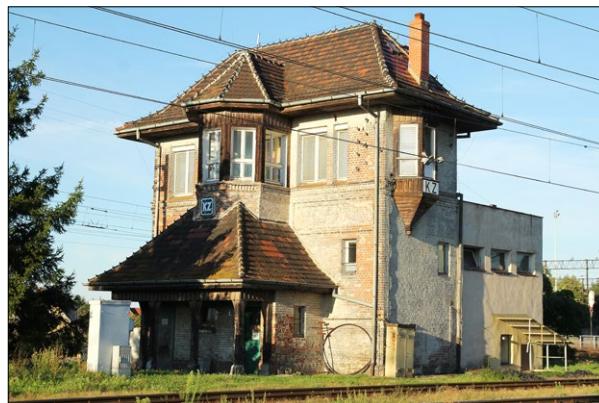
Fig. 4. The “KZ” signal box in a native style in Kamieniec Żąbkowicki; 2023, photo by M. Urbaniak

Setting aside the monumental nature of these buildings, the artistic reorientation is also clear. It has a varied dimension and it is difficult to make a clear characterization of it, but undoubtedly the influence of the so-called native style (*Heimatstil*) is evident, especially in Silesia. The signs of this influence are the visually flowing roof surfaces, bay windows, additions to facades made out of fachuwerk or stone cladding, wooden siding in the upper wall parts, etc. Good examples are the “ŚŚ1” and “ŚŚ” signal boxes in Ścinawka Średnia from around 1914, and the “KG” command signal box in Kłodzko from 1906. One of the most valuable of such projects in Poland, namely the richly articulated “KZ” signal box in Kamieniec Ząbkowicki, was also built in a similar spirit [Dominas 2010, p. 74; Dominas, Przerwa 2015, pp. 135–138] (Fig. 4).

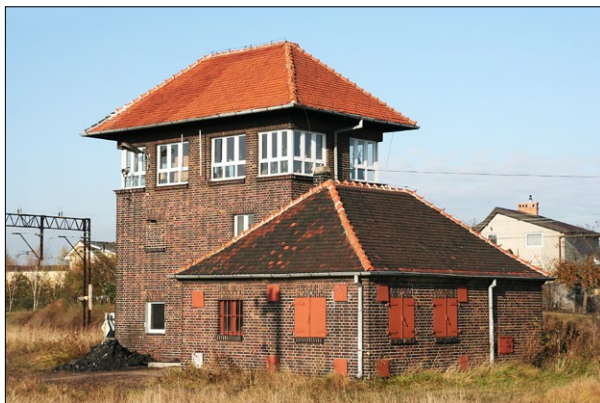
Fig. 7. Signal box with a power plant at Gniezno station – “Otto” program; 2009, photo by M. Urbaniak

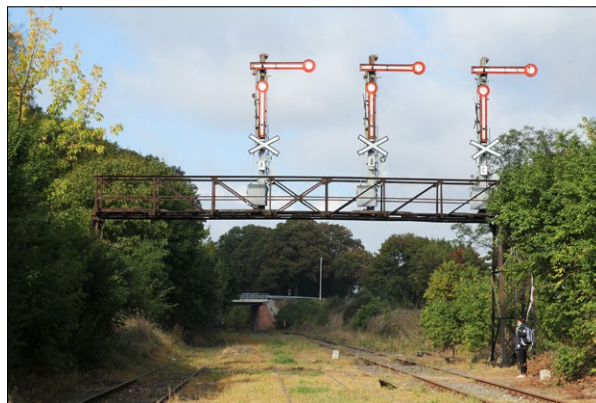
Fig. 8. Signal gantry in Międzychód; 2015, photo by M. Urbaniak

Wśród sygnalizatorów kształtowych wyróżniamy przede wszystkim semaforów jedno- i dwuramienne, zezwalające na wjazd (wjazdowe) na stację oraz wyjazd (wyjazdowe) ze stacji; ponadto istnieją semaforów drogowskazowe (na większych stacjach). Cechują je maszty nitowane bądź spawane o wysokości do 12 m, co zapewnia odpowiednią widoczność. Unikatywne są kształtowe semaforów karzełkowe o wysokości od 3,0 do 5,5 m; tego typu rarytasy jeszcze niedawno pracowały przynajmniej na kilku stacjach, ale w ostatnich latach zniknęły z Torunia Wschodniego, Chełmży (bodaj najsłynniejszy „karzełek” w Polsce) czy Gniezna (tam funkcjonował jedyny w Polsce elektromechaniczny semafor karzełkowy). Jak podaje Michał Jerczyński, w chwili obecnej ostatni „karzełek” na sieci PKP funkcjonuje na stacji w Starogardzie, co czyni go bezcennym zabytkiem techniki [Jerczyński 2024, s. 88]<sup>3</sup>. Podobnie jest też w odniesieniu do specyficznych konstrukcji semaforów kształtowych na stalowych pomostach nad torami. Ostatni taki w Polsce, choć nieczynny, znaleźć można w Międzychodzie, gdzie na ramie stoją trzy sygnalizatory. Jeszcze niedawno pomost sygnalowy z dwoma semaforami był w Skwierzynie, ale w 2019 r. został zdemontowany; innym technicznym rarytasem jest tarcza ostrzegawcza na pomoście (na wjeździe z Poznania do Wolsztyna). To również ostatni taki obiekt techniki na liniach PKP (ryc. 8).

p. 88].<sup>3</sup> The same is also true for the specific design of manual semaphores on gantries. The last one of its kind in Poland, although out of service, can be found in Międzychód, where three traffic signals stand on a gantry. Until recently, there was a signal gantry with two semaphore signals in Skwierzyna, but in 2019 it was dismantled; another technical rarity is the warning sign on a gantry (at the entrance to Wolsztyn from the direction of Poznań). It is also the last such piece of technology on PKP lines (Fig. 8).

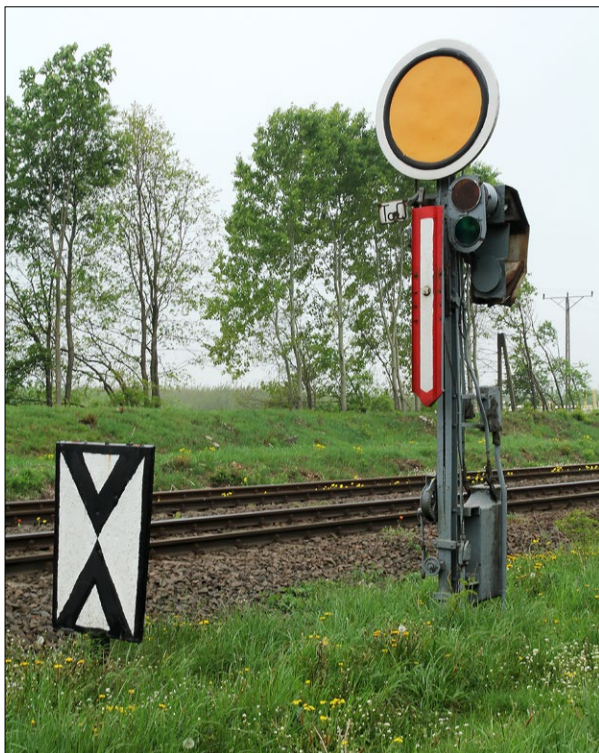
*Fig. 9. Poland's sole electrically powered, tri-interlock warning signal in Żary; 2018, photo by M. Urbaniak*

Exit semaphore signals are located within stations, while entry semaphores are erected at a suitable distance from a station's first switch and preceded by warning signs at a prescribed distance (up to 1,000 m on main lines). The latter warn the engine driver of the approach to the station and the signal given on the entry semaphore so that he can safely start braking the train. Three-position warning signs (with a vertical arrow and mirror chamber) are very specific and rare, and their last specimens can be found in, among other places, the Lubusz Voivodeship. Their unique status is due to the fact that they were introduced on the German Reichsbahn only starting in 1935 (Fig. 9).

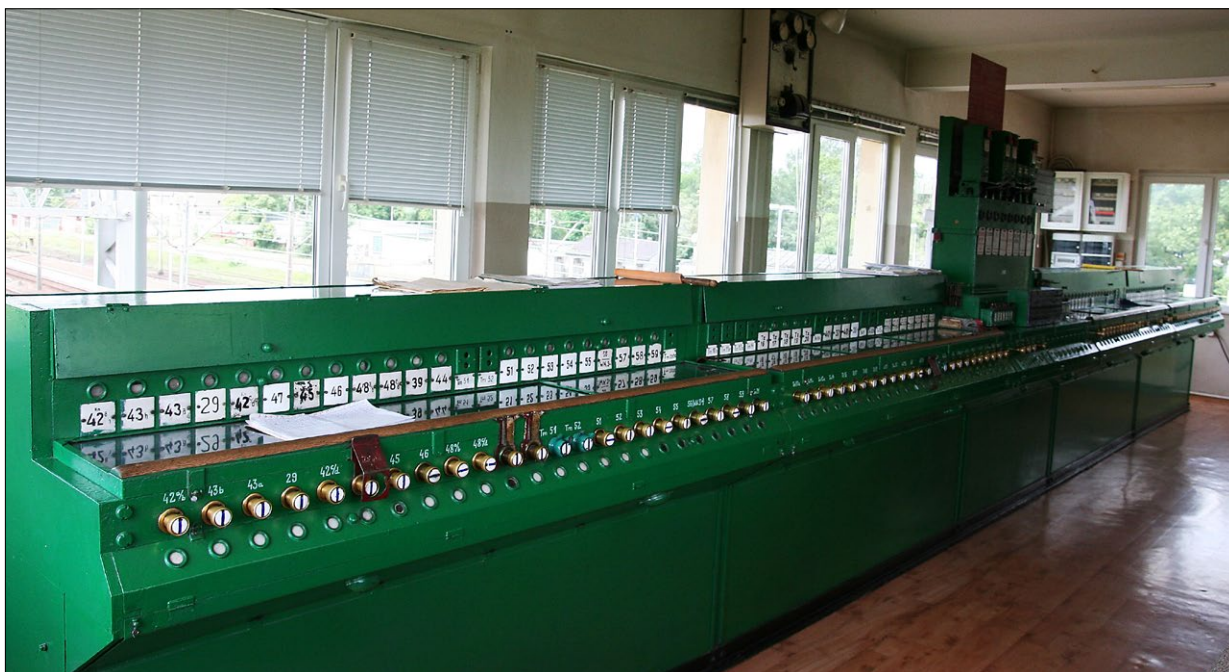
Ryc. 10. Nastawnica elektryczna suwakowa jednorzędowa nastawni „GnA” w Gnieźnie; 2010, fot. M. Urbaniak

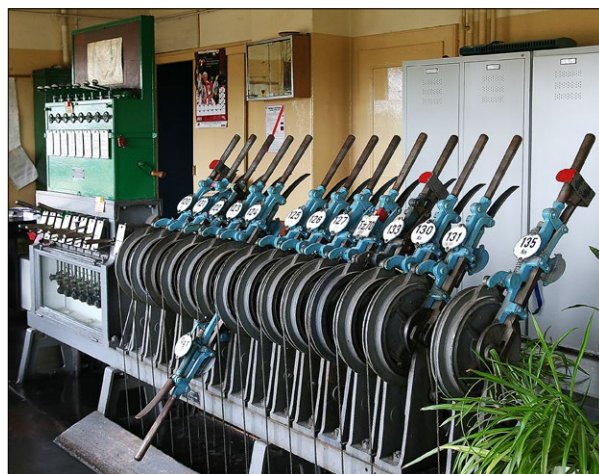
Fig. 11. Mechanical lever frame with a track circuit in Gniezno; 2009, photo by M. Urbaniak

Paradoxically, although evolutionarily older, mechanical devices are much more common, with mechanical lever frames being the main design element. The size and length of the frames depend on the number of switches, bolts and signals to be operated, which sometimes makes them sizable. They are complemented by block apparatuses, key boards and dependency boxes (including those with runner levers). They rule out misalignment of switches and signals to prevent trains from colliding on a single track [Karaś 1980, p. 35, Mikulski 1955, p. 170] (Fig. 11).

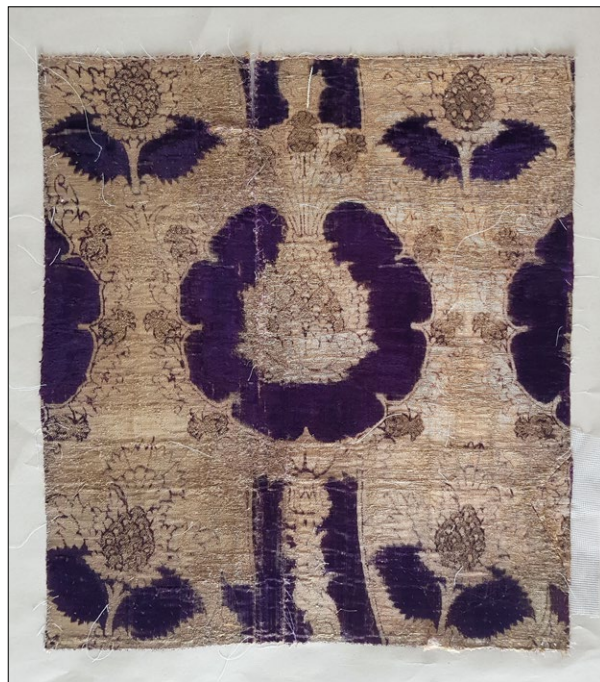
Ryc. 2. Fragment tego samego welum, stan w trakcie konserwacji, po oczyszczeniu na mokro

*Fig. 2. Fragment of the same velum, state during conservation, after wet cleaning*

Przykładem zabytku poddanego głębokiej ingerencji w strukturę tkaniny jest welum z tkaniny z 2. połowy XV w. z kompletu szat liturgicznych fundacji biskupa Piotra Gamrata ze zbiorów katedry na Wawelu (ryc. 1, 2). Konieczność utrzymania wartości funkcjonalnej obiektu nieuchronnie pociągała za sobą potrzebę naprawy jego zużytych części. Wykruszona okrywa runowa altembasu<sup>3</sup>, tworząca wzór na tkaninie welum, została w przeszłości podczas naprawy zastąpiona ścięciem hafciarskim odtwarzającym śladowo zachowany w tle deseń. Naprawa poczyniła szkody w obiekcie, gdyż zasłoniła pozostałości oryginalnej kompozycji nowo powstałym, schematycznie przedstawionym wzorem. Autentyczne nitki osnowy obecne jeszcze w strukturze tkaniny zostały wypchnięte podczas przyszywania tkaniny igłą. Ponadto, choć welum, jak wskazują wyniki badań, oryginalnie było fioletowe, pod koniec XIX lub na początku XX w. zostało przefarbowane przy użyciu fioletu metylowego lub fioletu krystalicznego<sup>4</sup> [Kruszyński 1930, s. 18–23; Krupa 2013, s. 115–116; Lech 2017, s. 312–313; Urban 2008, s. 219–222].

from the collection of the Wawel Cathedral (Figures 1, 2). The need to maintain the functional value of the object inevitably entailed the need to repair its worn parts. The crumbling fleece pile of the altembas,<sup>3</sup> which forms the pattern on the velum fabric, was replaced in the past during repairs with an embroidery stitch reproducing the vestigial pattern preserved in the background. The repair did damage to the object, as it obscured the remains of the original composition with a newly created schematic pattern. Authentic warp threads still present in the fabric structure were pushed out when the fabric was stitched with a needle. In addition, although velum was, as determined by research, originally purple, it was recolored using methyl violet or crystal violet in the late nineteenth or early twentieth century<sup>4</sup> [Kruszyński 1930, pp. 18–23; Krupa 2013, pp. 115–116; Lech 2017, pp. 312–313; Urban 2008, pp. 219–222].

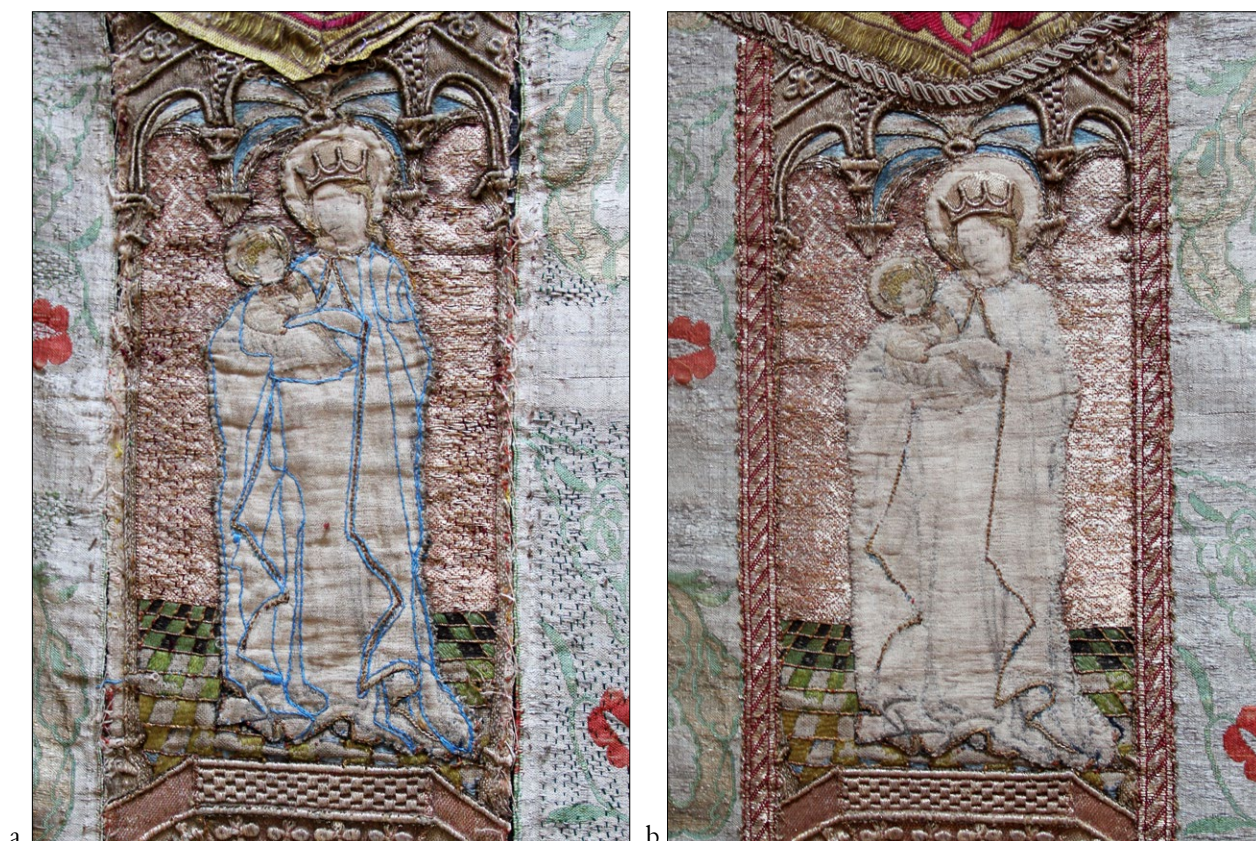
Ryc. 3. Fragment gotyckiej preteksty z ornatu ze zbiorów kościoła pw. św. Katarzyny Aleksandryjskiej w Wolbromiu: a) stan przed konserwacją, b) stan po konserwacji

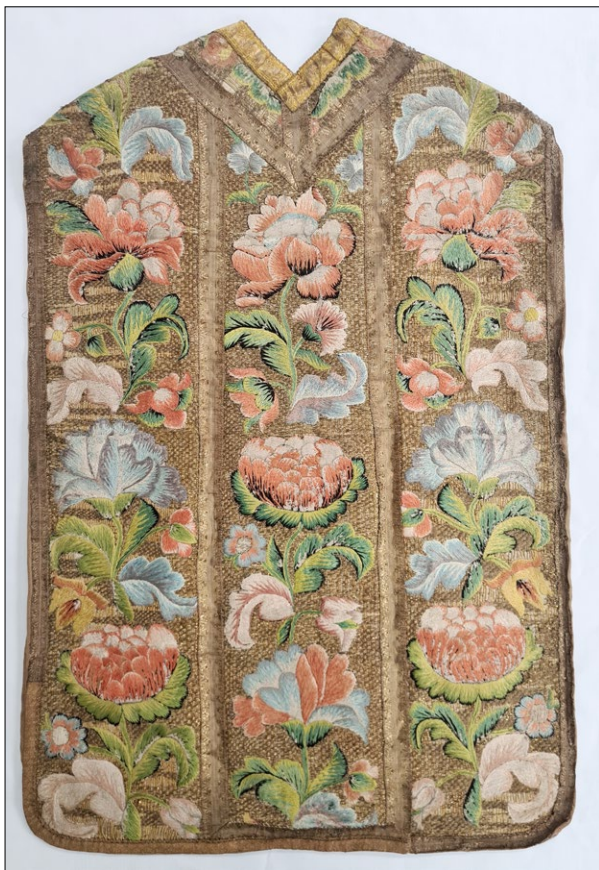
Ryc. 4. Ornat ze zbiorów kościoła pw. św. Klemensa w Trzemeśni (XVIII w.), stan przed konserwacją, widoczne uzupełnienia haftu barwnymi nićmi

Fig. 4. Chasuble from the collection of the Church of St. Clement in Trzemeśnia (eighteenth century), condition before conservation, visible additions to the embroidery with colored threads

One example of this type of repair is a set of chasuble with a stole from the Church of St. Clement in Trzemeśnia, made in the eighteenth century (Fig. 4, 5). An analysis of the object's state found extensive old repairs that reconstructed the composition of the

embroidery. A thorough study of the structure of the embroidery and a comparison of the front and back parts of the chasuble allowed conclusions to be drawn about the heavily outlined interference with the original structure of the asset. Both in the color part of the composition and in the part of the metal background, additions can be identified in the form of covering up the original structure of the object with contemporary embroidery. The comparison of the front and back of the chasuble shows a wide variation in the embroidery's state of preservation. The back part of the robe features an aggressive complement of colorful embroidery stitches. The flaxen, pale colors of the flower petal fill in the front of the chasuble fade in contrast to the vivid hues of the threads covering the fields of the reconstructed composition. In this comparison, the original cannot compete with the past repair that covers a significant part of the asset.

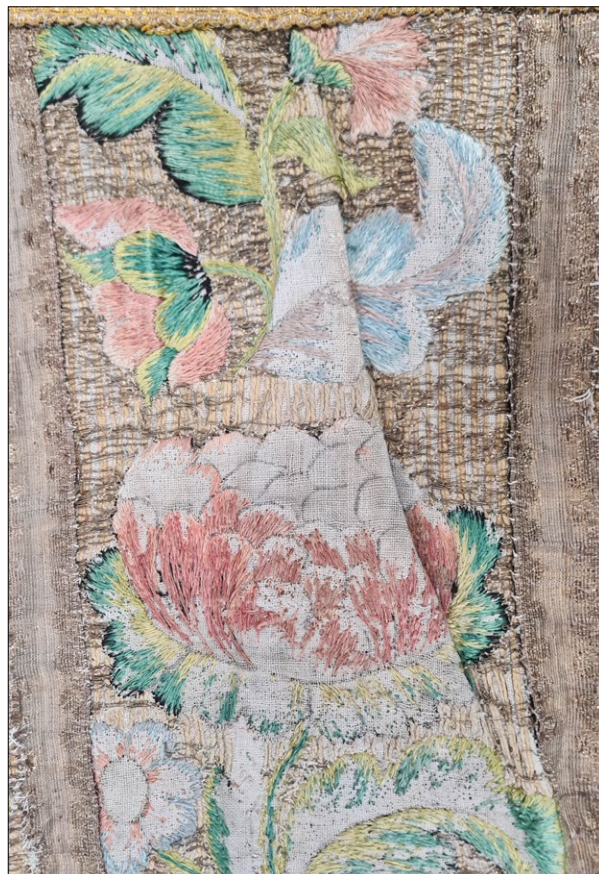
Ryc. 5. Fragment przedniej części tego samego ornatu, widoczne zachowane oryginalne ściegi hafciarskie

Fig. 5. Fragment of the front part of the same chasuble, showing preserved original embroidery stitches

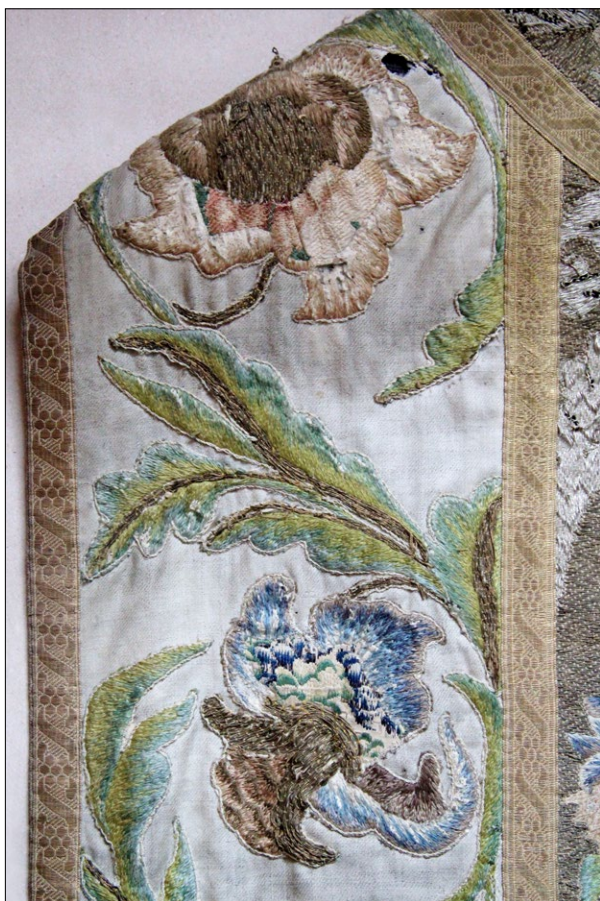
Ryc. 6. Fragment ornatu z kościoła pw. św. Jana Chrzciciela z Korzkwi (boki z końca XVII w., kolumna z początku XVIII w.), stan przed konserwacją, widoczne elementy haftu wycięte i wtórnie wprowadzone na nowe tło

*Fig. 6. Fragment of a chasuble from the Church of St. John the Baptist in Korzków (sides from the end of the seventeenth century, orphrey from the beginning of the eighteenth century), condition before conservation, visible elements of embroidery cut out and reinserted on a new background*

is the repair within the chasuble from the Church of St. John the Baptist in Korzków (Fig. 6, 7). The side parts of the chasuble were made of embroidered floral compositions cut out and re-composed on a new base. Locally, within the flower petals, needle stitch inserts were introduced from eighteenth-century fabrics made in Jean Revel's naturalist style or compositions with floral motifs from the late eighteenth century. These applications were supplemented with contemporary embroidery, giving them a new expression and floral form.

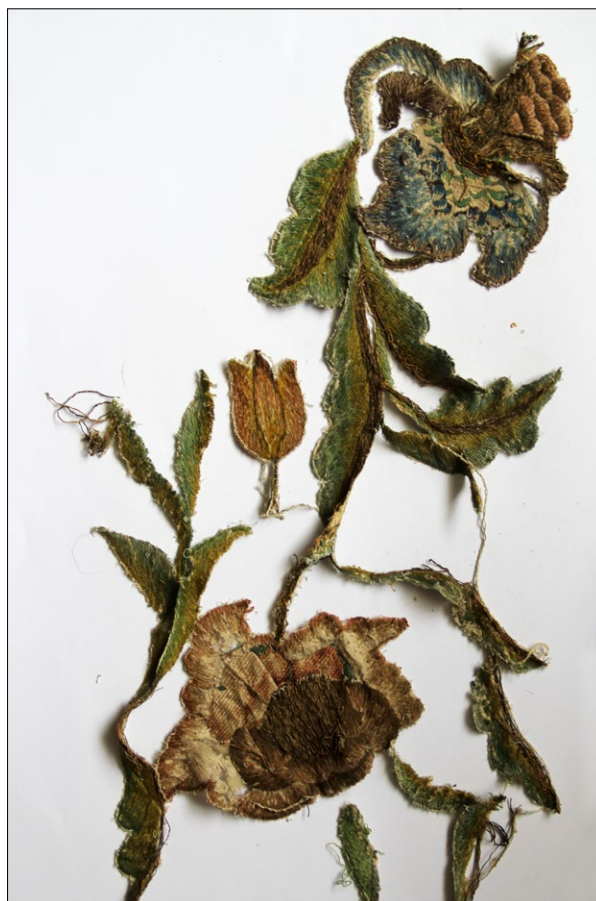
Ryc. 7. Fragmenty kompozycji oryginalnego haftu w trakcie konserwacji, widoczne elementy haftu zdemontowane do czyszczenia na mokro

*Fig. 7. Fragments of the composition of the original embroidery during conservation, visible elements of the embroidery dismantled for wet cleaning*

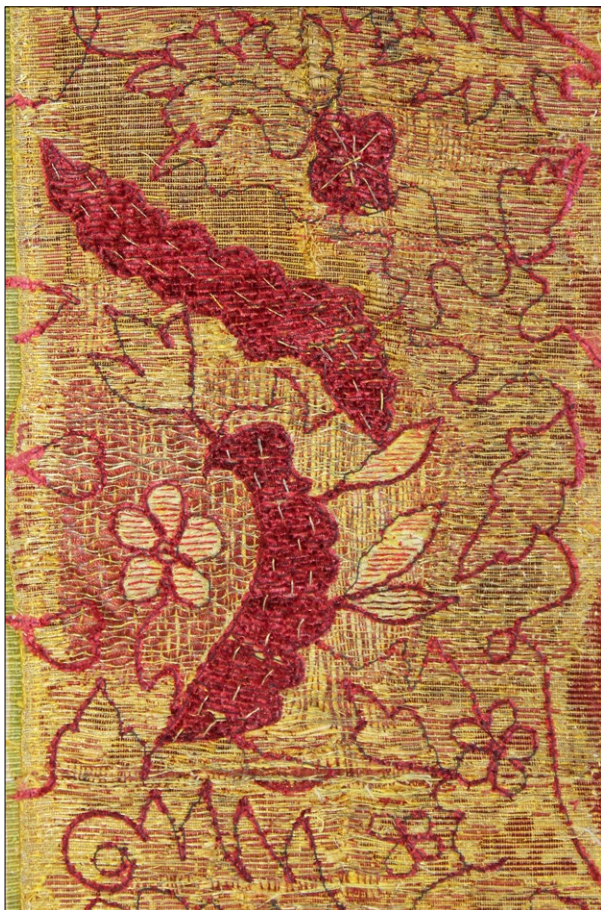
Ryc. 8. Fragment tkaniny z przedniej części ornatu ze zbiorów kościoła pw. św. Jakuba w Więclawicach (3. ćw. XV w.), widoczne dawne naprawy renesansowej tkaniny

*Fig. 8. Fabric fragment from the front part of a chasuble from the collection of the Church of St. James in Więclawice (third quarter of the fifteenth century), former repairs to the Renaissance fabric are visible*

One example of an object that demonstrates the harmfulness of repair interventions and their impact on the historical value of an asset is a chasuble from the collection of the Church of St. James in Więclawice. The chasuble was composed of two Renaissance fabrics: altembas from the third quarter of the fifteenth century, and smooth velvet found in the side parts of

the robe (Fig. 8, 9). Initial inspection indicated the presence of a single valuable Renaissance fabric in the chasuble. The reason for the misidentification was the numerous traces of overlapping repairs, particularly visible in the front part of the chasuble. The altembas fabric underwent repairs that deeply interfered with the fabric's structure, made using embroidery. The result was a pattern on the surface of the column of the front of the chasuble, outlining, in a schematic, caricature-like manner, the pattern of the fabric sewn into the back. Failure to analyze the fragmentary pattern of the altembas during the repair contributed to the distortion of the original Renaissance fabric, the repair obscured the original pattern, and consequently

closed the way for research into the dating of the listed asset. During the restoration of the chasuble in 2020, it was decided by commission to remove the old repairs, and to the eyes of the restorers the original fabric appeared, making it possible to study the style of Italian textile design of the late fifteenth and early sixteenth centuries. Indeed, the obscured fabric from the front of the chasuble column is not the same altembas as the fabric from the back column. Two different valuable fabrics of Italian origin, dating back to the late fifteenth century, have been incorporated into the chasuble from Więclawice.

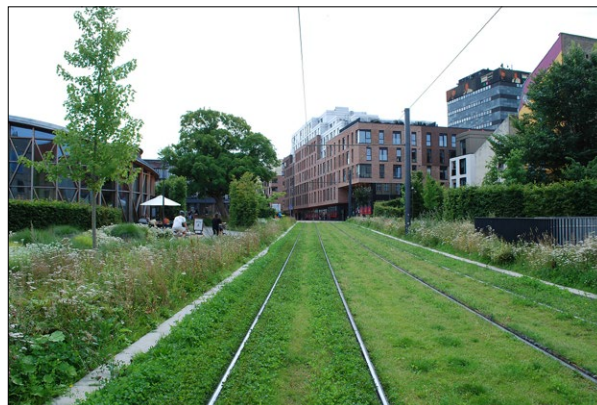
Fig. 2. Odense – green streetcar track in place of removed four-lane road; to the left is the new H.C. Andersen Museum designed by Kengo Kuma Associates; 2022

Ryc. 2. Odense – zielony tor trolejbusowy zamiast zlikwidowanej czterojezdniowej drogi; po lewej widoczne Muzeum H.Ch. Andersena zaprojektowane przez firmę Kengo Kuma & Associates; 2022

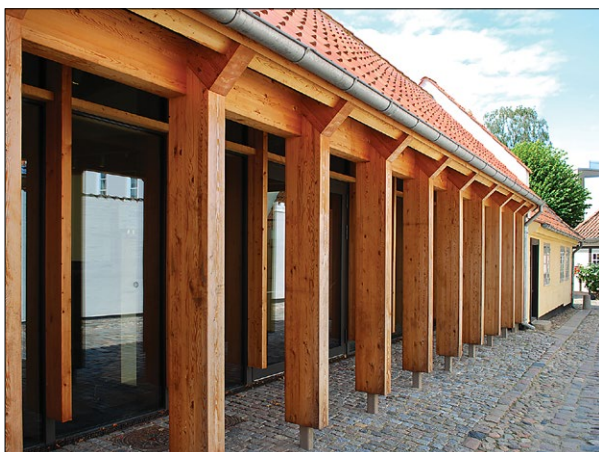
Fig. 7. The facade of the Museum at Bangs Boder street frontage  
Ryc. 7. Fasada Muzeum w obrębie pierzei ulicy Bangs Boder

the side of Bangs Boder (Fig. 7), it consists of an old house renovated by Kuma's office in cooperation with a local architect.

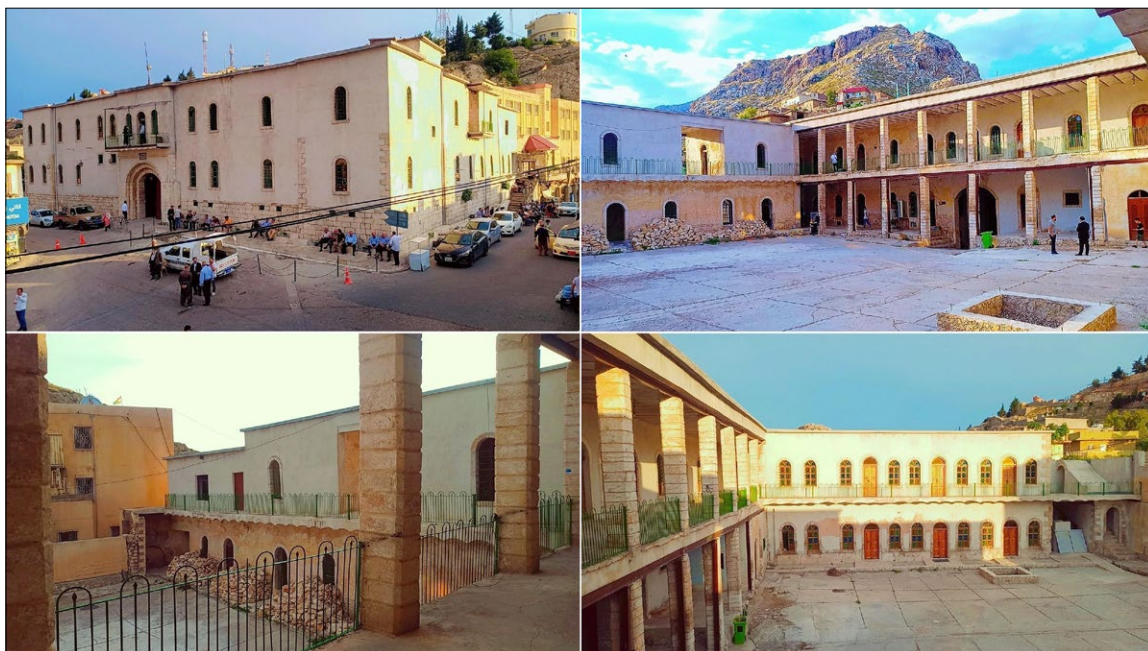
**Fig. 3.** Building of the Qishla of Akre: a) the building, its main entrance, and the building's surroundings, b) the courtyard, view from the northeast, c) the courtyard, view from the southwest, d) photo from the first-floor arcade to the courtyard, view the southeast; by the authors, 2023.

Ryc. 3. Budynek Kiszli w Akrze: a) budynek, główne wejście, otoczenie obiektu, b) dziedziniec, widok od strony północno-wschodniej, c) dziedziniec, widok od strony południowo-zachodniej, d) zdjęcie z podcienia na pierwszym piętrze z widokiem na dziedziniec, widok od strony południowo-wschodniej; zdj. autorzy, 2023.

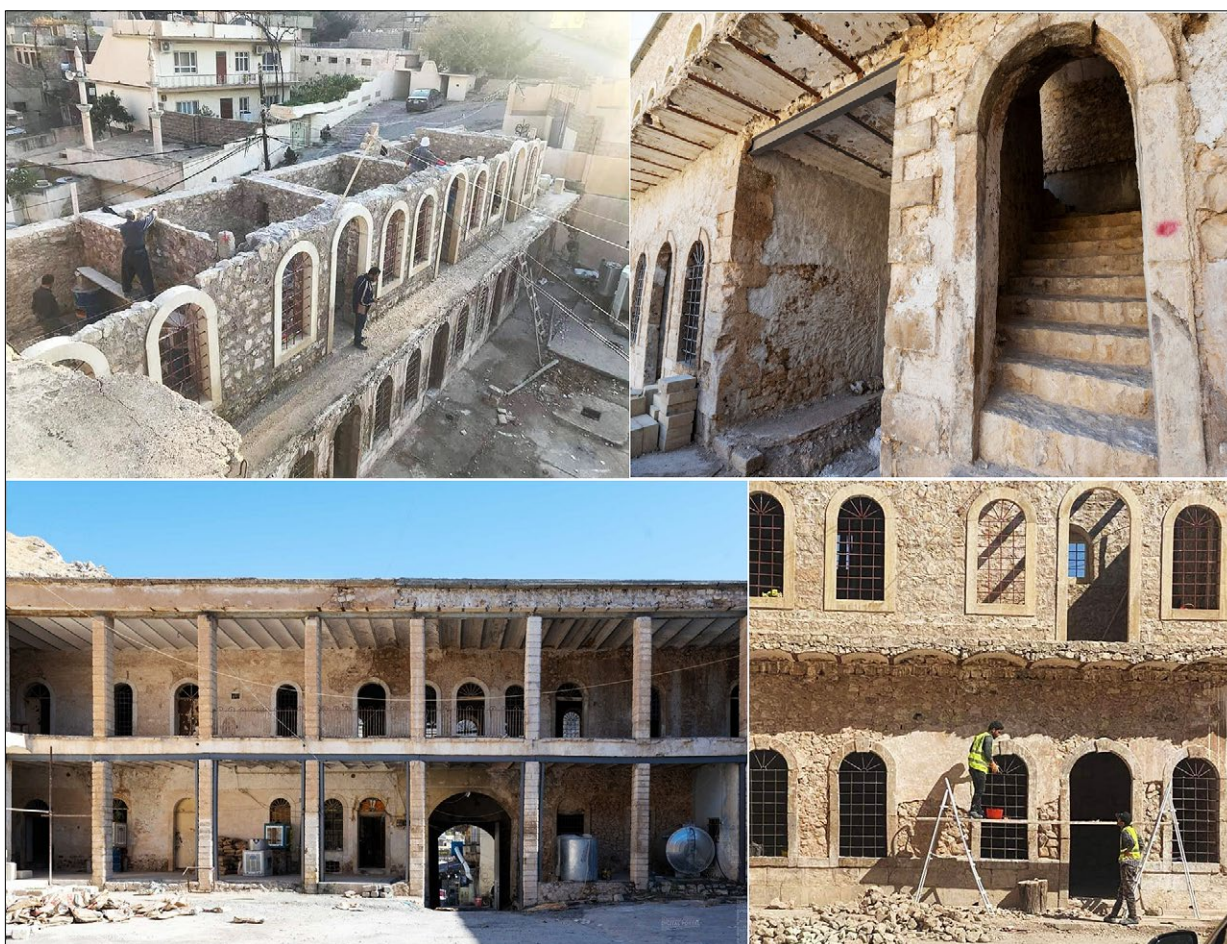
**Fig. 5.** *Preservation work on the Qishla of Akre: a) reconstruction of the first floor walls using traditional materials; source: [pukmedia.com 2022], b) cleaning the original walls, removing the damaged cladding materials, and cleaning the iron beams to prepare them for maintenance work; source: [rudaw.net/ 2023], c) the main entrance facade from the courtyards, showing the scraping of the damaged finishing materials and preparation for restoration work; source: [rudaw.net/ 2023], d) repair work on the walls using tools that are harmless to the original structure; source: [pukmedia.com 2022].*

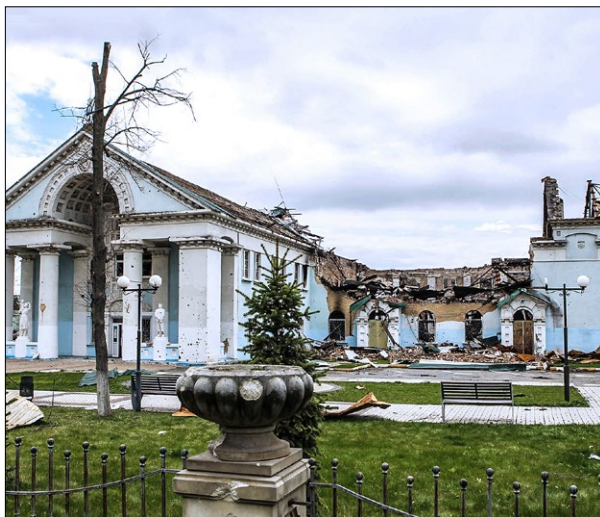
Ryc. 1. Zniszczone dobra kultury w Irpeniu, fot. W. Koskin  
Fig. 1. Damaged cultural assets in Irpen, photo by V. Koskin

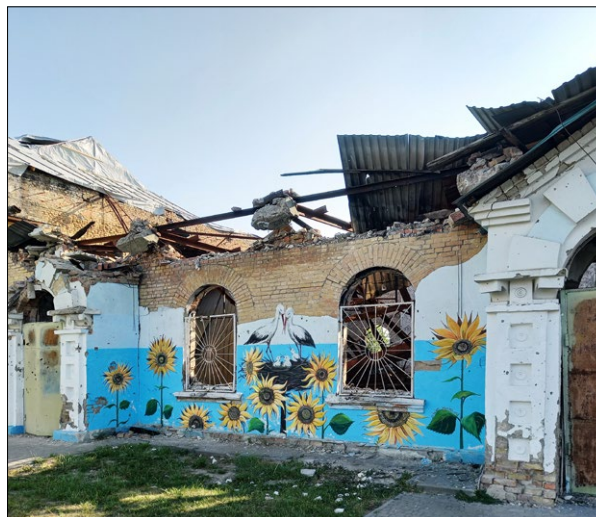
Ryc. 2. Zniszczone dobra kultury w Irpeniu, fot. W. Koskin  
Fig. 2. Damaged cultural assets in Irpen, photo by V. Koskin

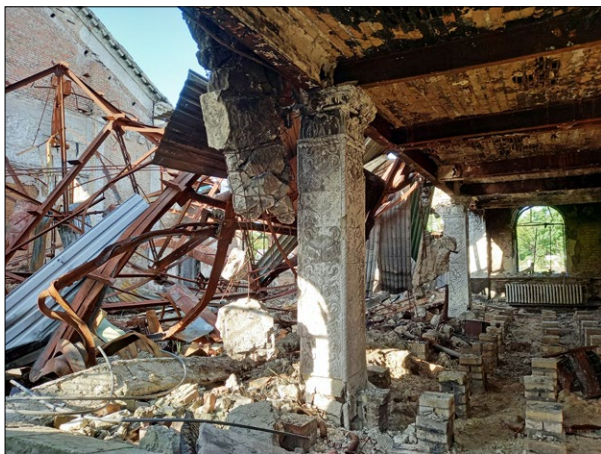
Ryc. 3. Zniszczone dobra kultury w Irpieniu, fot. W. Koskin  
Fig. 3. Damaged cultural assets in Irpen, photo by V. Koskin

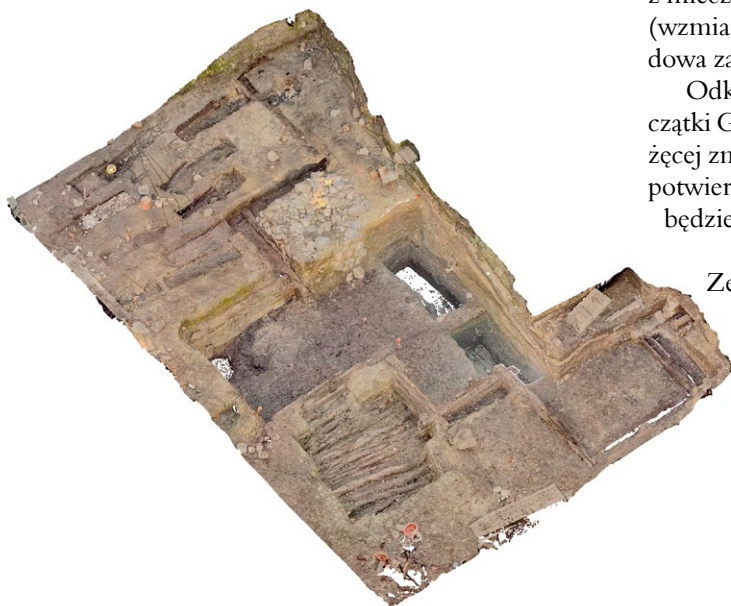
Widok aksonometryczny części stanowiska na Zamczysku w Gdańsku z odsłoniętymi ścianami drewnianego kościoła i cmentarzyskiem; skan S. Kowalski

Badania archeologiczne objęły niemal całą powierzchnię działki, włącznie ze znacznymi partiami pod zabytkowym składem kupieckim z 1747 r. Kontekst stratygraficzny stanowiska jest nieciągły z powodu wielkich przebudów i makroniwelacji związanych z rozbiórką grodu i budową zamku krzyżackiego (ok. 1340 r.), a następnie rozbiórką tegoż (po 1454 r.), wreszcie parcelacją Zamczyska po 1648 r. W części zachodniej znaleziono cmentarz (późnośredniowieczny i wczesnonowożytny – prawdopodobnie tożsamy z dotychczas zaginionym cmentarzem Osieka, tzw. Ram-bau). Podczas prac odsłonięto pozostałości zabudowy zrębowej i towarzyszącej jej sieci ulic. Najistotniejszym odkryciem jest ustalenie przebiegu ścian zrębowych (o wysokości prawie 1,7 m) – prawdopodobnie na planie krzyża greckiego (zachowały się: część wschodnia i dwa ramiona, północne i południowe). Świątynia jest wstępnie datowana na lata 40. XII w., co należy wiązać z tworzeniem organizacji parafialnej Pomorza Wschodniego. Po jej rozbiórce ok. 100 lat później wzniesiono kościół murowany (kamienniego-ceglany) – odkryto pozostały po nim fragment posadzki ceramicznej oraz kamienną płytę przedstawiającą rycerza w kolczudze, z mieczem i tarczą. Kres istnieniu murowanej świątyni (wzmiankowanej po raz ostatni w 1326 r.) położyła budowa zamku krzyżackiego.
