# Economic and Environmental Viability of Building Recovery in Seville (Spain)

## Phase 1: Database in Arcgis

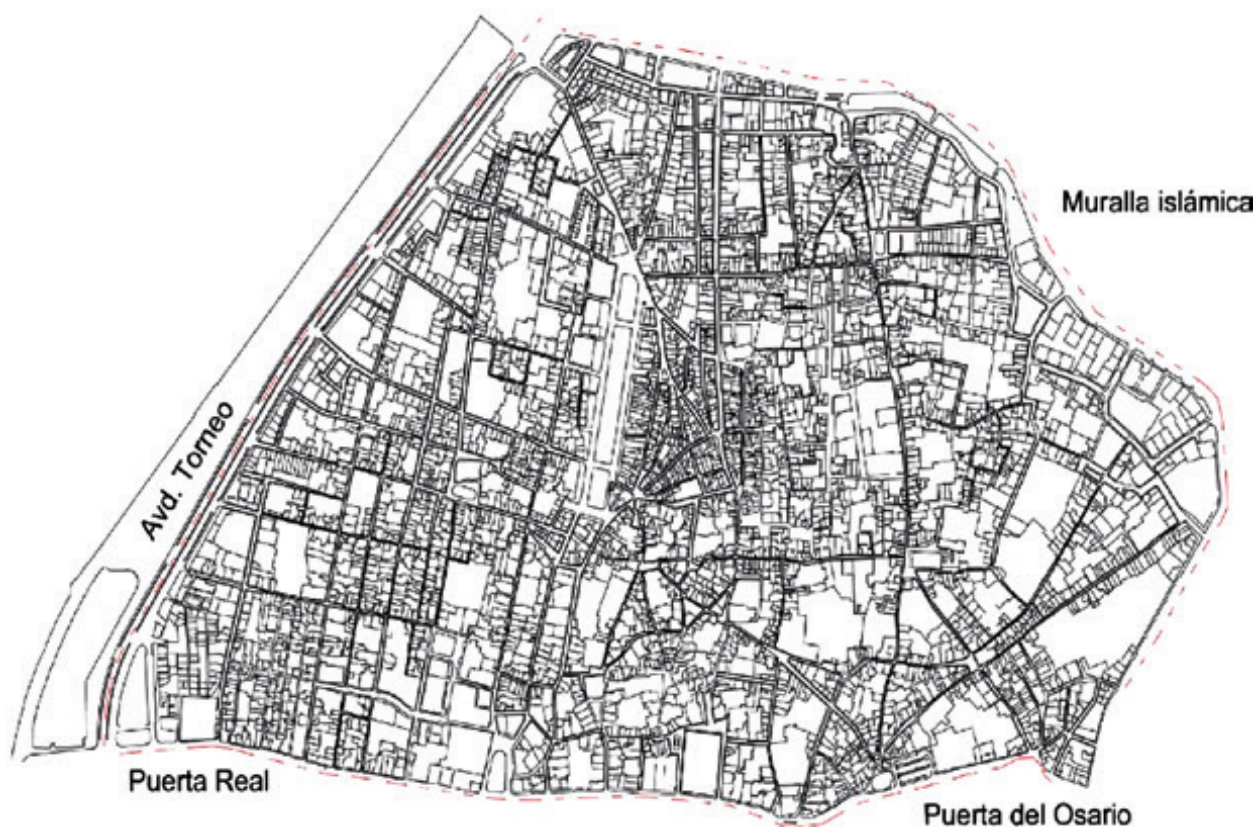
il. 4. Hypothetical axis delimiting the northern part of the historical centre of Seville

Due to the requirement of a minimum age of 50 years for the buildings, the first sampling of identification focuses on the northernmost area of the historical centre (Fig. 3). The area of this sample is bounded by Torneo Avenue, the Islamic wall of Macarena, and a hypothetical axis drawn by the Osario city gate and the Royal city gate (Fig. 4). The northern area of the city centre is traditionally the poorest and most degraded area of the historical centre, housing a large majority of the working-class sector, and, until recently, hosting many industries, such as factories, warehouses, and workshops. Despite covering an area smaller than that of the southern neighbourhoods, the northern part of the city has always presented a greater population (approximately 60% of the total) [8].
